## Review of District Plan Appendix 1D Notable Trees

### Part 2 – STEM Assessments of Notable Trees, Manawatu District Council

Report Date – 4<sup>th</sup> February 2022

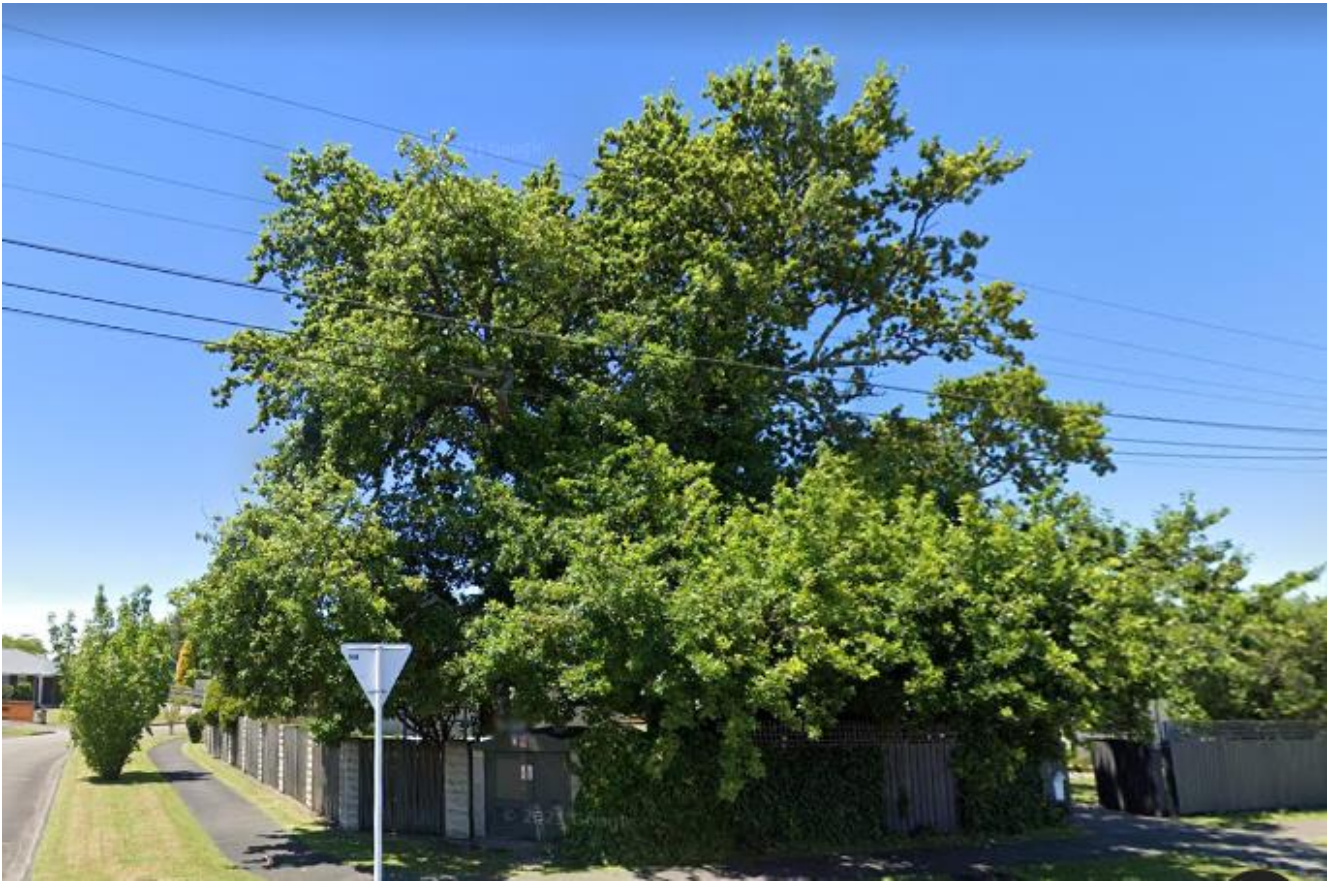
**Assessor's notes:** Canopy over footpath. Die back from tips evident and extensive dead wood. Multi budding on tips and thin internal growth indicates trees are under stress. 2019 photo shows tree in good condition so decline likely to be rapid. Tree owner said that he had been trying to kill ivy around tree by spraying with Round Up. This could be cause of tree's decline and stress if it has entered tree vascular system. It is also possible that dieback could have been caused by root damage caused by upgrade of footpath and resultant root damage. Large pieces of deadwood and thinning crown. Ivy is so thick not possible to inspect condition of roots or trunks. Ivy needs removing. Dead wooding and removal of ivy may cause tree to recover. 1995 assessment indicated decay but this does not mean the tree is unsafe. Recommend crown reduction and remove deadwood and monitoring annually in case disease spreads.

**Nuisance/negative factors:** Overhanging path. No significant nuisance or negative factors such as damage to structures.

**Suggested care and maintenance:** Crown reduce 15 to 20%, deadwood, remove ivy. Trees unlikely to fail given size and weight.

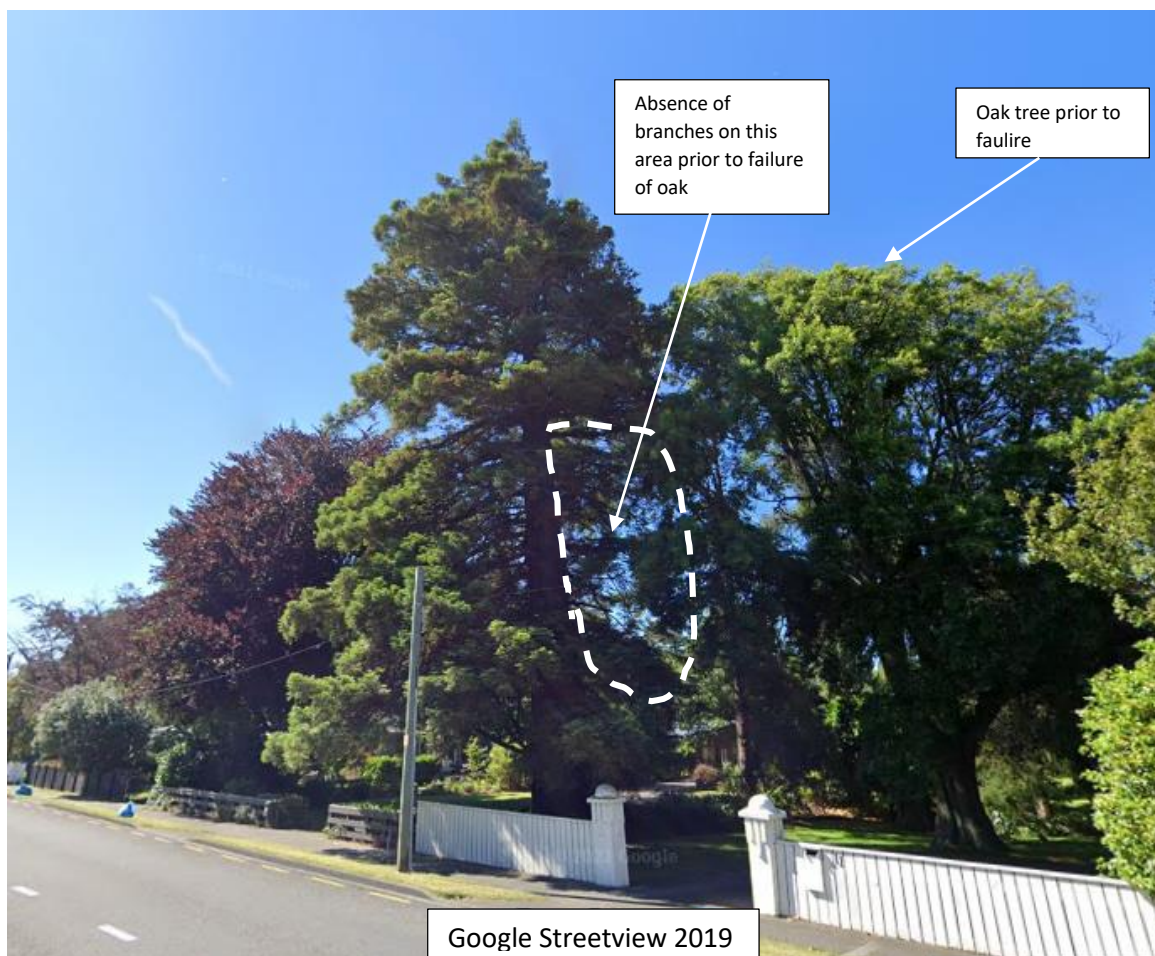
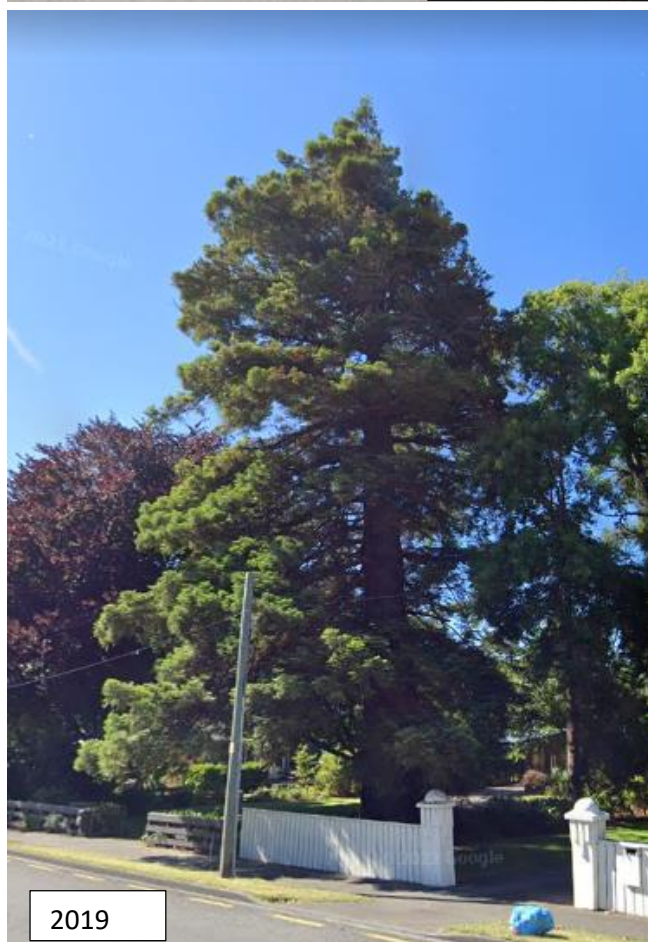
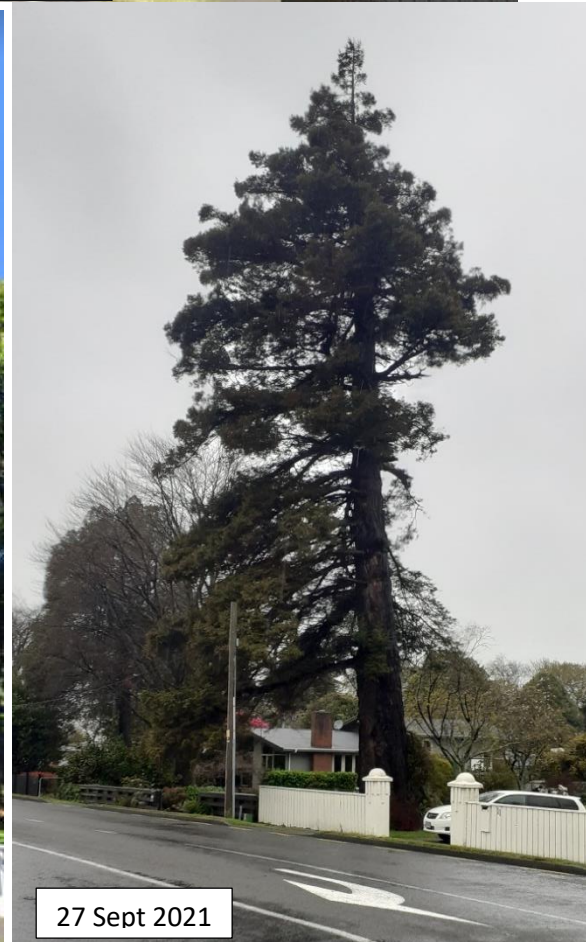
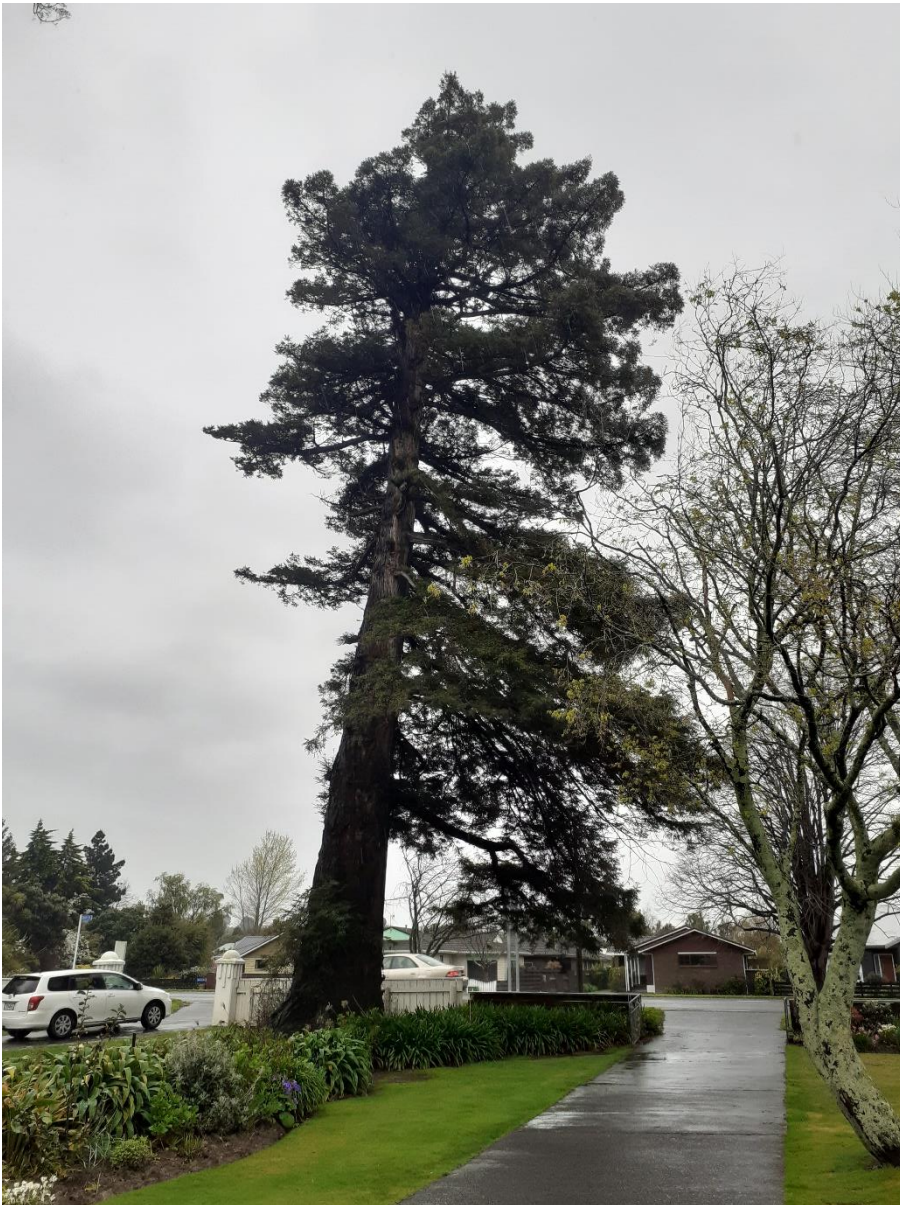
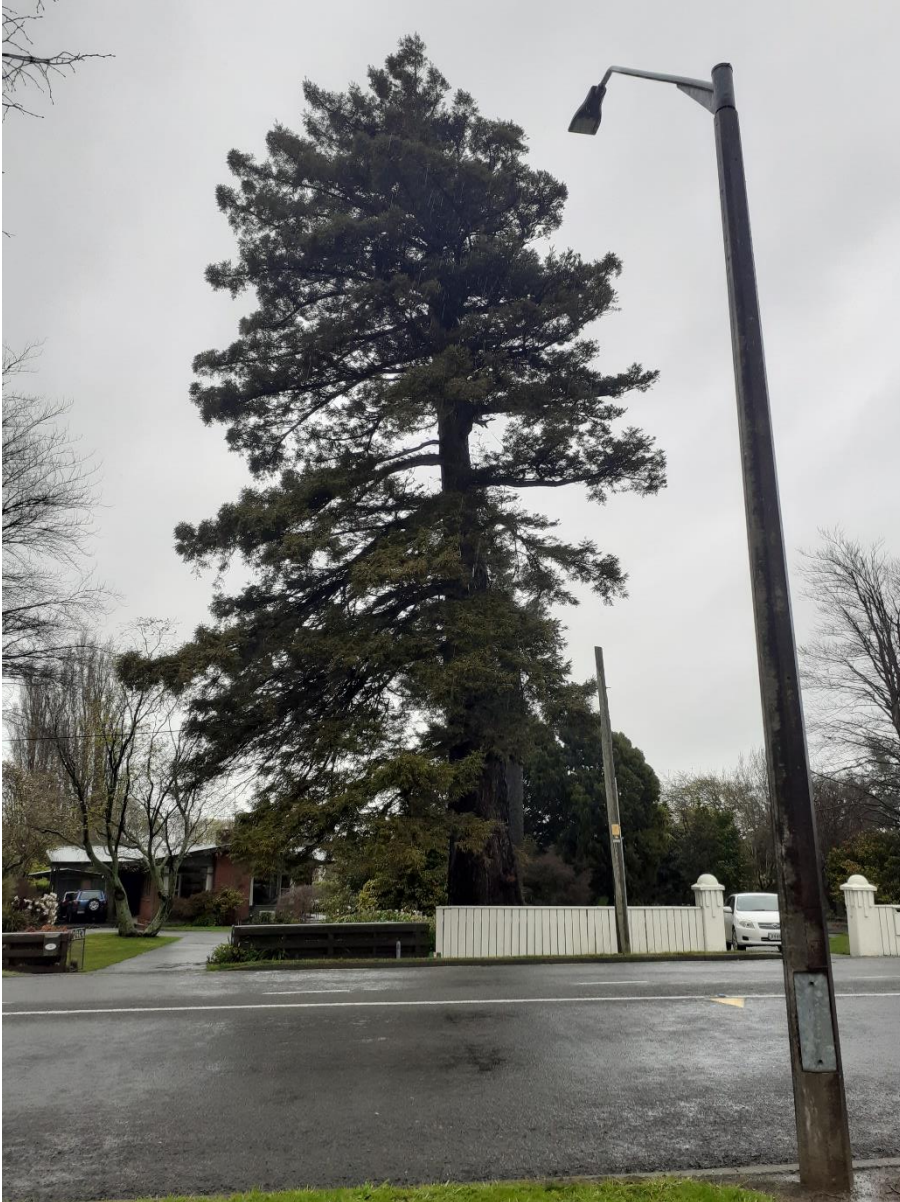
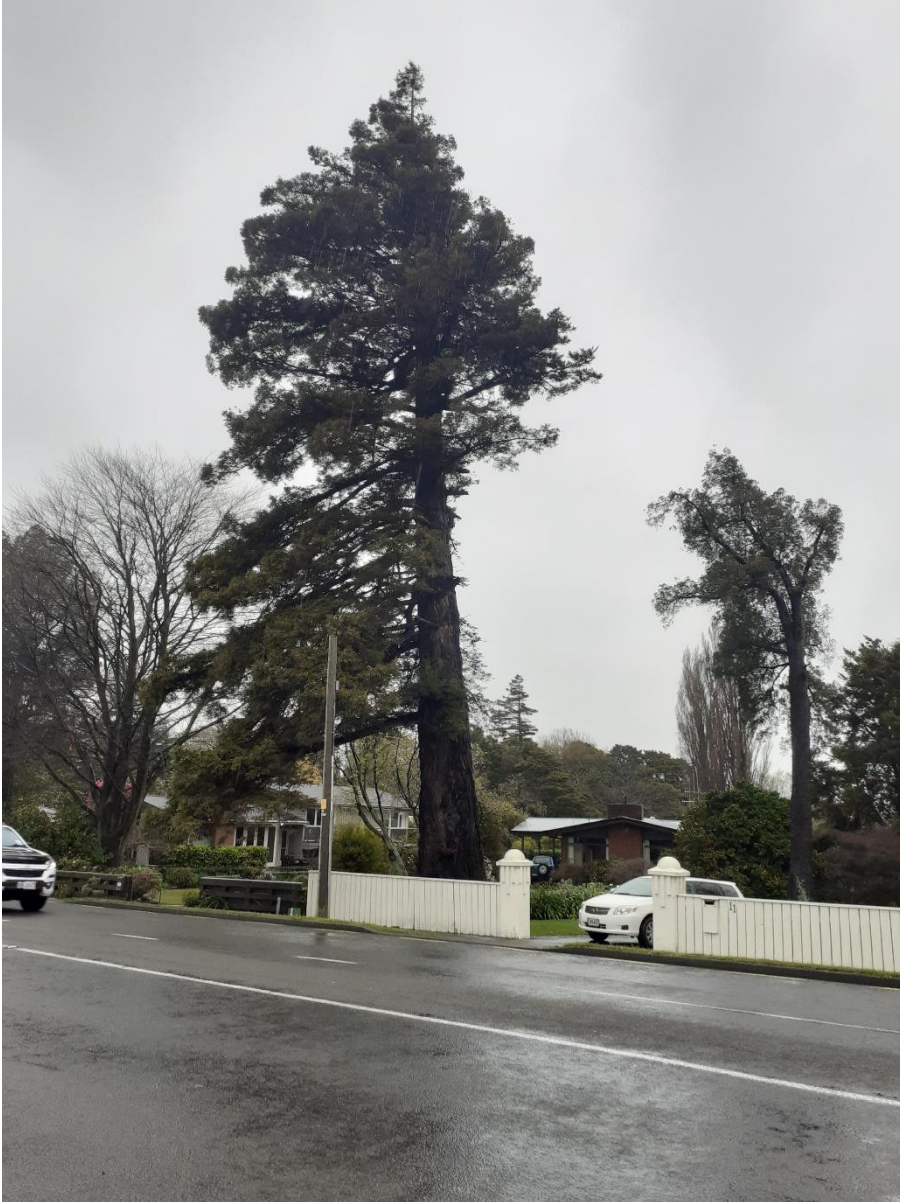
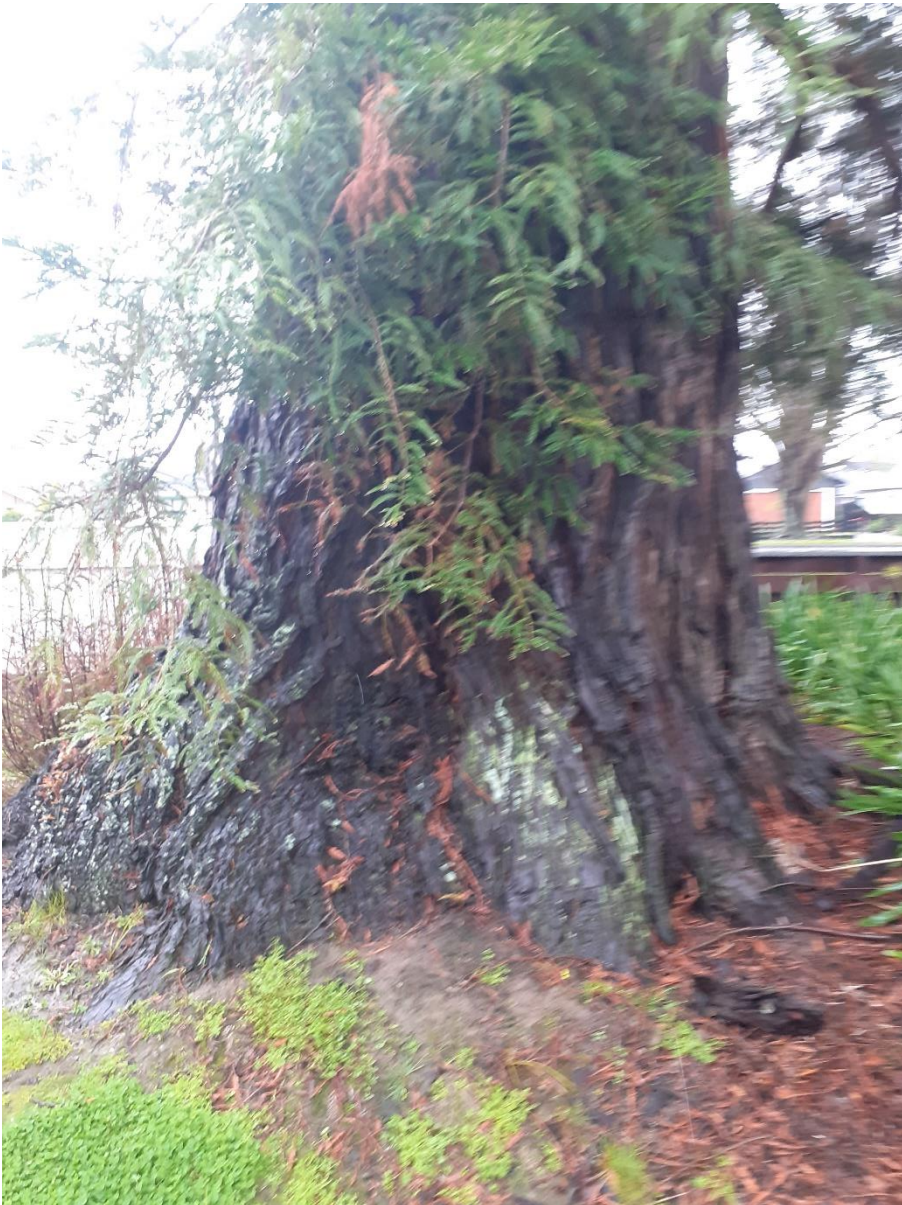
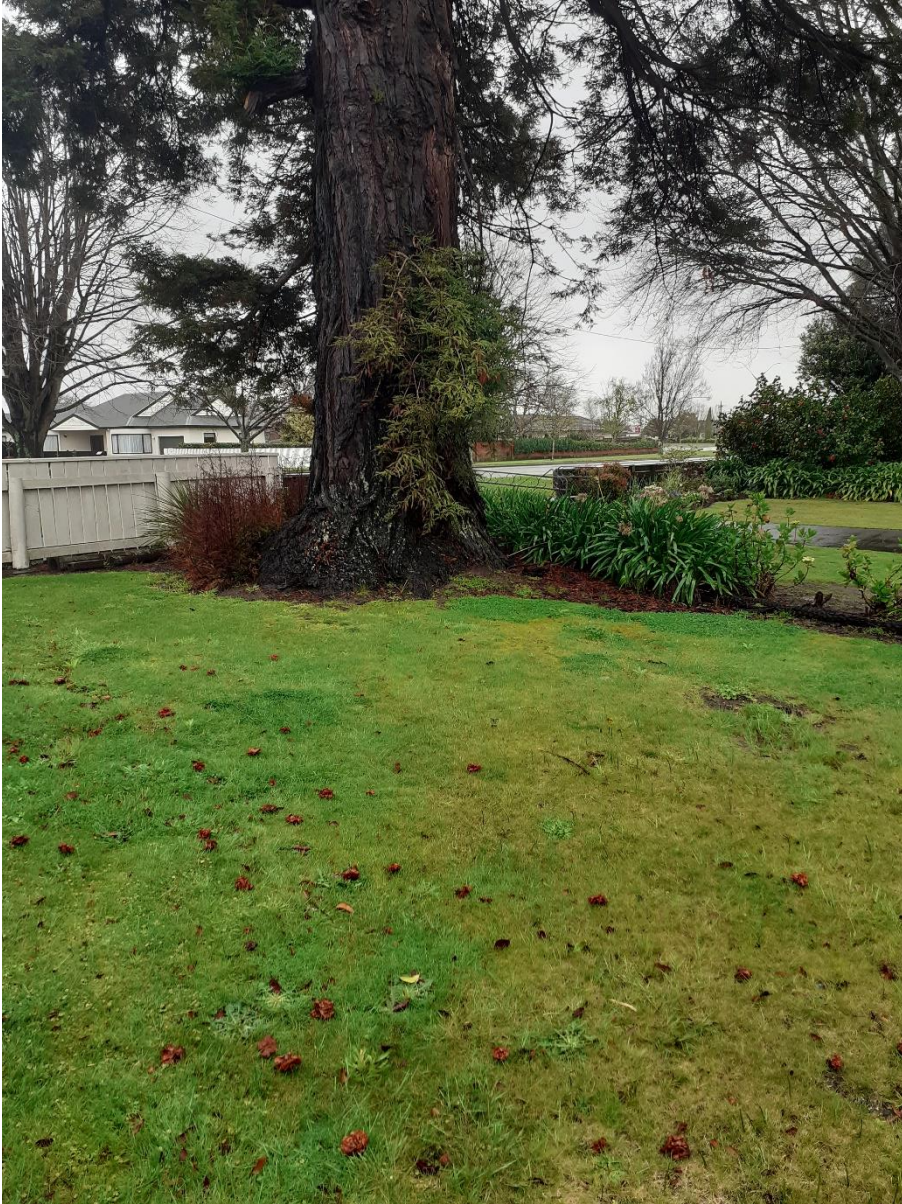
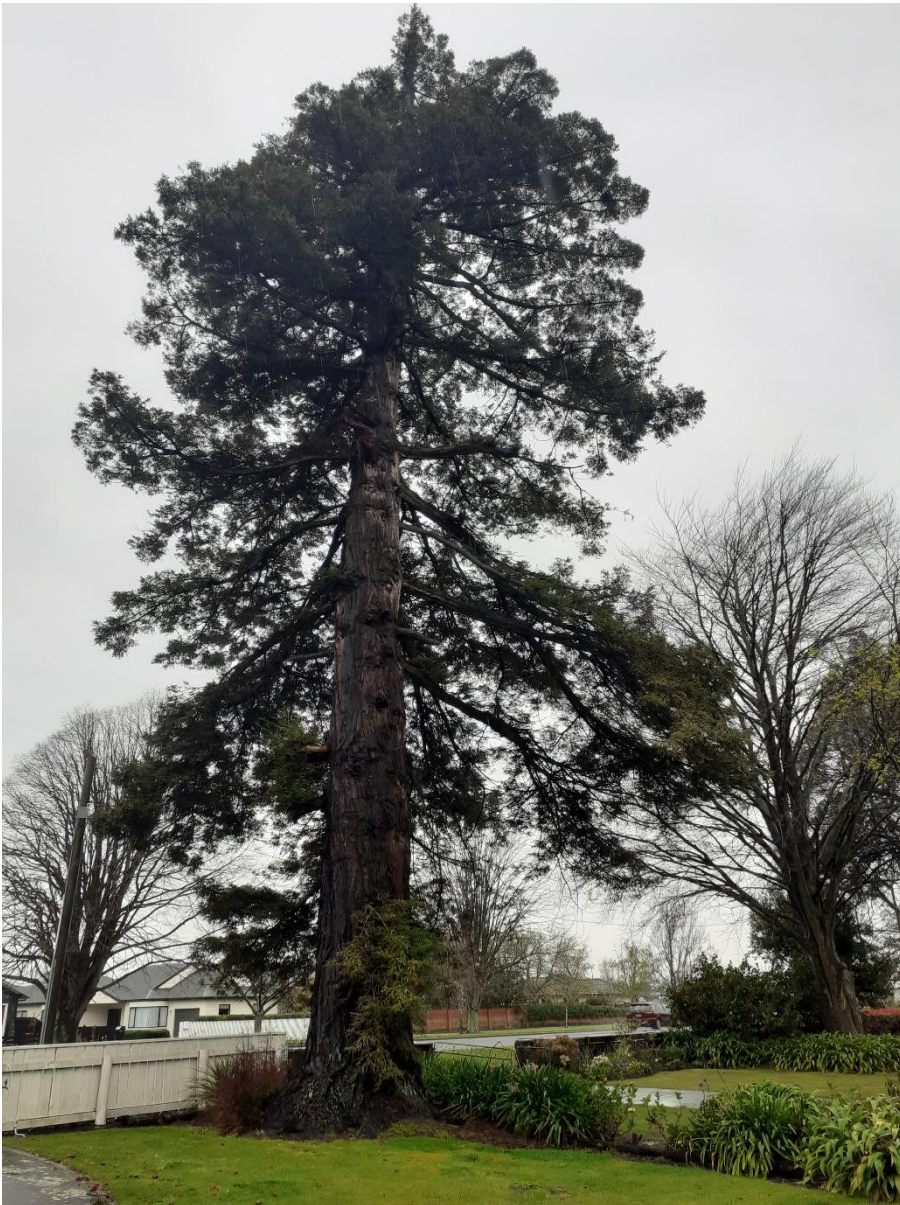
**Assessor's notes:** An adjacent Notable oak tree failed and fell into redwood in 2019/20 damaging the southern side of redwood and damaging branches. Google street view photos below show that the proximity of the oak had already caused few branches to develop on this side and forced the tree into a slight lean. So there are few branches up to 15m on South side. The oak tree was close to the redwood before it came down and the canopies touched with the oak outcompeting the redwood and likely causing it to have few branches on its south west side and causing the redwood to lean due to phototropic effect.

The tree has a lean to the north west of approximately 70 degrees. In my opinion the lean is not as a result of the impact of the oak or any root plate lift but was caused by the proximity of the oak. There are no signs of root plate lifting on the tree's south west side and in the lawn. It is therefore likely that the tree is stable in this position with a slight lean. The loss of the oak may have increased wind forces on the tree from the west which is an issue to monitor. I have compared Google Street View photos from 2008 to 2019 against the photos I took when I inspected the tree and I can see no change in the lean of the tree from then to now. This further evidences the case that the current lean is pre-existing phototropic and not caused by either the collapse of the oak into the tree or any more recent tree movement.

As a result of the proximity of the oak the tree has an imbalanced canopy structure with longer branches and more growth to the north west, especially lower down the tree. I would recommend that the north west side of the tree is trimmed to create a better balanced canopy.

**Suggested care and maintenance:** Remove lowest limb south, reduce length of lower branches south by 2 to 3 metres. Reduce weight on lean by balanced crown reduction north side as required. Monitor tree annually for 3 years to determine if tree is under any wind stress.

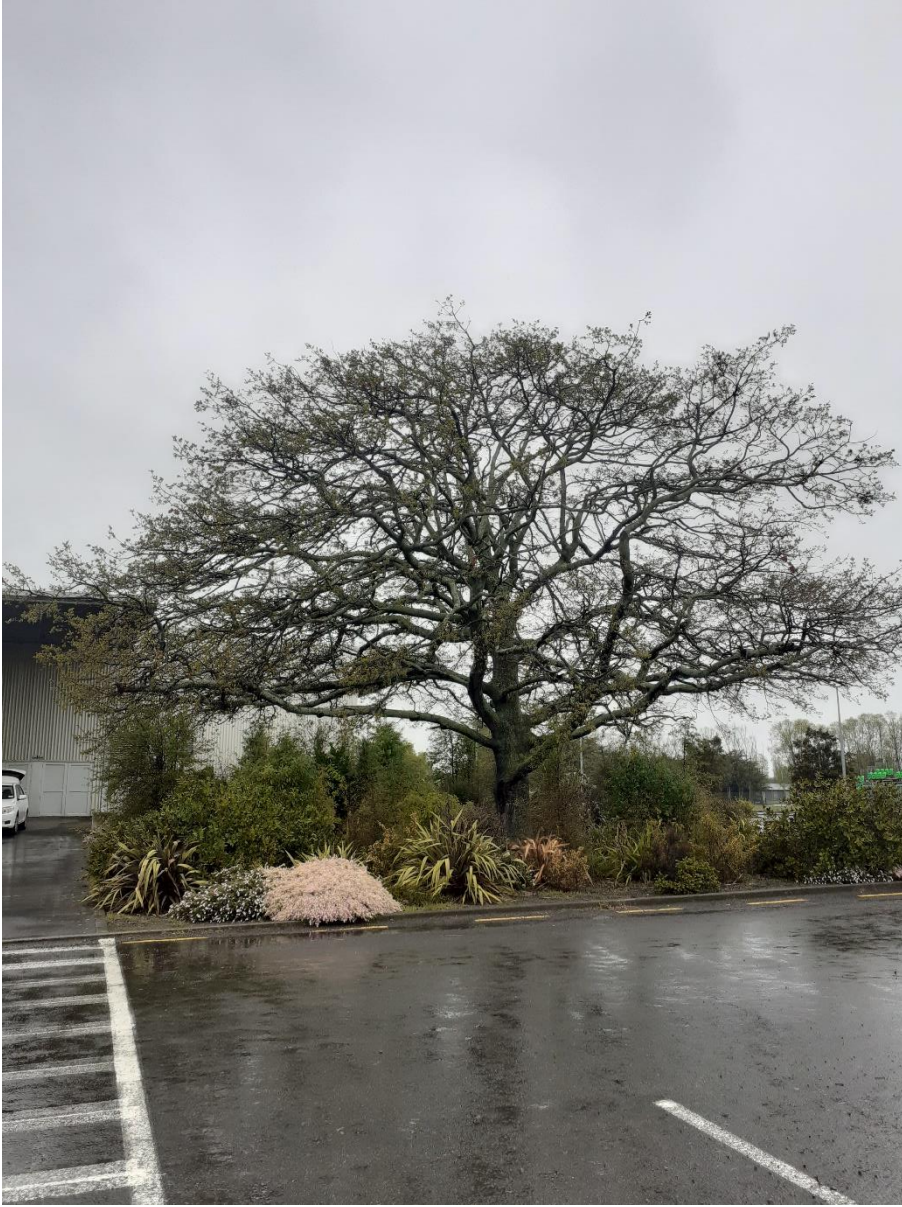
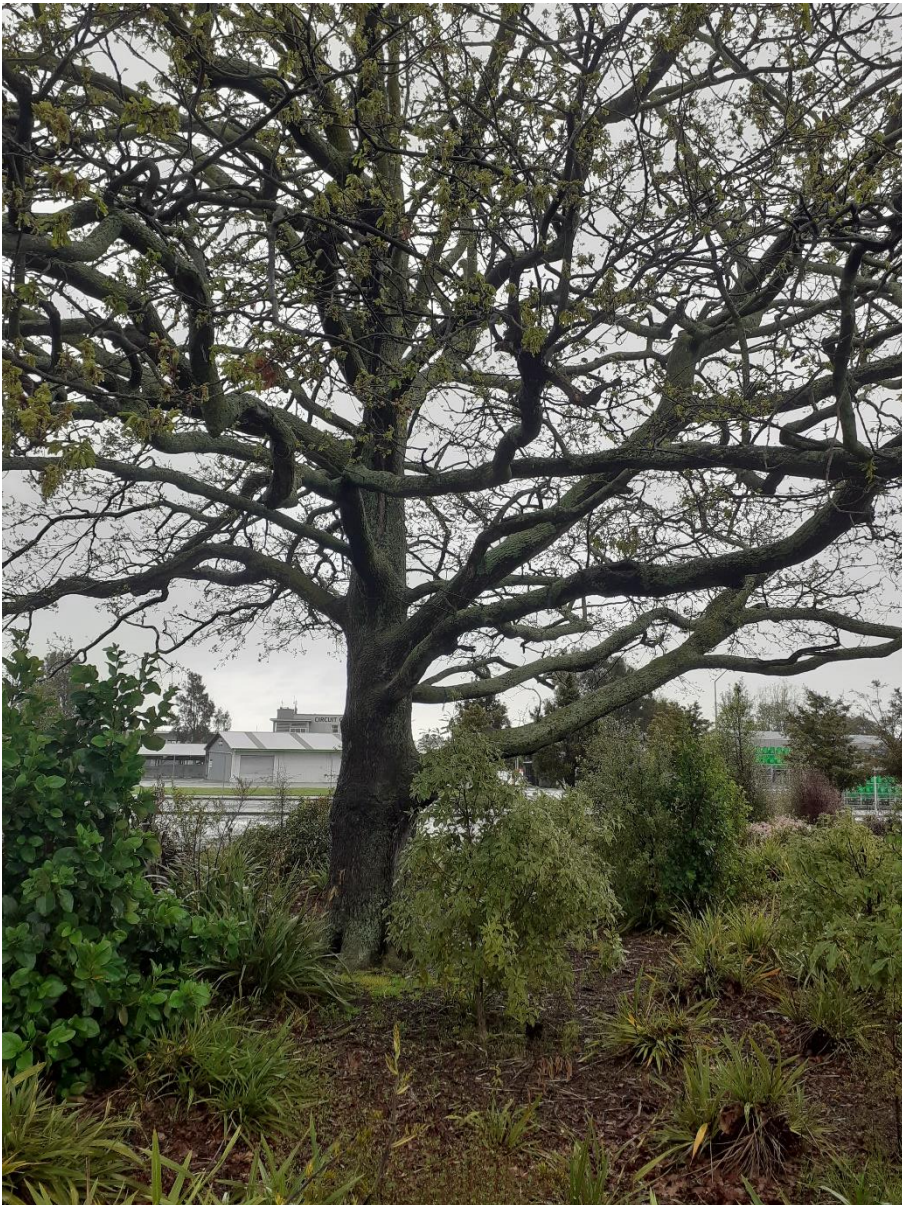
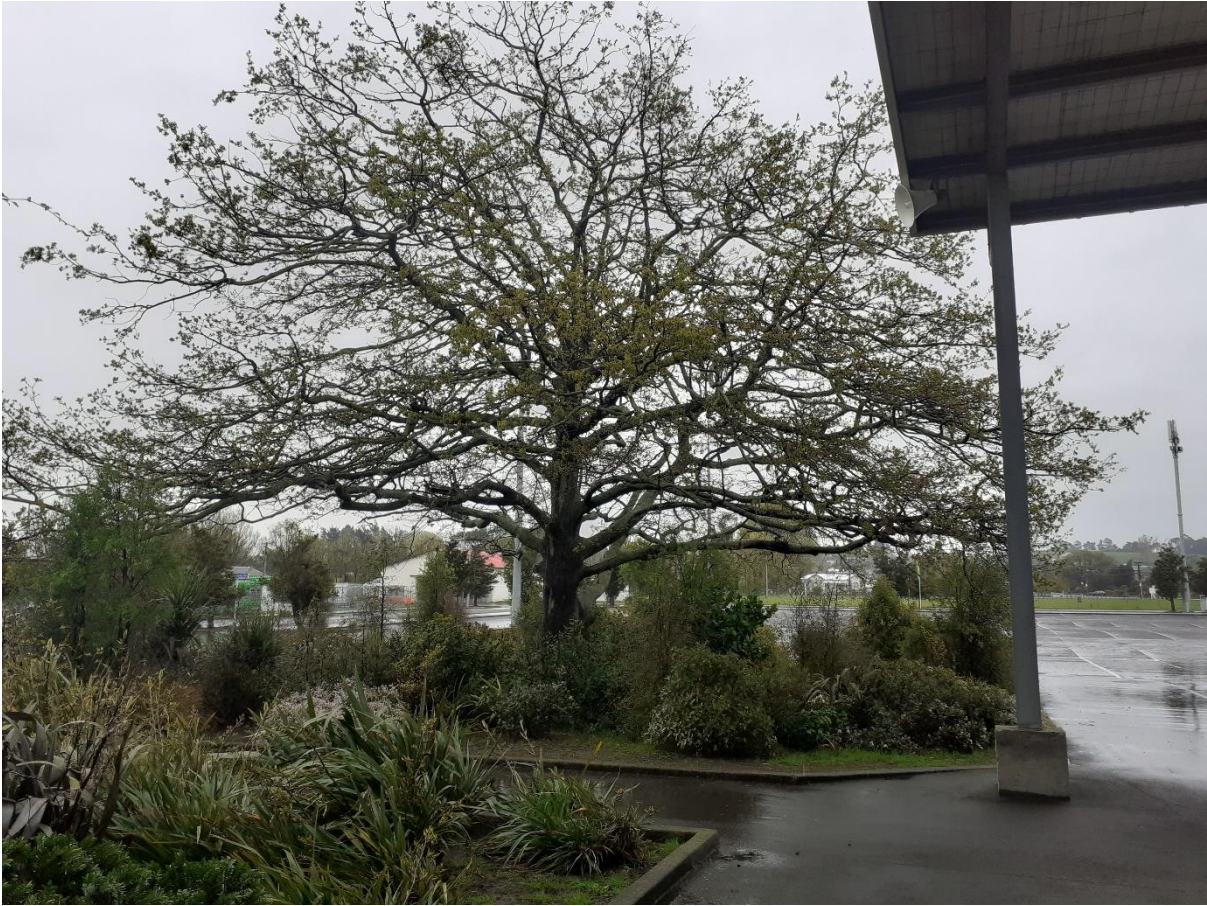
**Assessor's notes:** Large wide spreading attractive highly visible tree. Lowest west limb hollow at base of tree so recommend reduce by 3 to 4 metres. Numerous decay sockets and medium failures visible. These may be symptomatic of early onset disease or possibly reaction to root pruning during construction of hard surfaces around tree. Otherwise excellent condition and form.

**Past and current management:** Well managed, some minor dead wood and hangers.

Reduce lowest limb west by 3 to 4 metres as decayed. Numerous decay sockets and medium failures visible. May have some kind of active decay. Recommend biennial condition and safety inspection and potentially ultrasound to map decay.

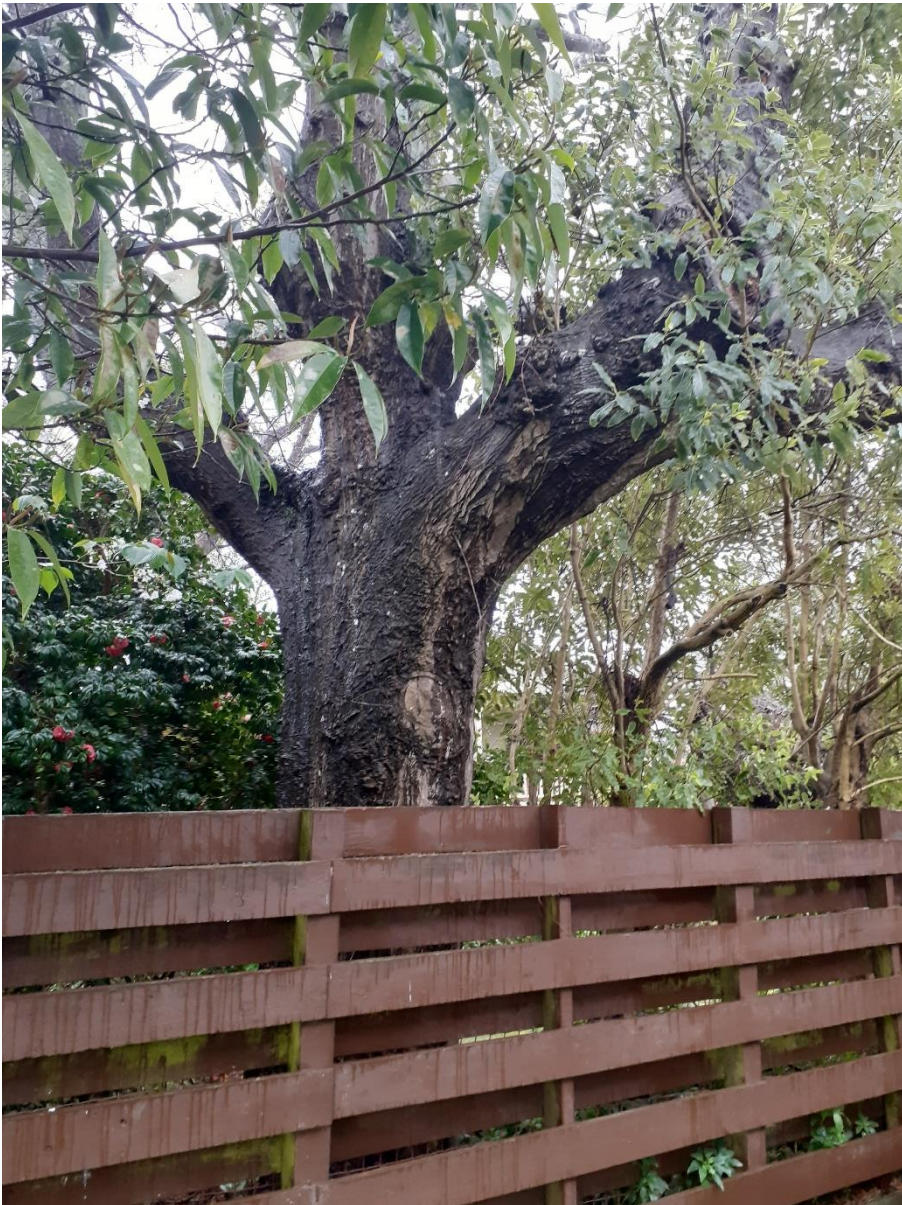
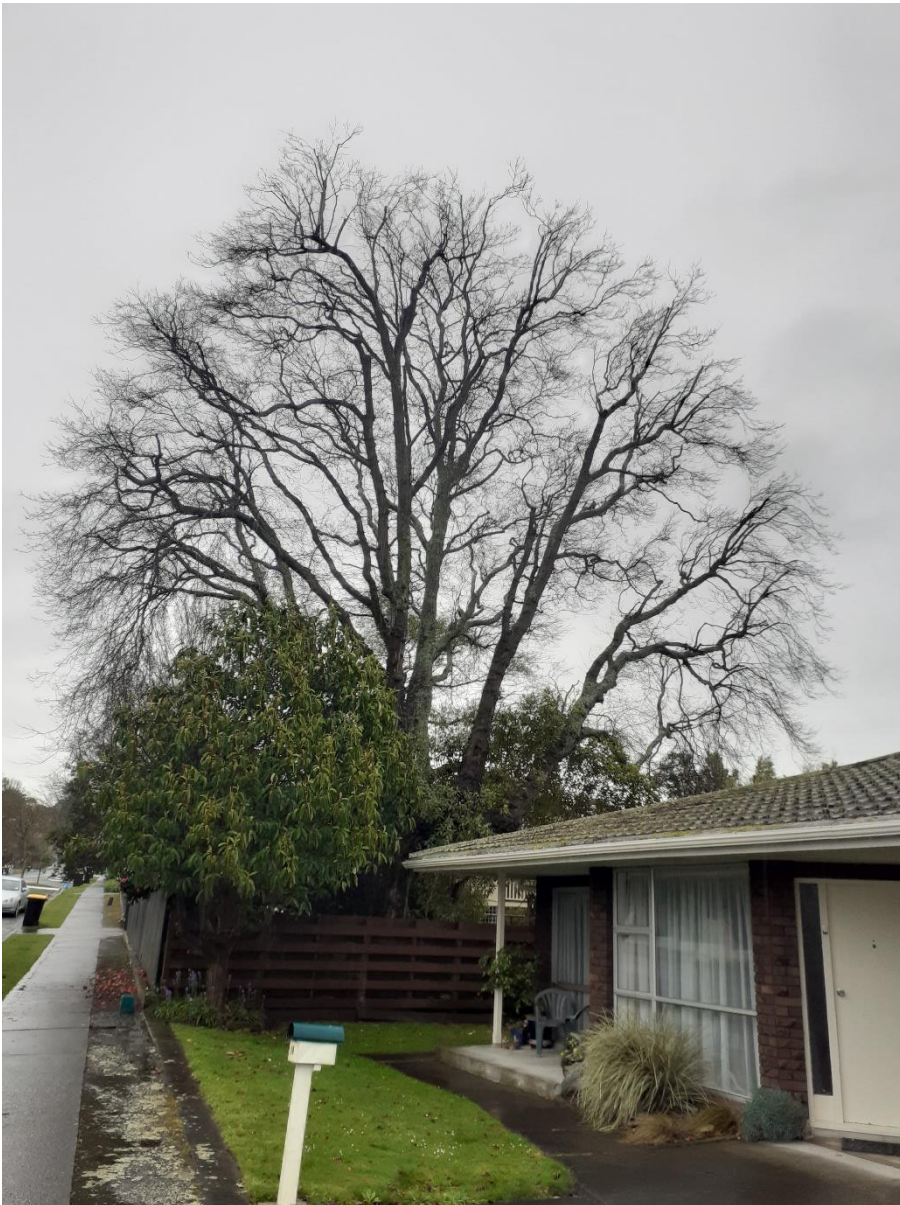
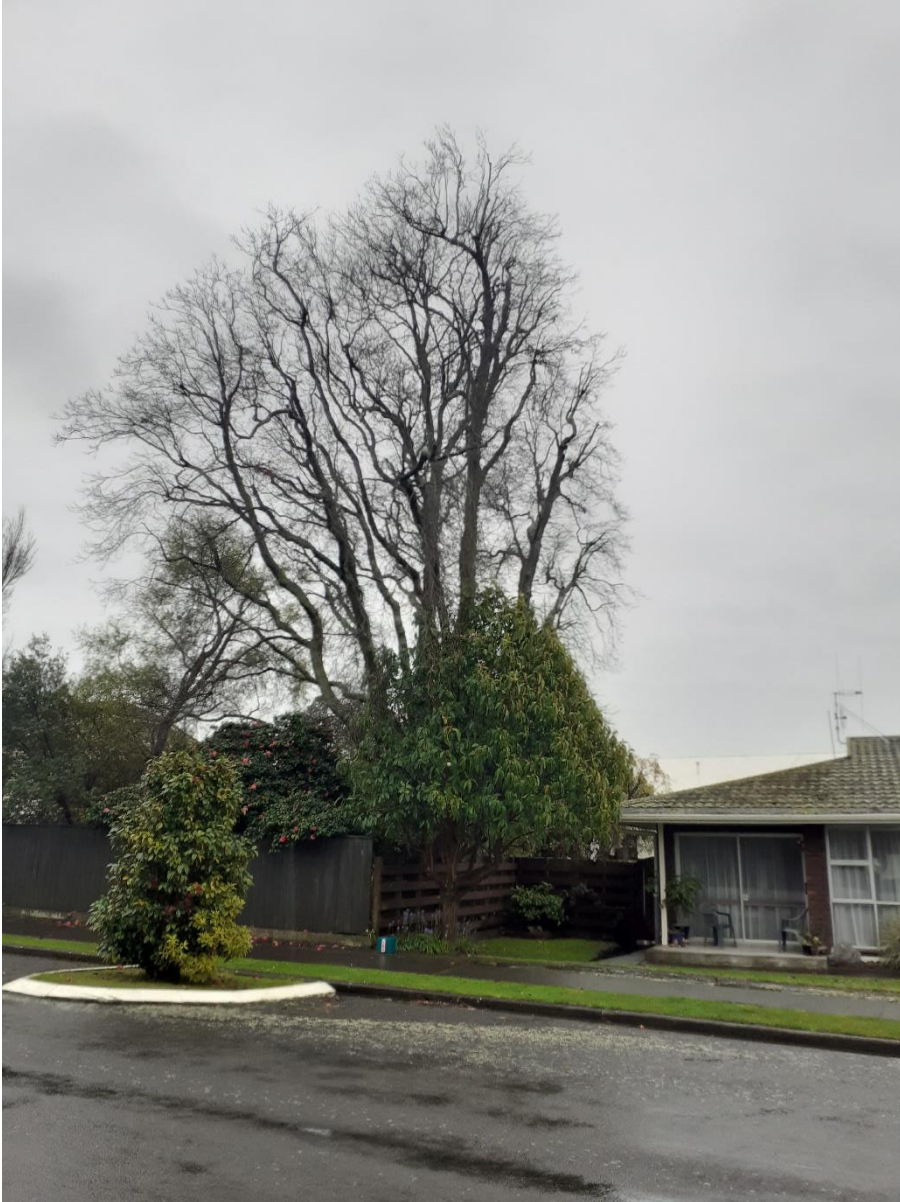
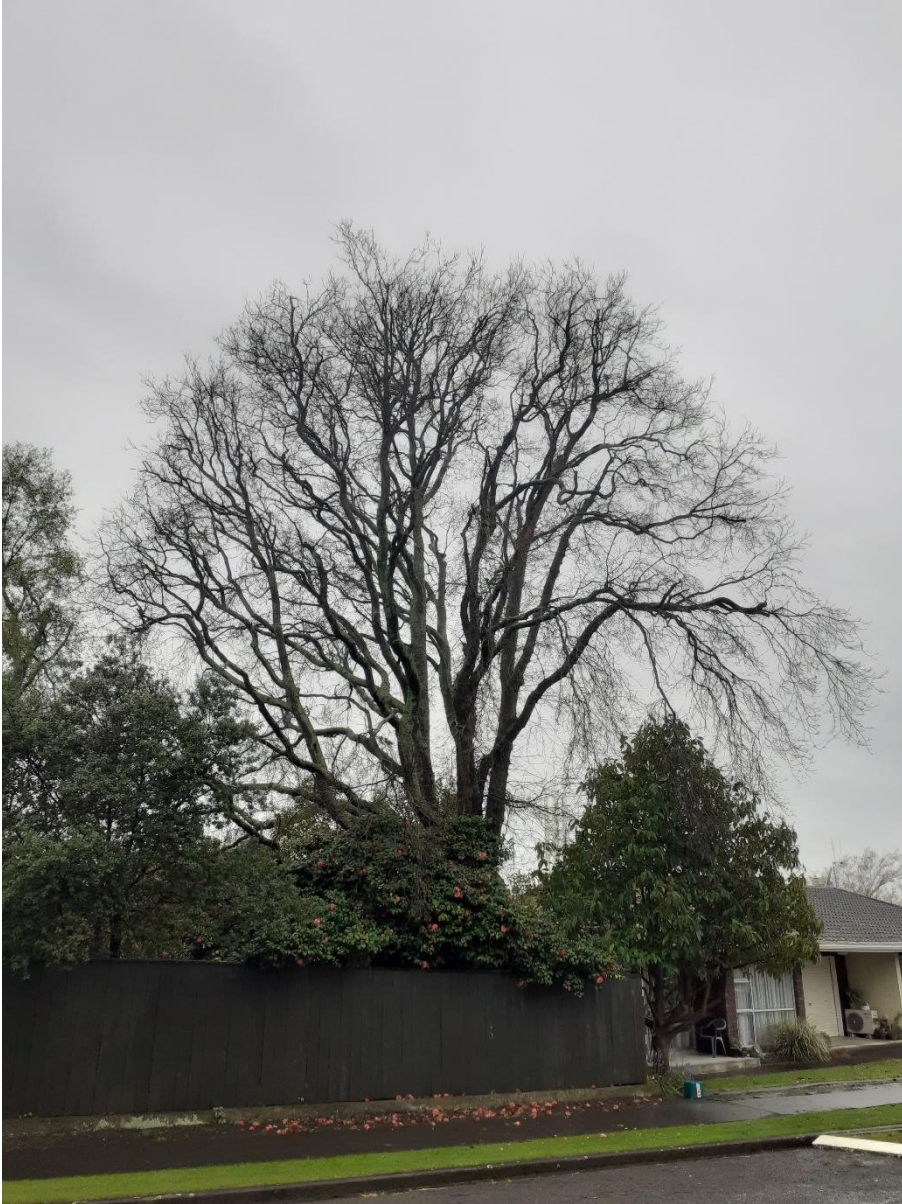
**Assessor's notes:** Large specimen, wide spread. Heavily managed as is regularly reduced to boundary line of neighbouring property. Has been reduced with limb removal, thinning and clear vertical cut to neighbor boundary. However, work has been done sensitively and tree is in overall good condition. Misidentified as Quercus robur on previous plan.

**Nuisance/negative factors:** Tree is pruned to boundary line on east side and this regular works obviates any perceived nuisance caused by overhanging branches. Branches overhanging a neighbouring property would not necessarily constitute a nuisance to justify not protecting a tree regardless. Overhanging path. No significant nuisance or negative factors such as damage to structures

Ongoing regime sufficient
