## Review of District Plan Appendix 1D Notable Trees

### Part 2 – STEM Assessments of Notable Trees, Manawatu District Council

Report Date – 4<sup>th</sup> February 2022

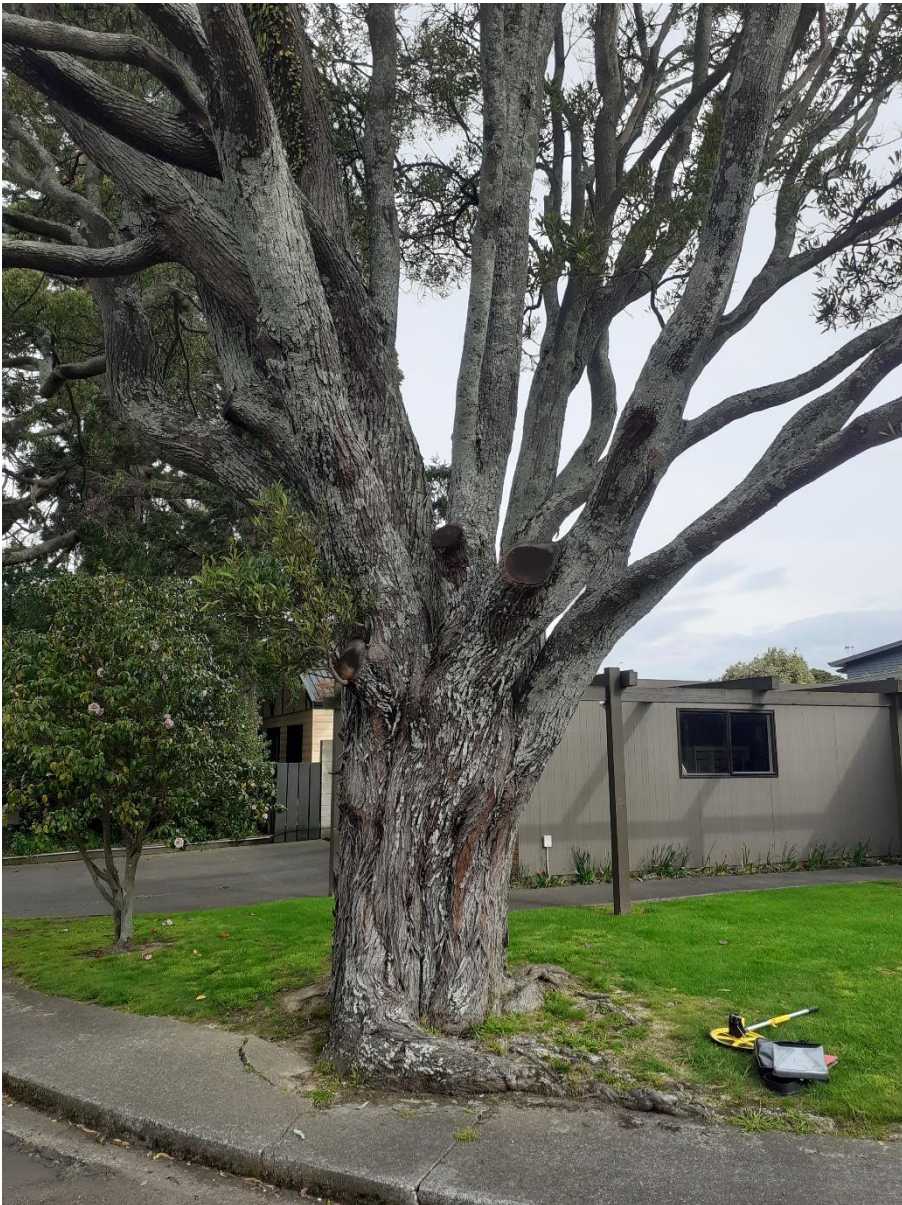
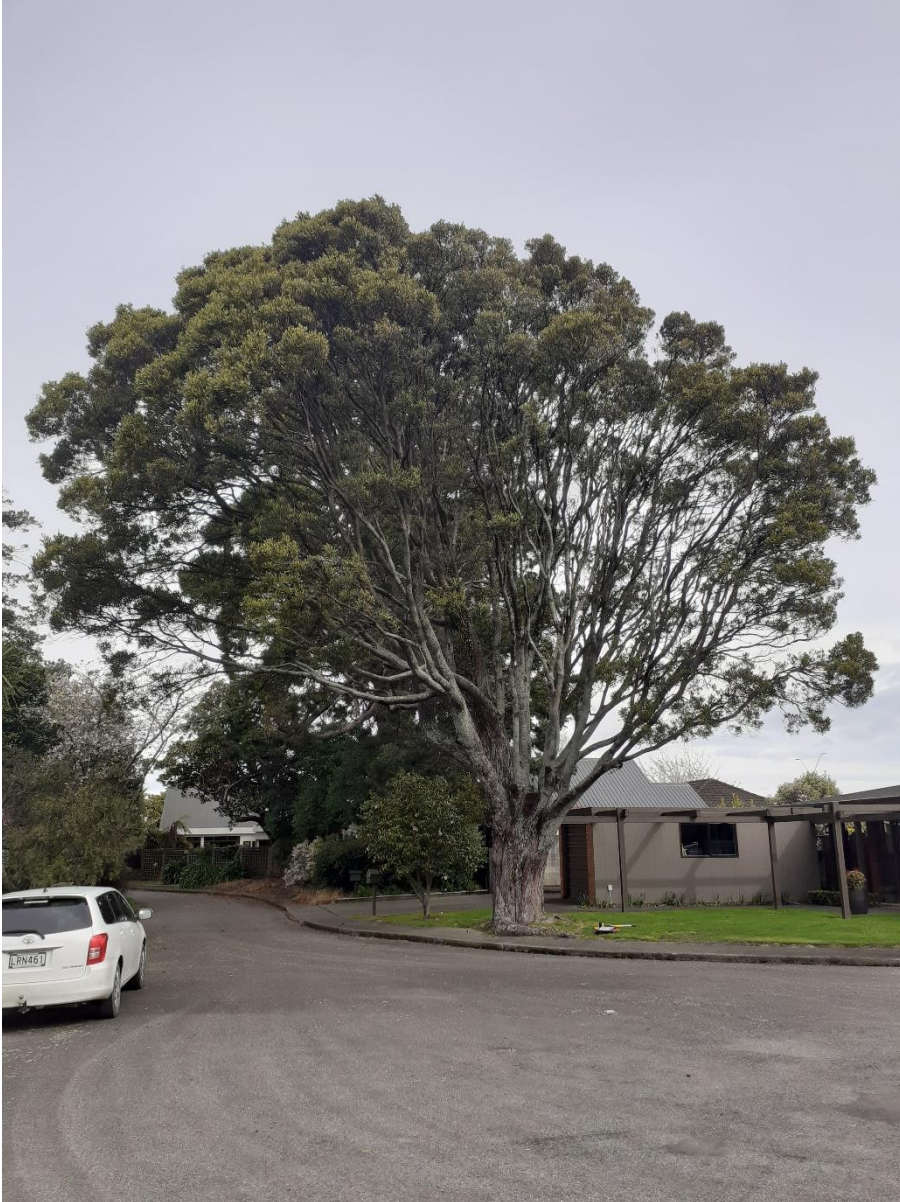
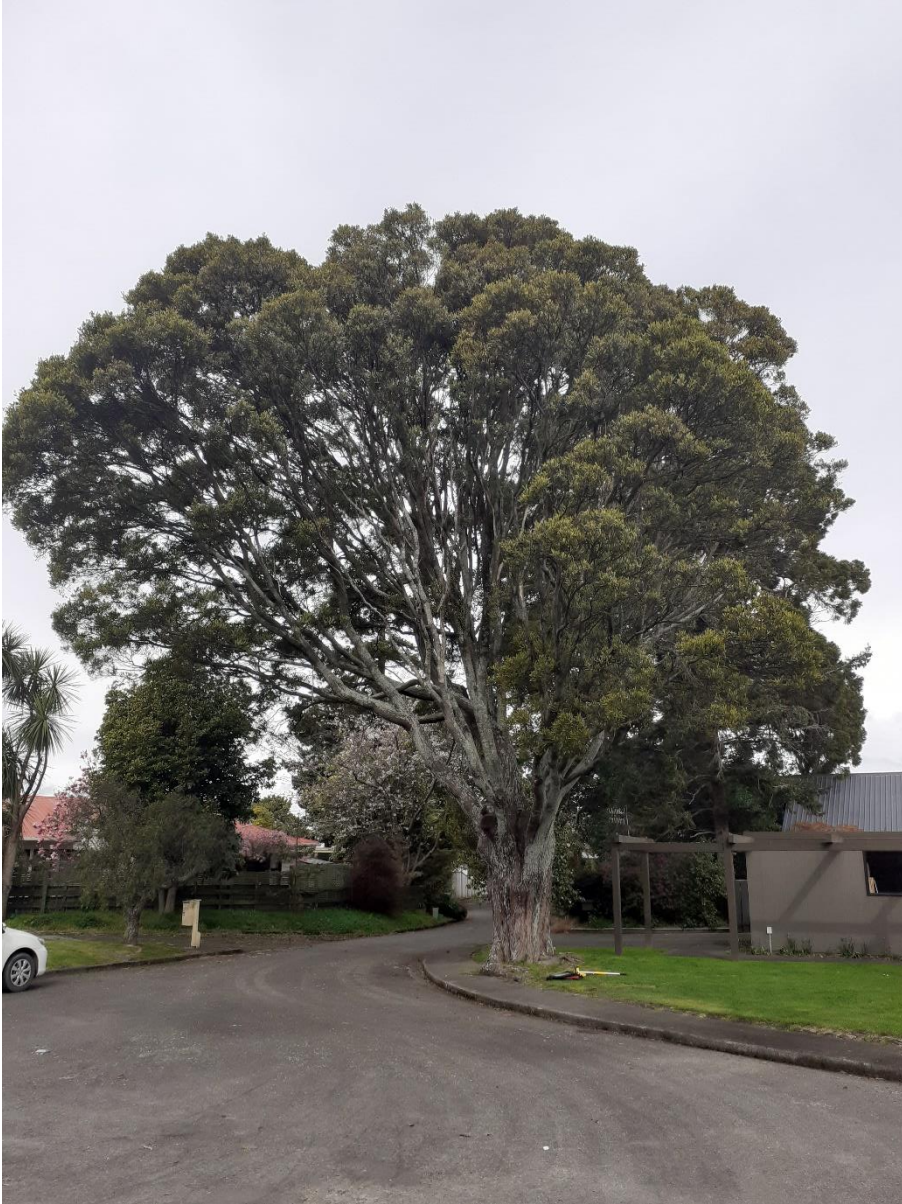
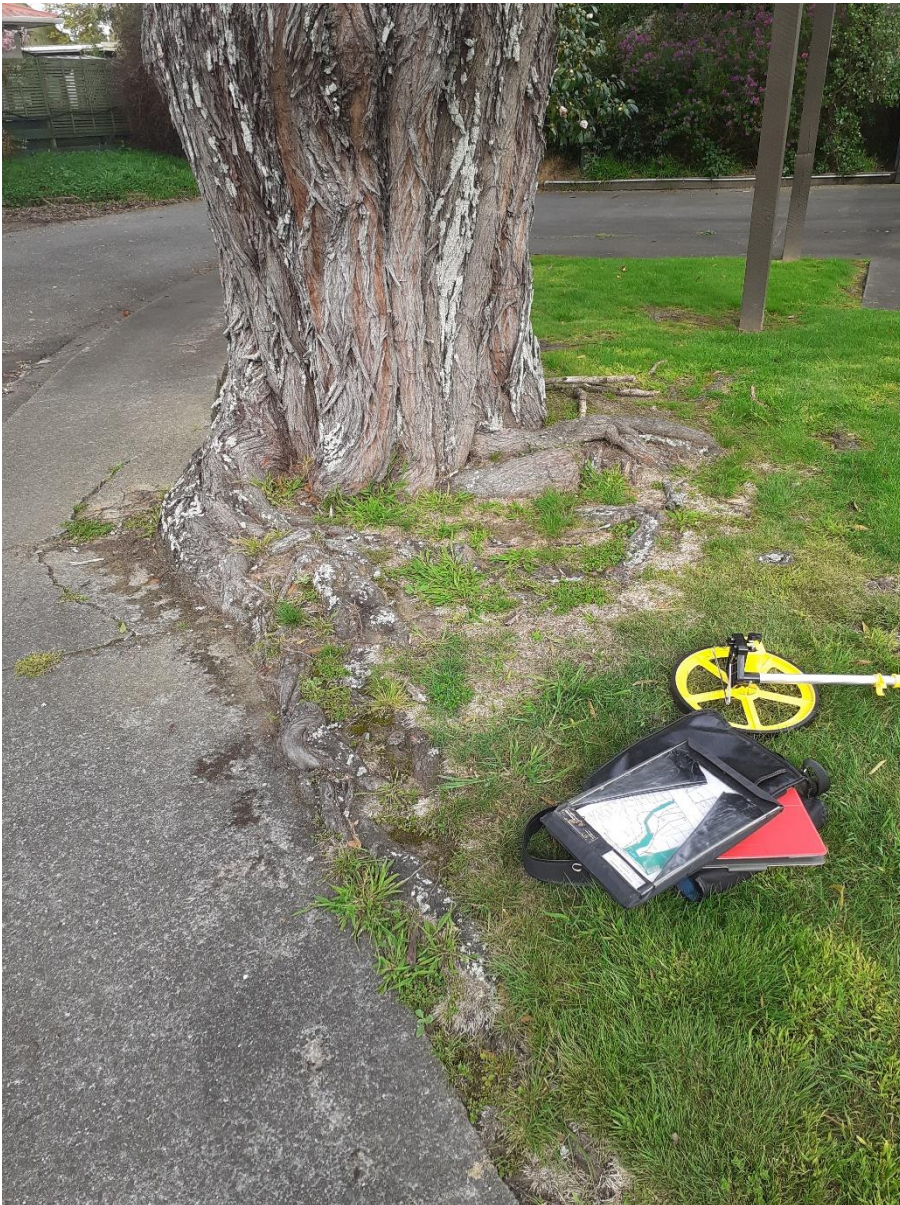
**Assessor's notes:** Wide spreading tree, unusual form as thin inner crown structure. Roots visible above lawn are mostly damaged but this is not significant to structural safety. Roots against pavement girdled so likely one sided but not significant defect. Some damage to footpath, potentially roots on pavement side damaged.

**Past and current management:** Overly thinned creating less than ideal crown structure.

**Nuisance/negative factors:** Overhanging path. Roots damaging public path, these could be repaired or roots bridged.

**Suggested care and maintenance:** Repairs to footpath under tree should be undertaken sensitive to not damage roots and allow permeability. Possible raised footpath to protect roots. When undertaken, a consultant arborist should help design new footpath under canopy and be present when old footpath removed to advise and assist.

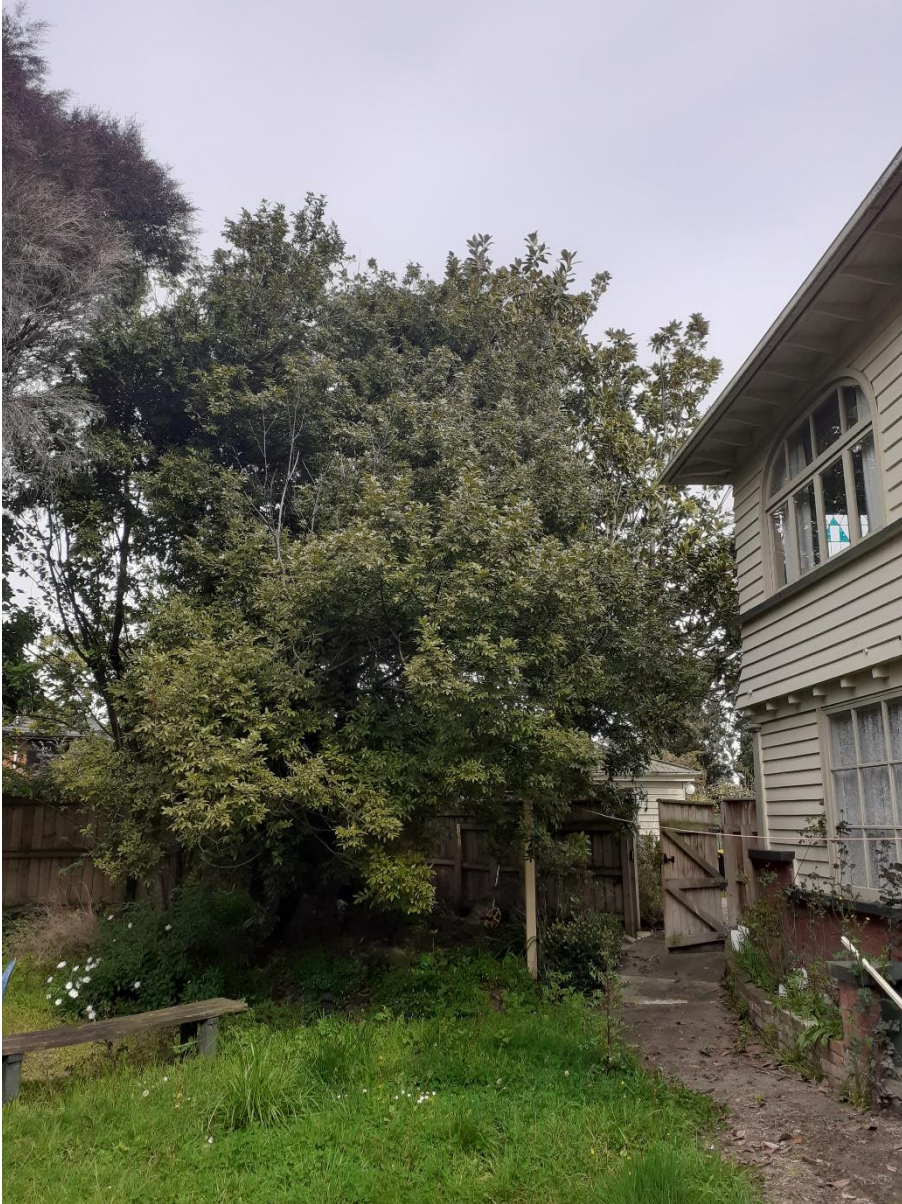
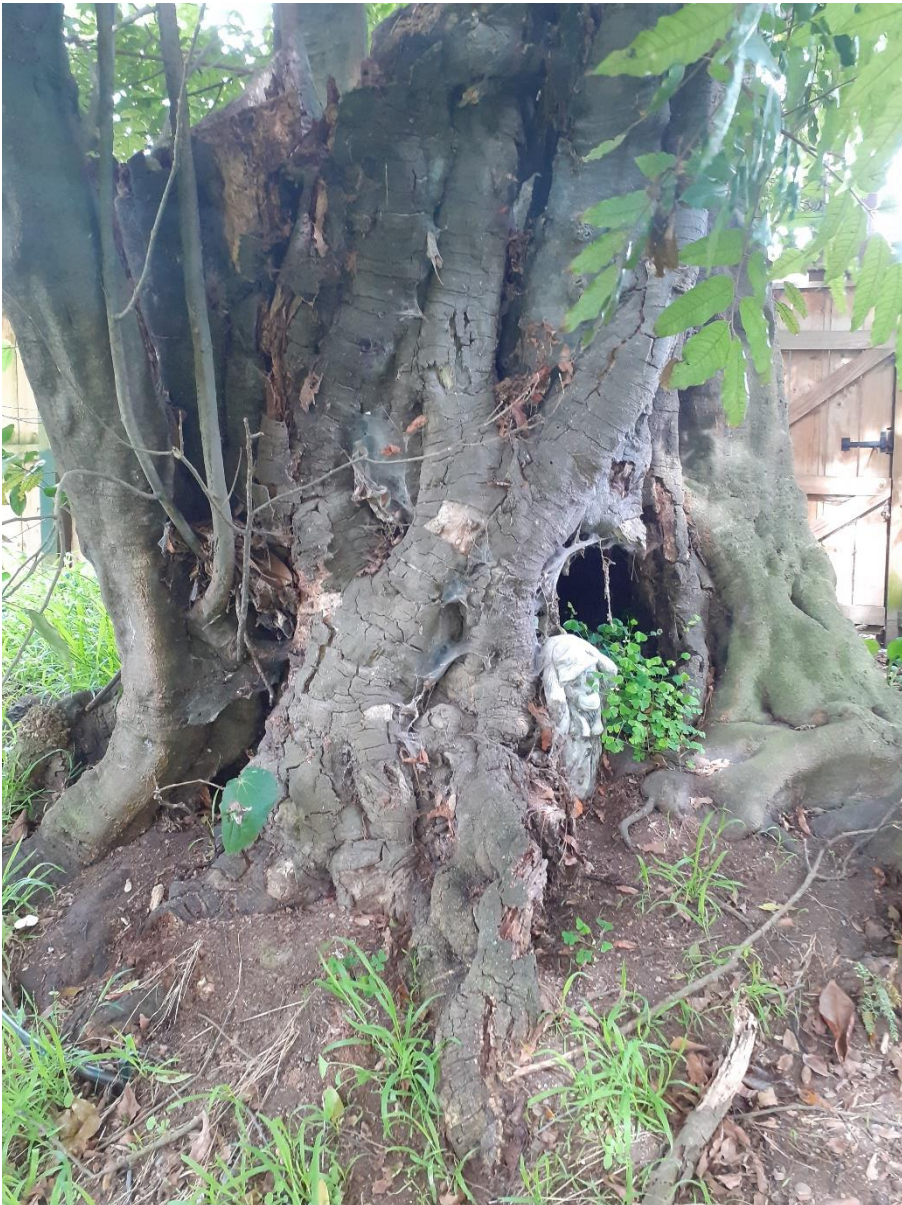
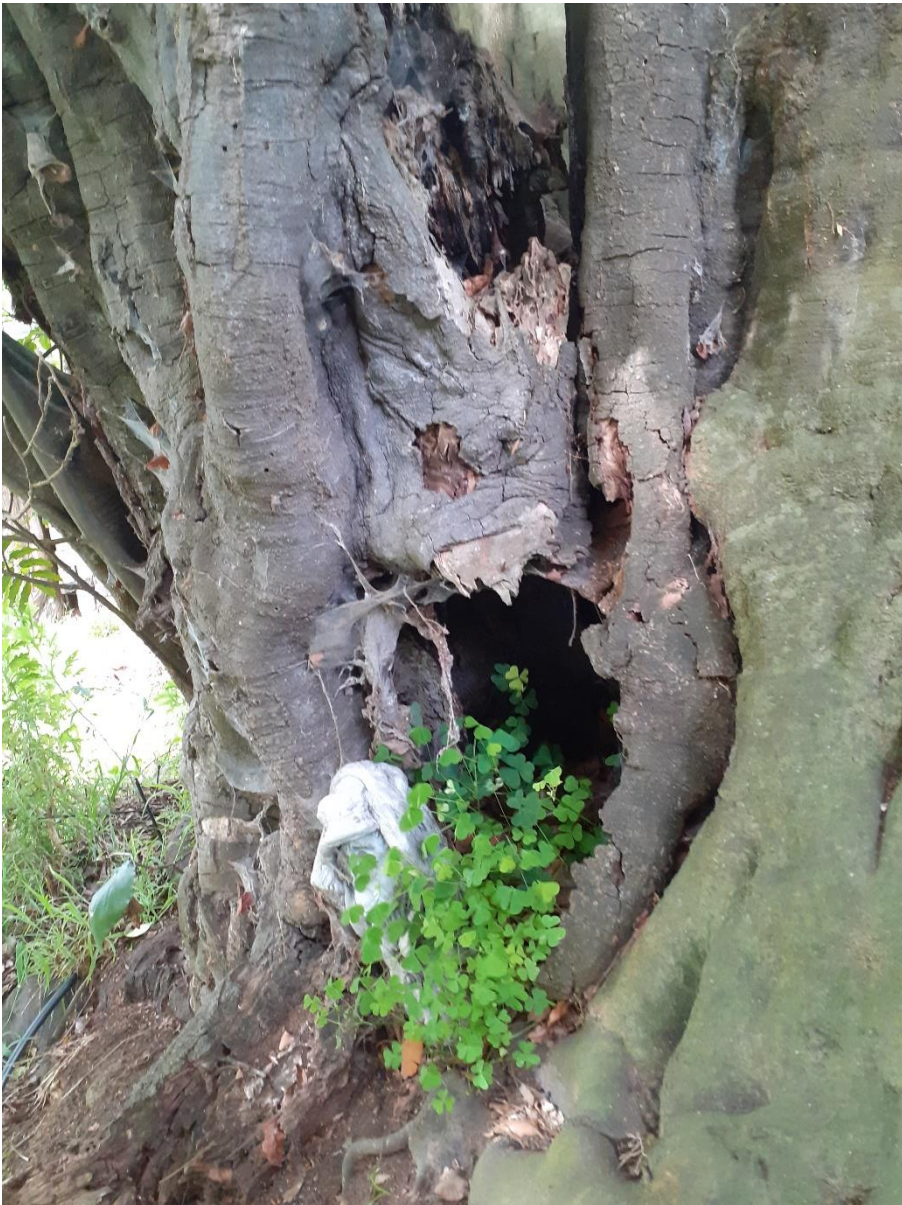
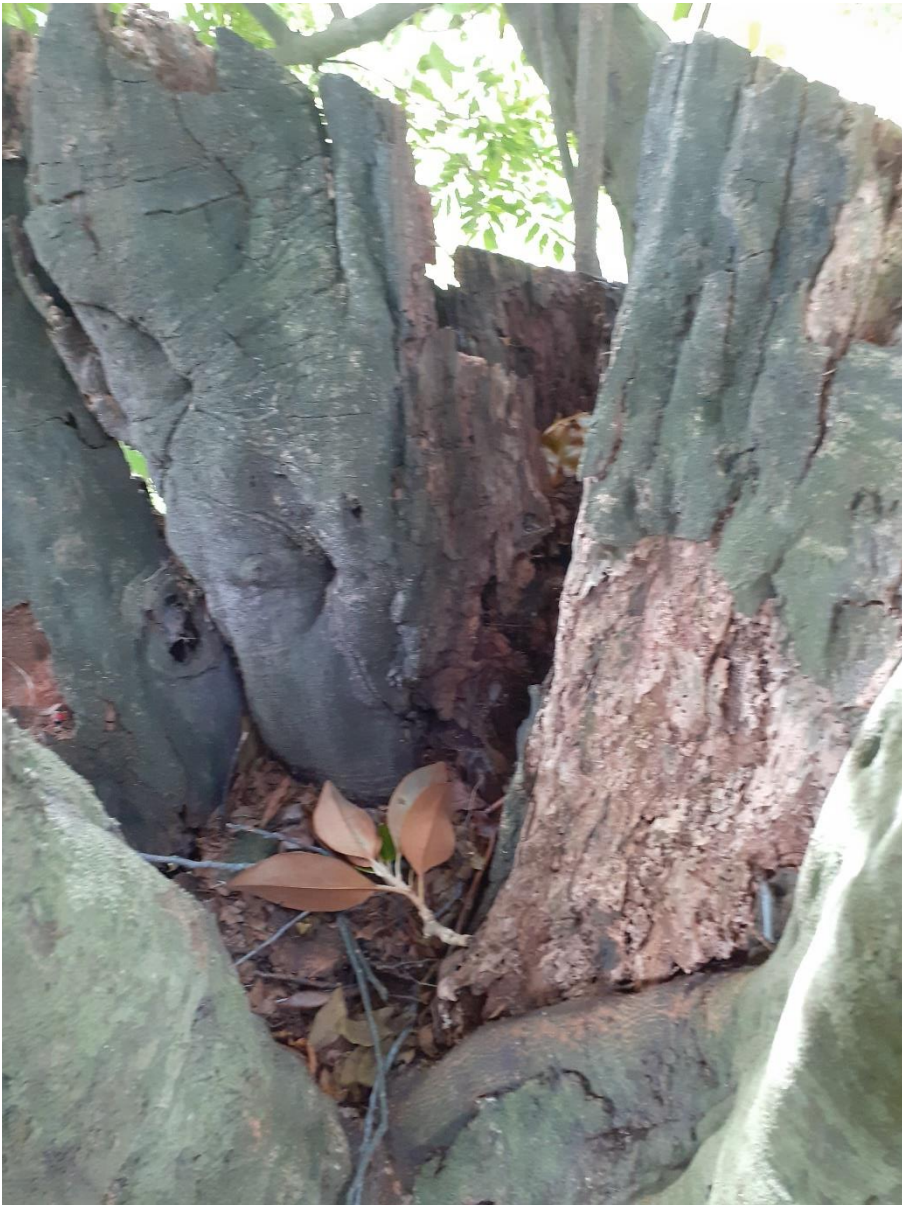
**Assessor's notes:** Has extensive major central stem decay cavity and root decay. Lost major limbs and part of stem and is unsafe and in rapid decline.

**Threats to the future of the tree:** Advancing decay and failure

**Suggested care and maintenance:** Remove or crown reduce

**Notable Tree listing recommendation:** The tree is unsafe and in rapid decline, it is therefore not appropriate for this tree to remain listed as Notable.

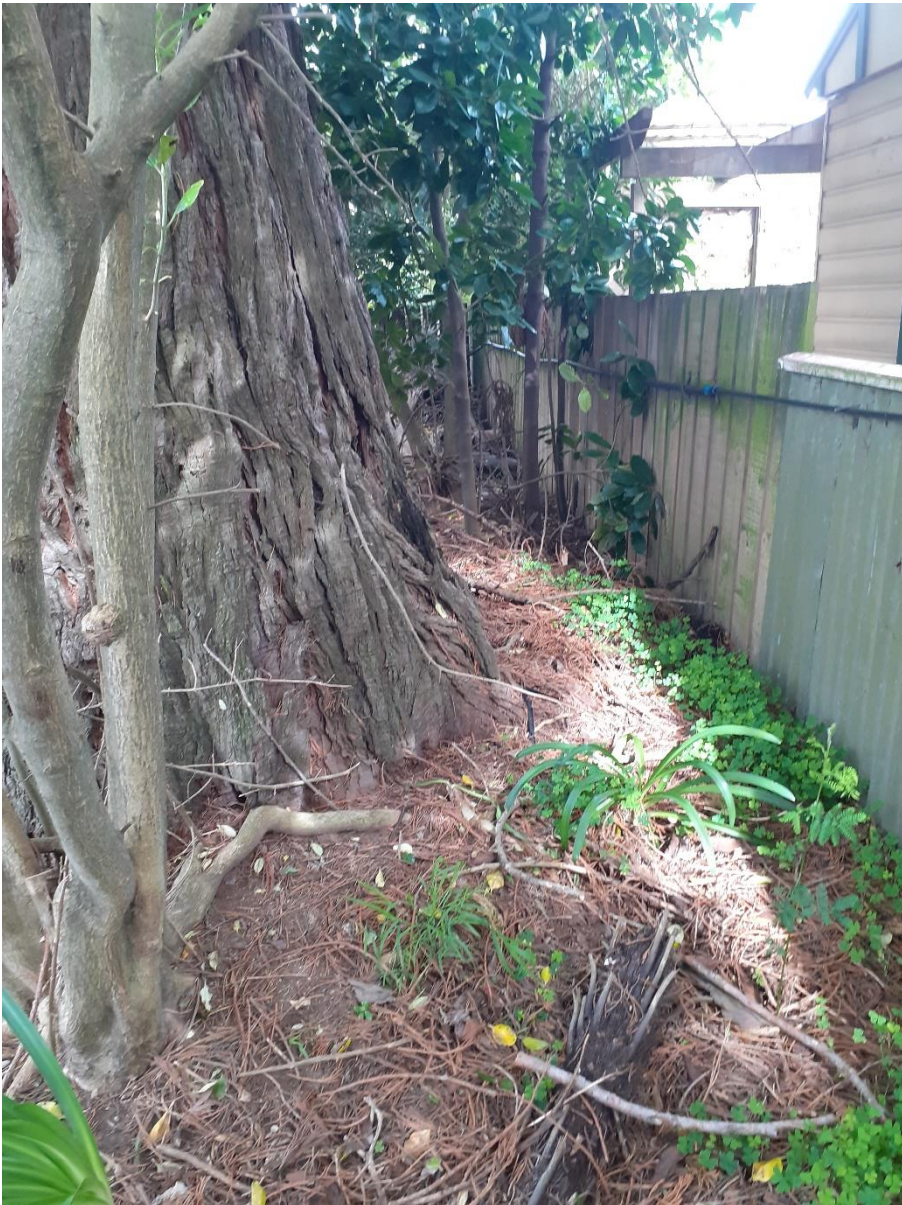
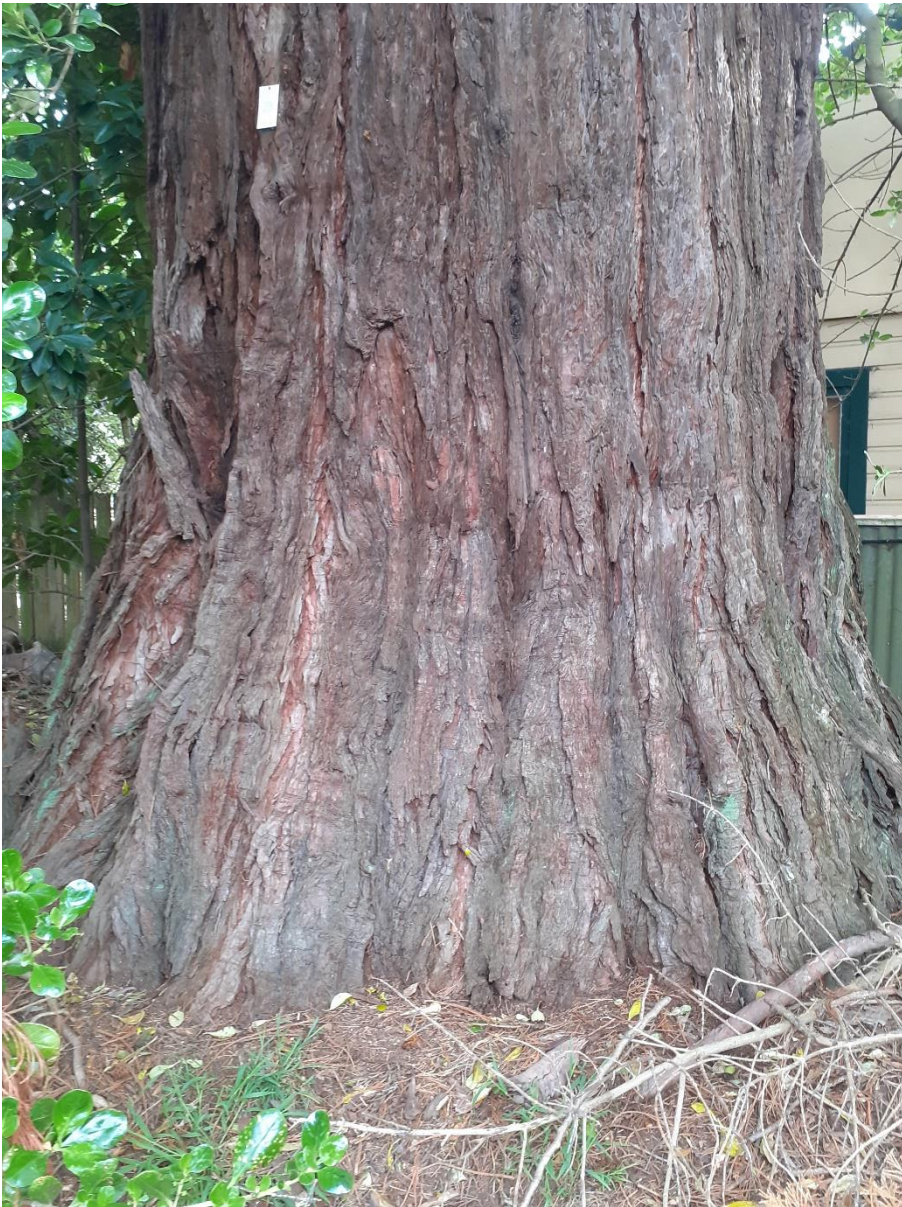
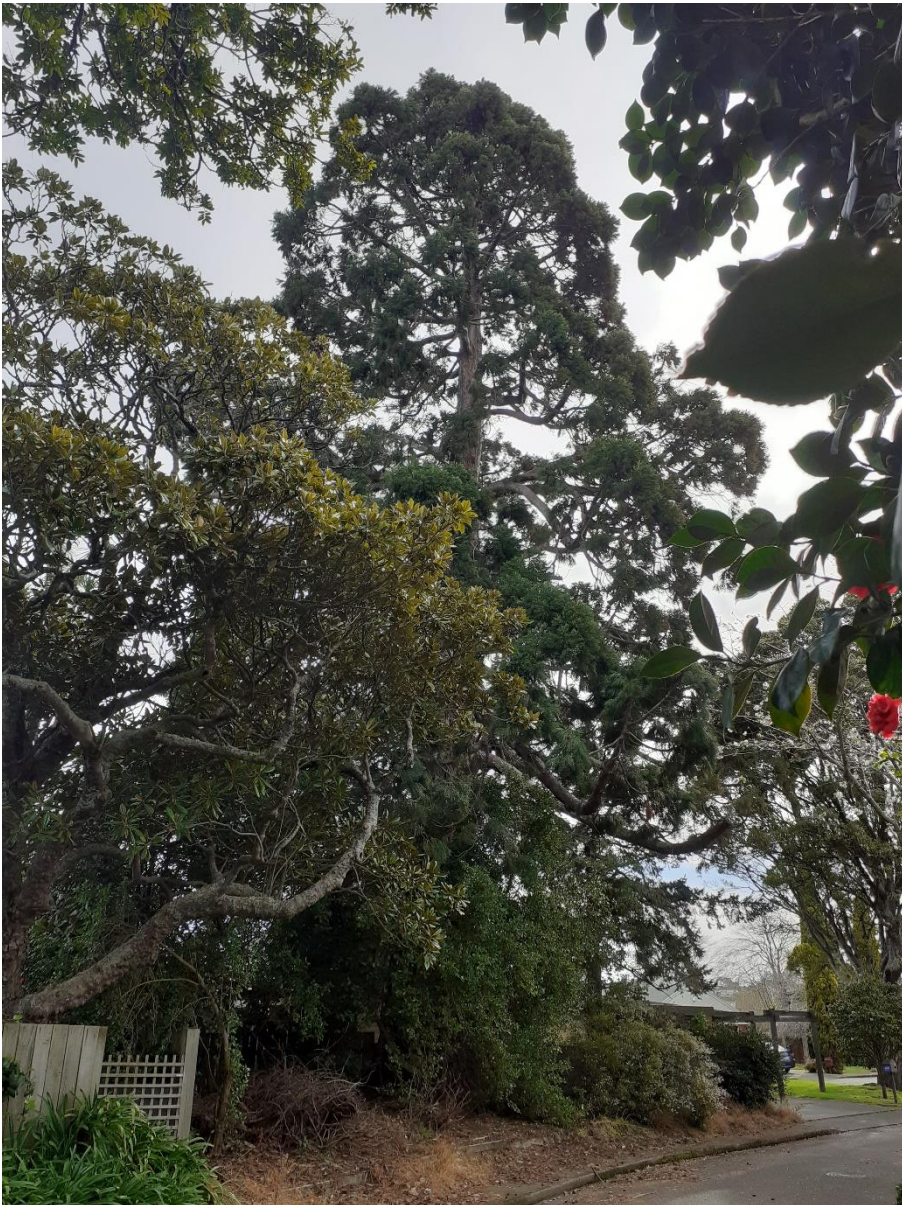
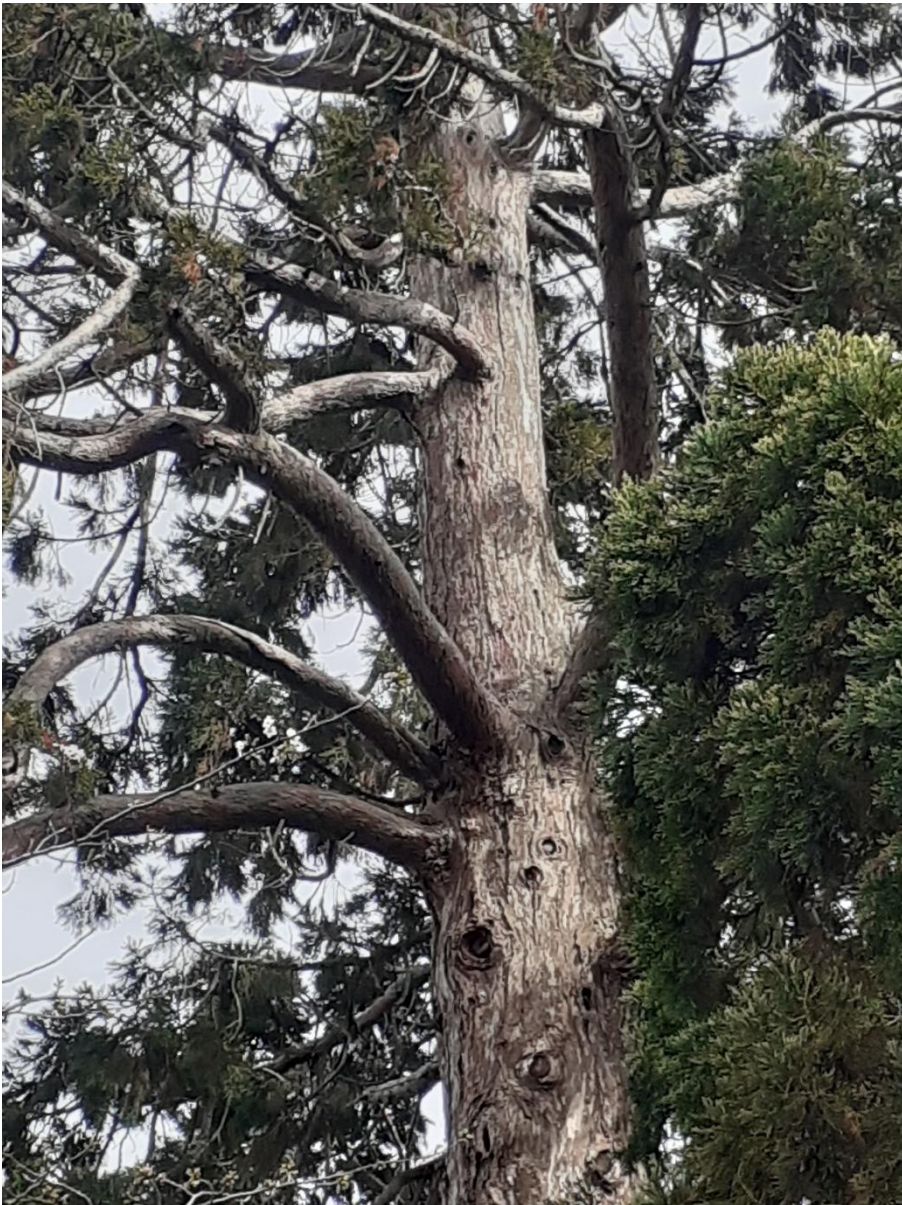
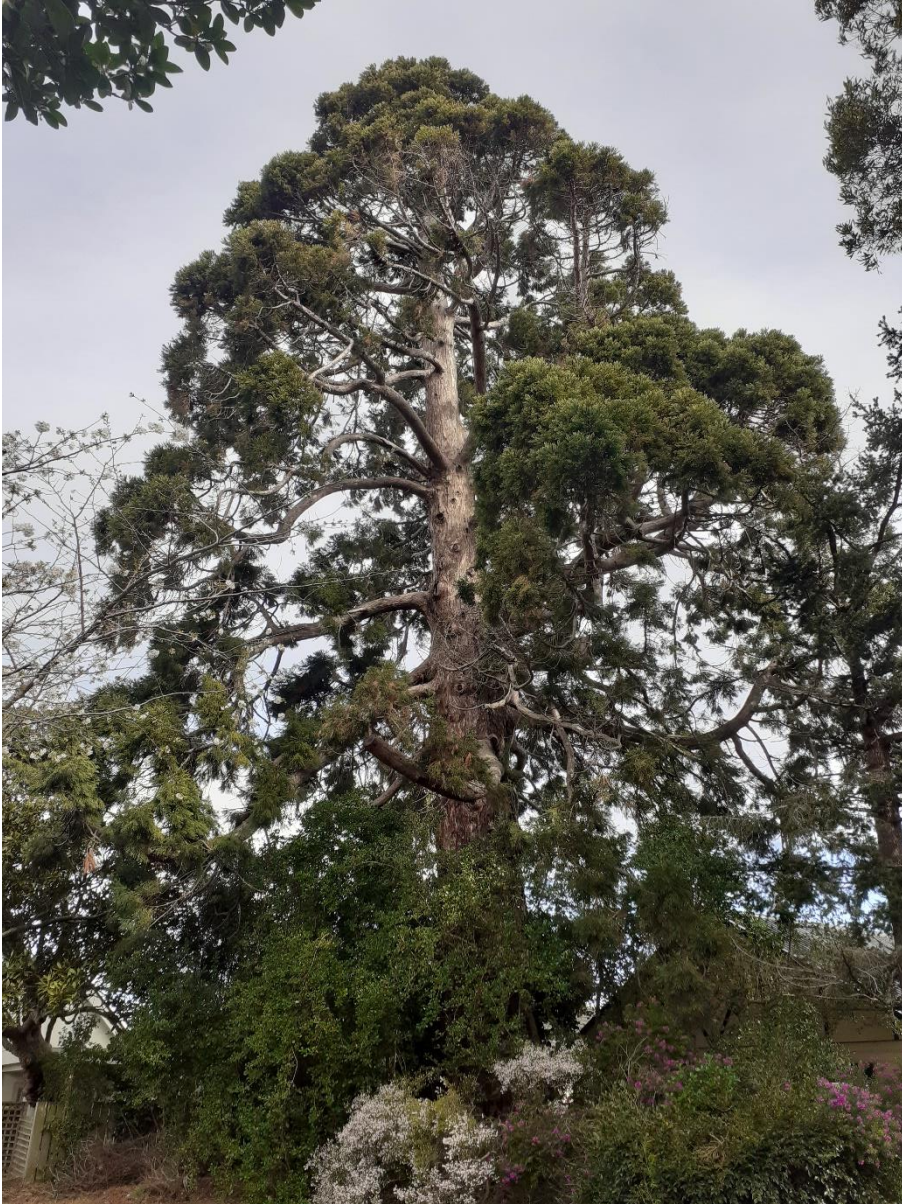
Assessor's notes: Reasonable form but has lost a number of branches on its north side. Some of the end branch structure is poor with tight bends and poor taper but this is not a structural safety issue and is more of an aesthetic issue. A large girth and relatively low height to girth ratio is likely caused by winds. No roots present to examine but stem is free of defects or cavities. No root damage to any nearby structures observed. Roads, kerbs and a garage within likely rooting area but no surface roots or damage to structures caused by roots observed. In good condition overall slight lean north west.

Appears to have had northern branches removed and tidied, otherwise little other work.

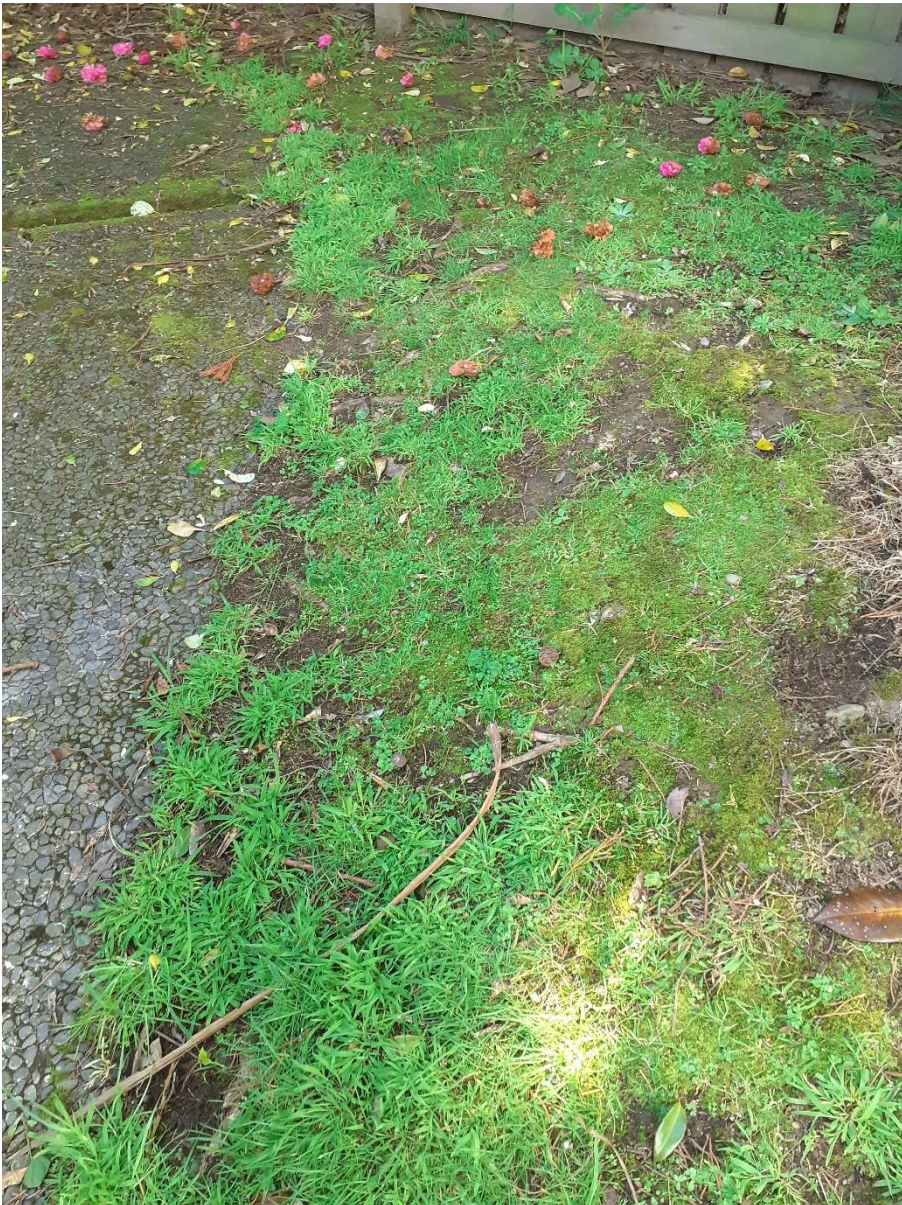
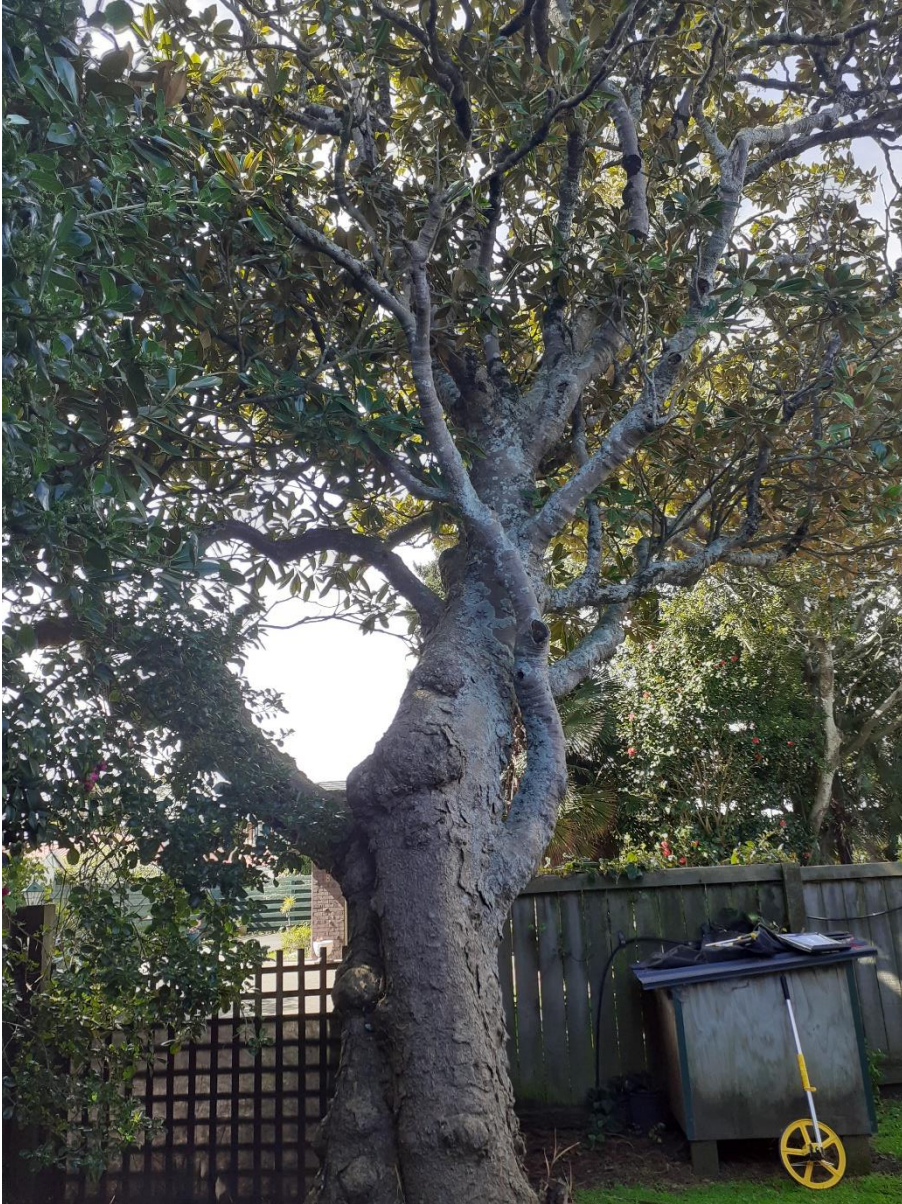
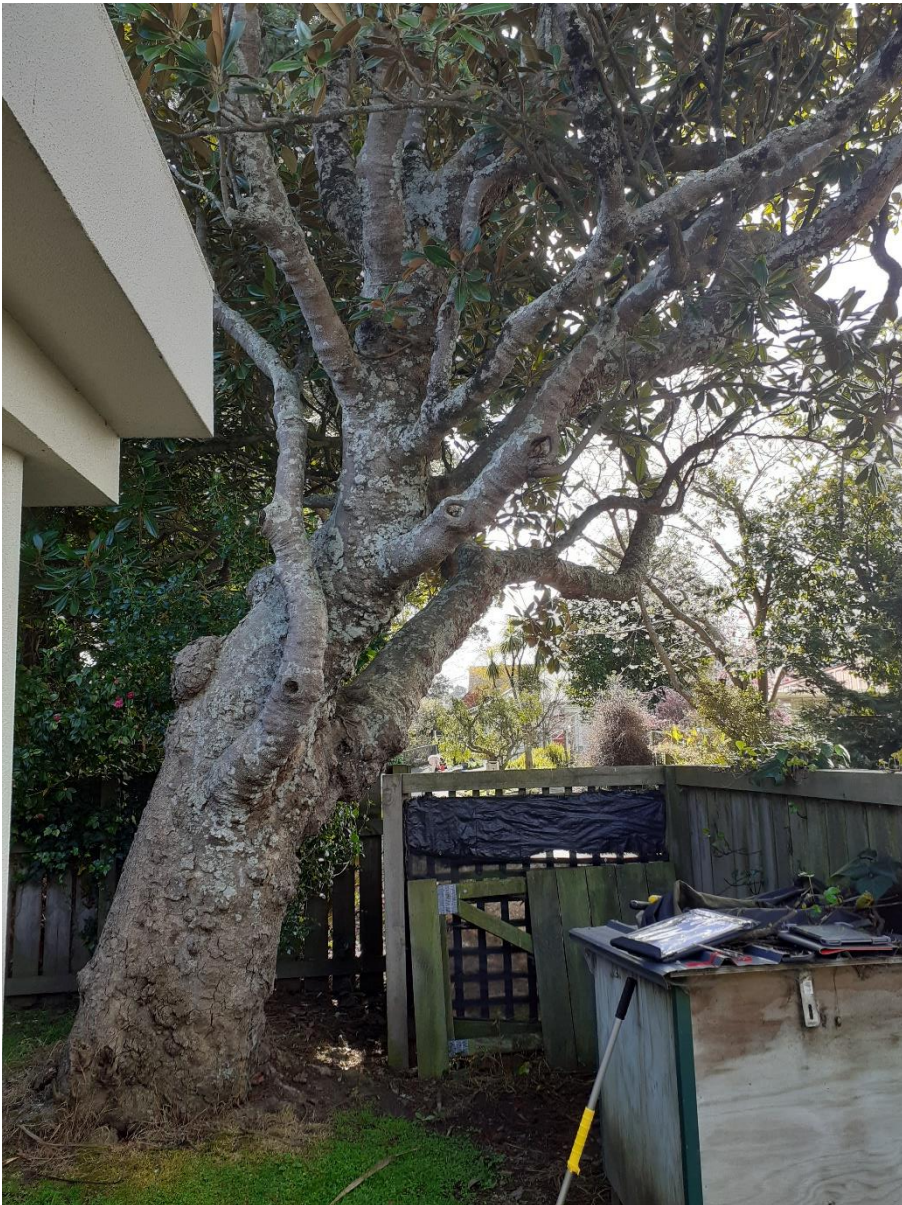
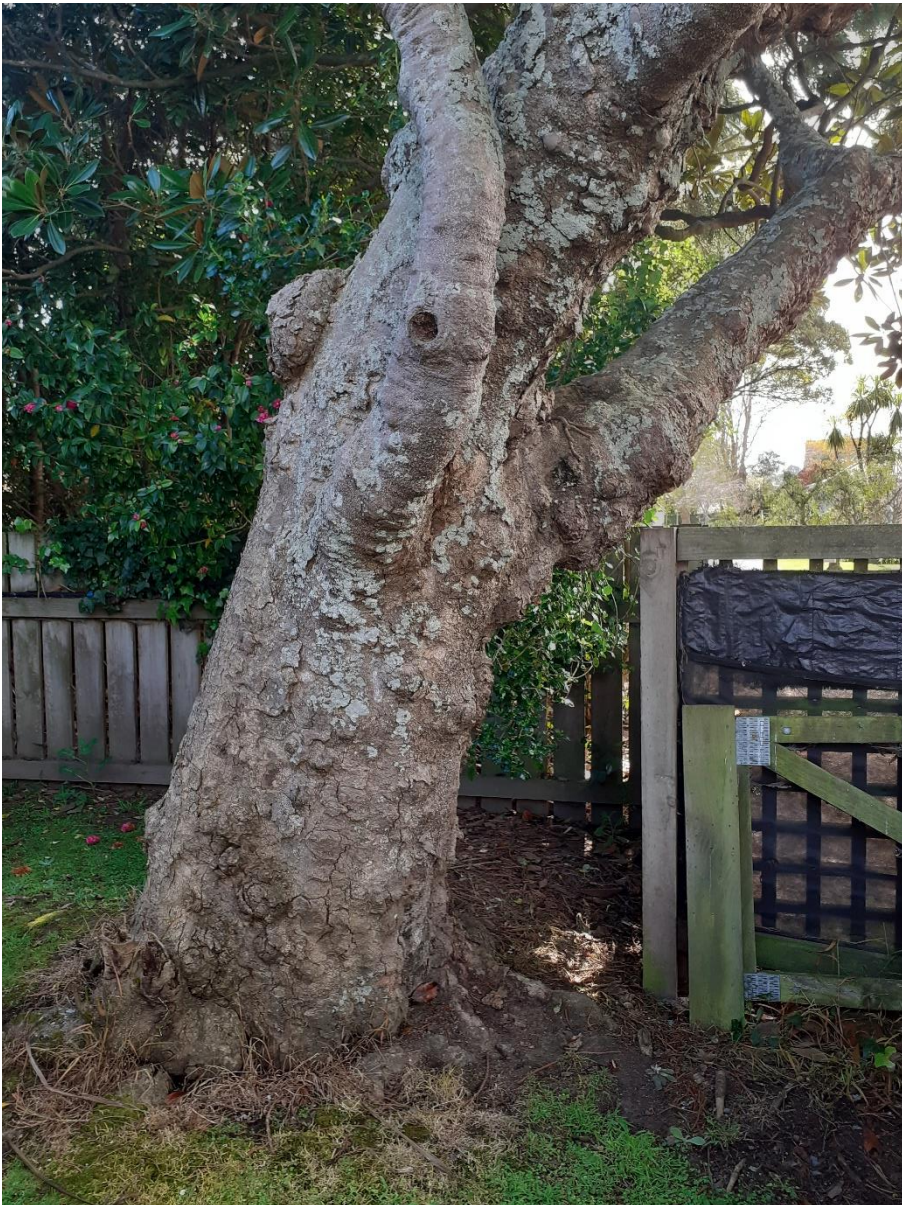
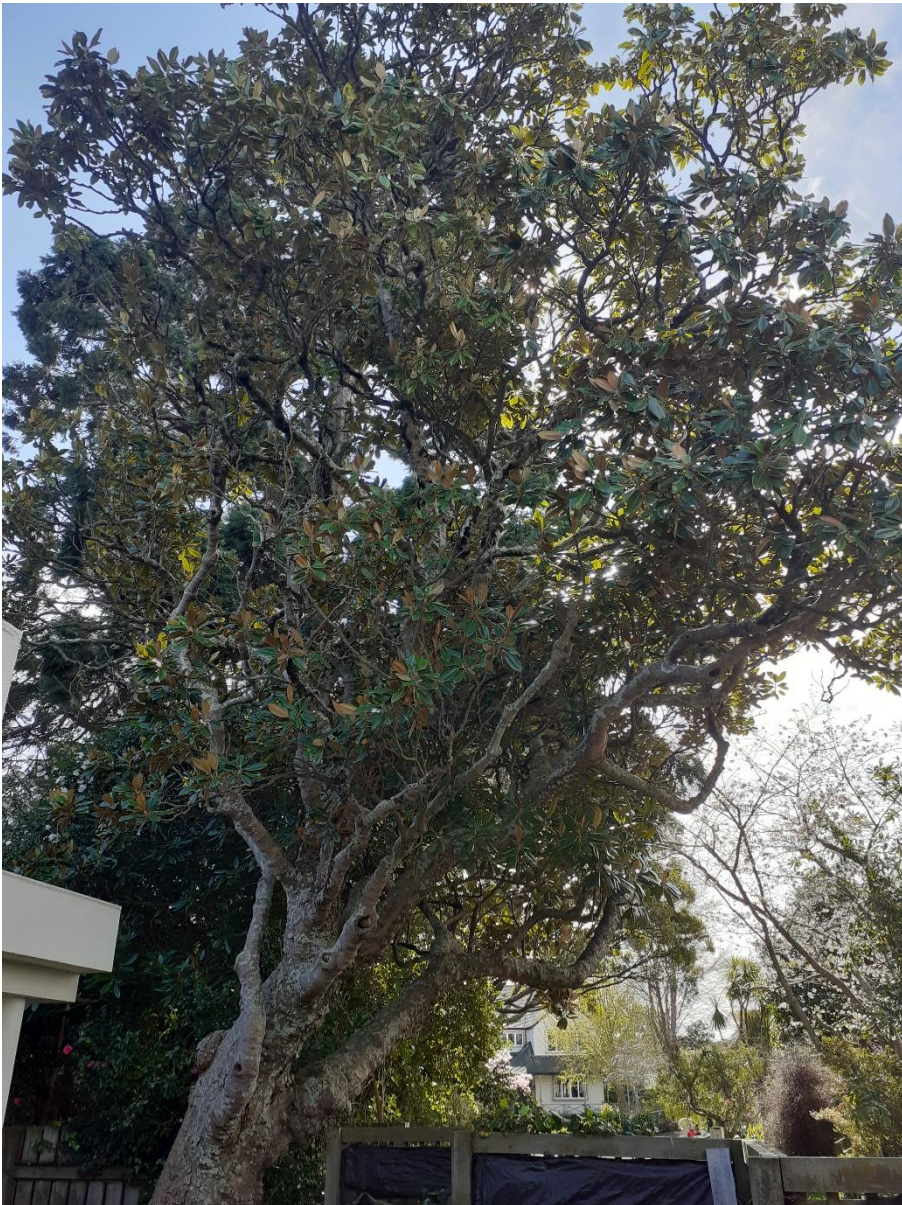
**Assessor's notes:** One sided canopy mostly to north, numerous decay pockets, showing signs of senescent aging decline, veteran and retrenching.

**Past and current management:** Root severance for path within garden may have damaged roots and now leaning as a result.

**Nuisance/negative factors:** Overhanging path. Roots are causing some damage to garden path but damage is minor.

**Suggested care and maintenance:** Reduce limb over road as hollow and could fail. Reduce end weight by 2 to 3 m
