## Review of District Plan Appendix 1D Notable Trees

### Part 2 – STEM Assessments of Notable Trees, Manawatu District Council

Report Date – 4<sup>th</sup> February 2022

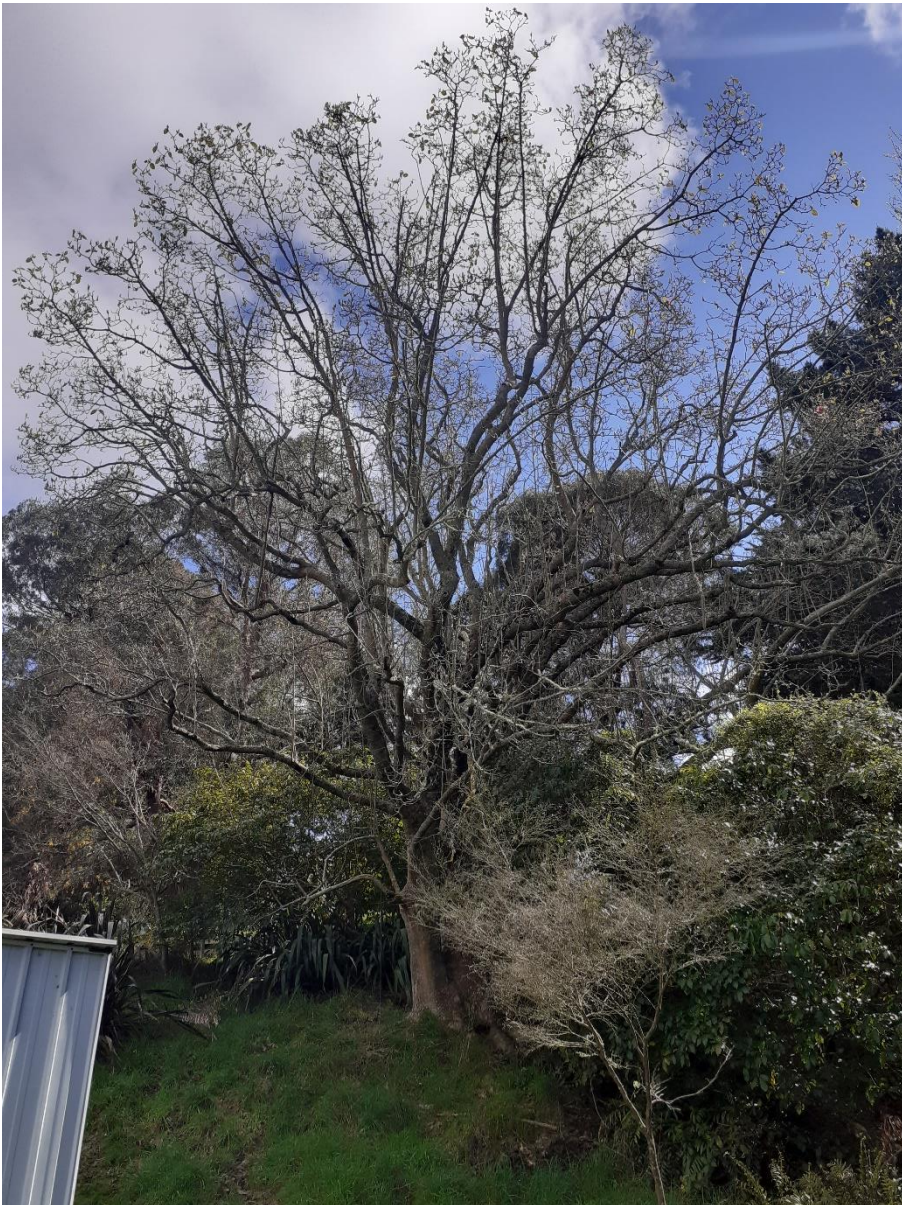
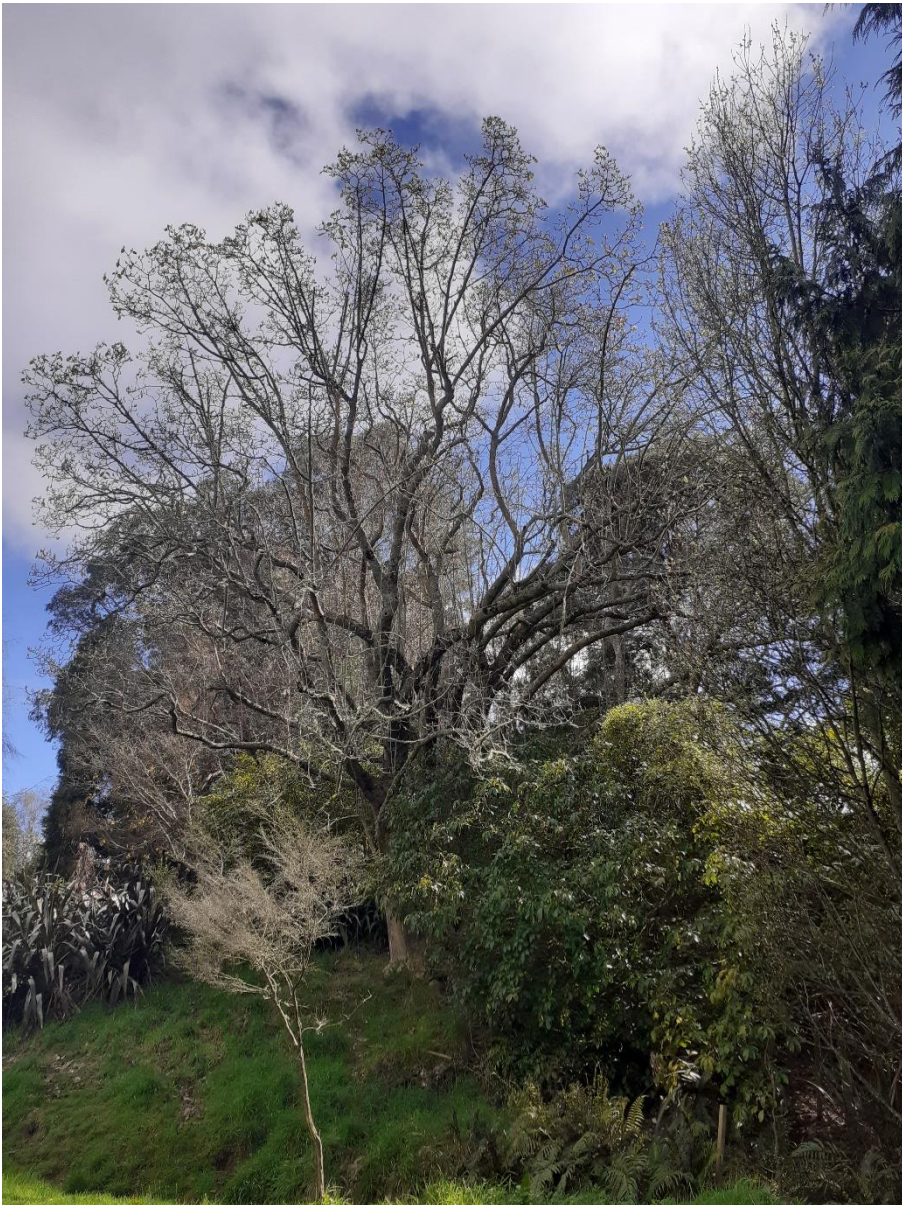
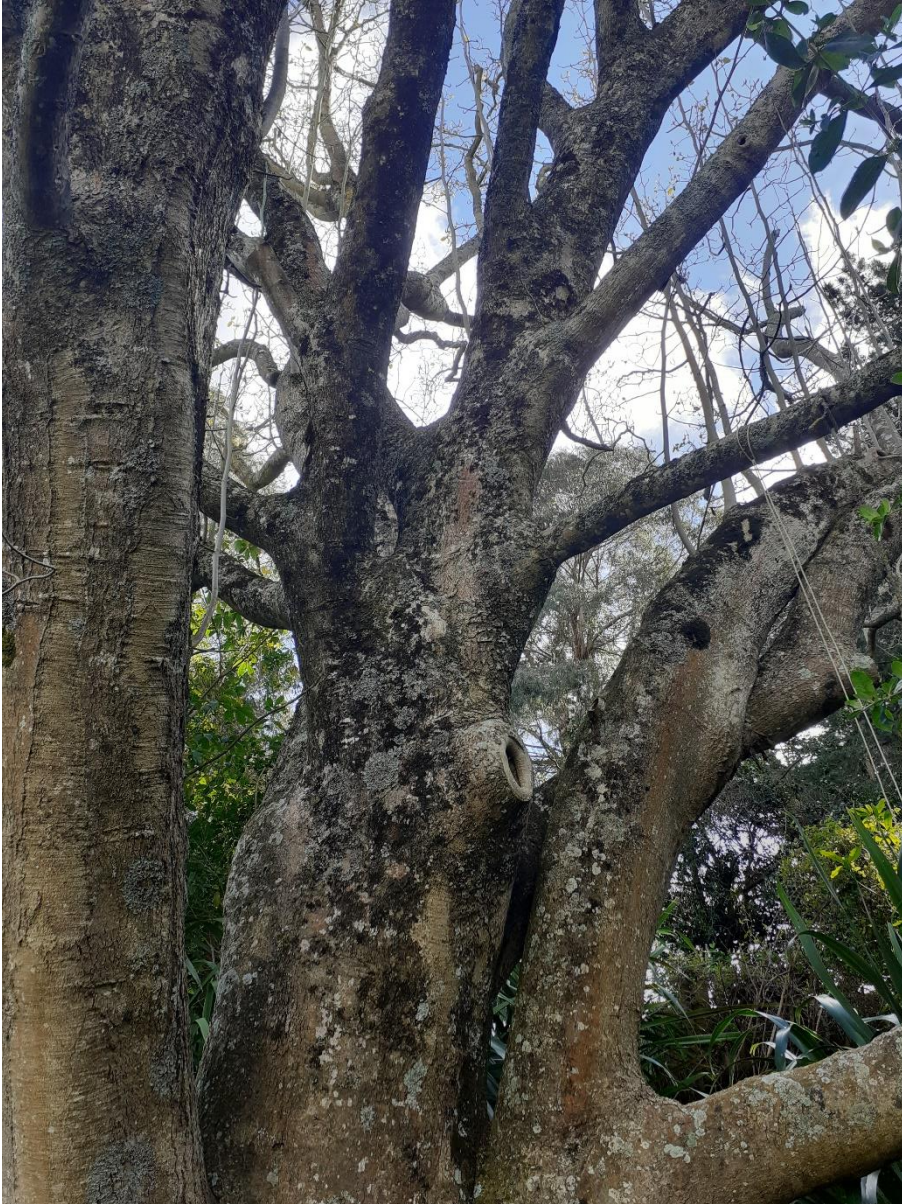
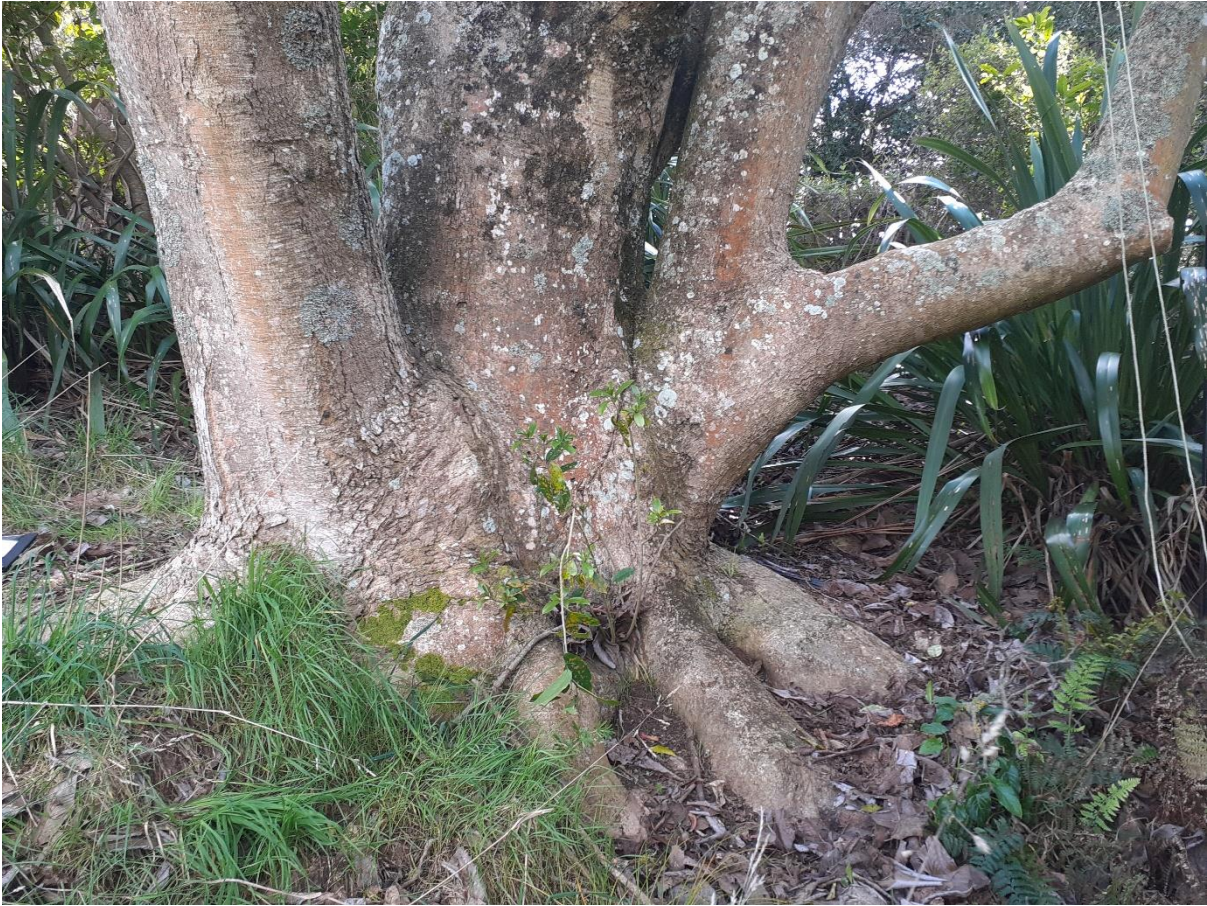
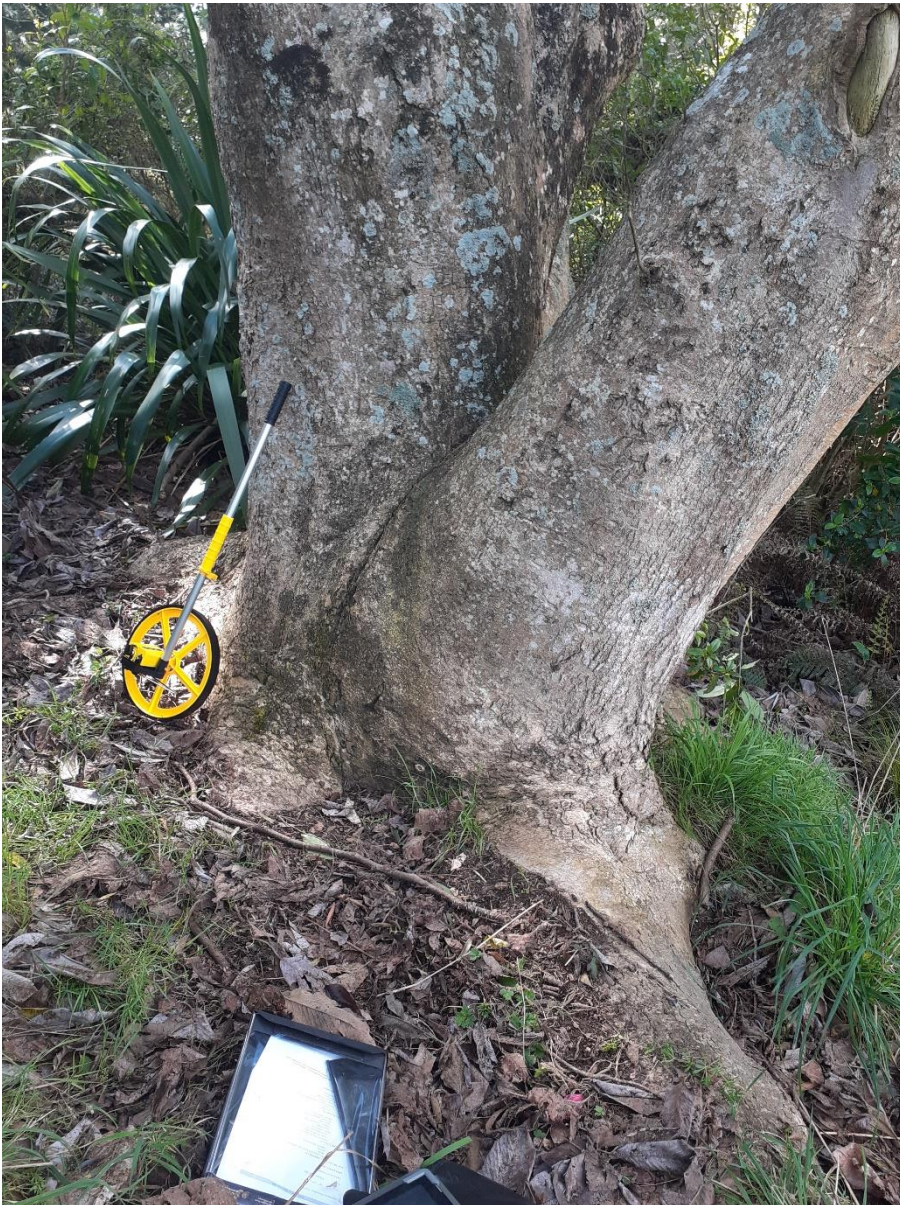
Large infrequently found tree. Good specimen.

**Past and current management:** Appears to have been thinned and dormant buds now emerging as water shoots. On steep slope (45 to 70 degrees). Stability of tree on slope is good despite incline. Large holding roots and buttresses upper slope side. Some major stems hollow north side but no signs of decay fungi. Maybe under disease stress.

**Suggested care and maintenance:** Recommend annual inspection to determine if diseased, and to recommend any suitable mitigation based on that finding.

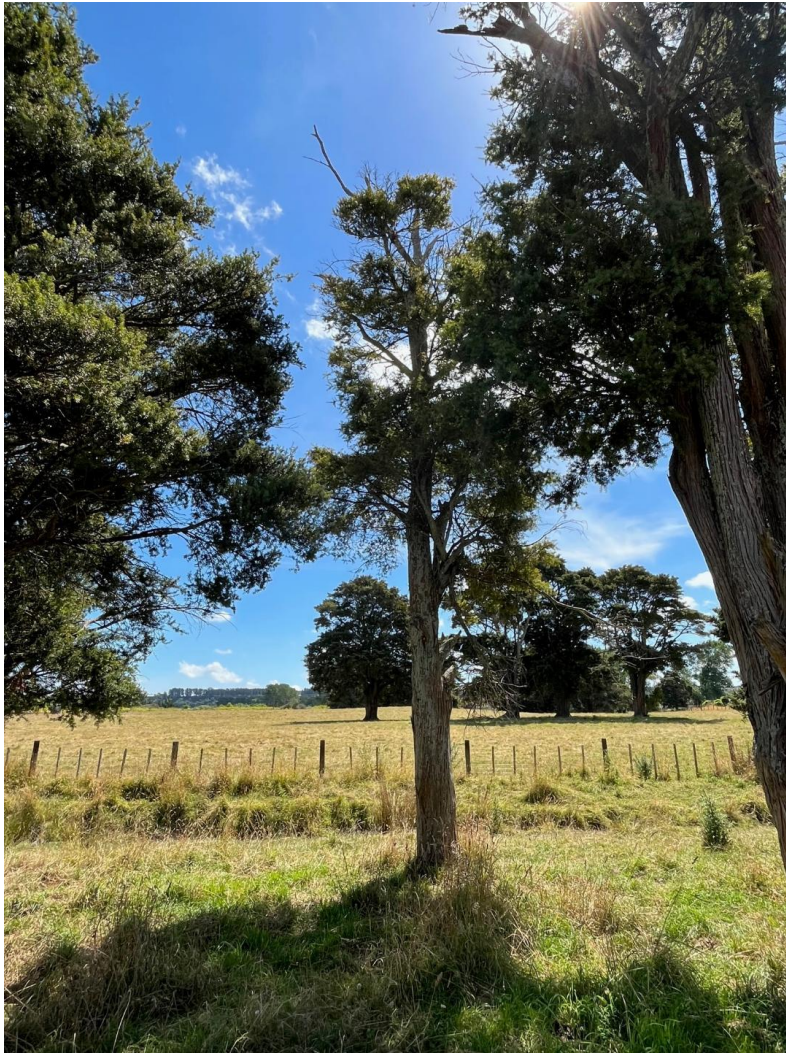
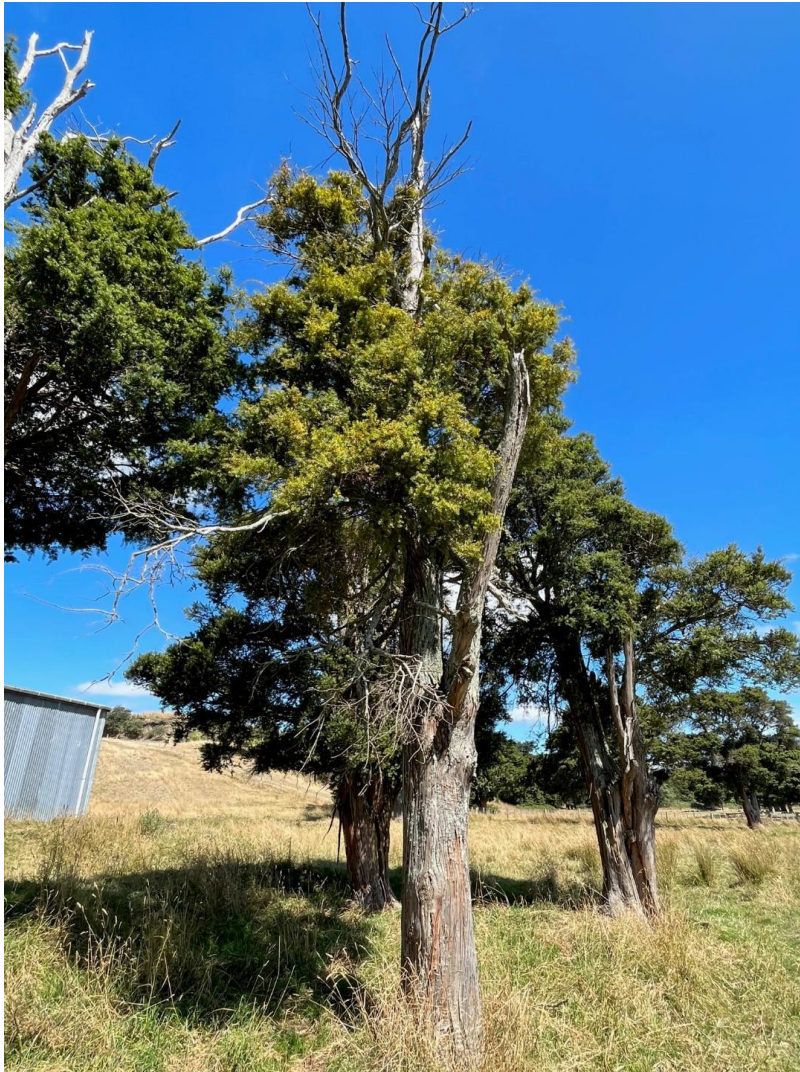
Photos below taken January 2022

**Location of Tree(s) on site:** In field, visible from road but a small declining tree which would be barely discernable from the public road. Many other totara nearby in a parkland like setting but this specimen is in very poor and declining condition and 'golden' needle colour is hardly discernable.

**Past and current management:** Unmanaged, appears to have not been managed or pruned, has lost many branches naturally as a result of decline and dysfunction.

**Threats to the future of the tree:** Compaction of soil and damage to roots caused by grazing pressure.

**Suggested care and maintenance:** In very poor condition and falling apart, management to remove dead wood may help but is unlikely to arrest decline. Not recommended to be listed as a Notable Tree as condition is very poor and dying.

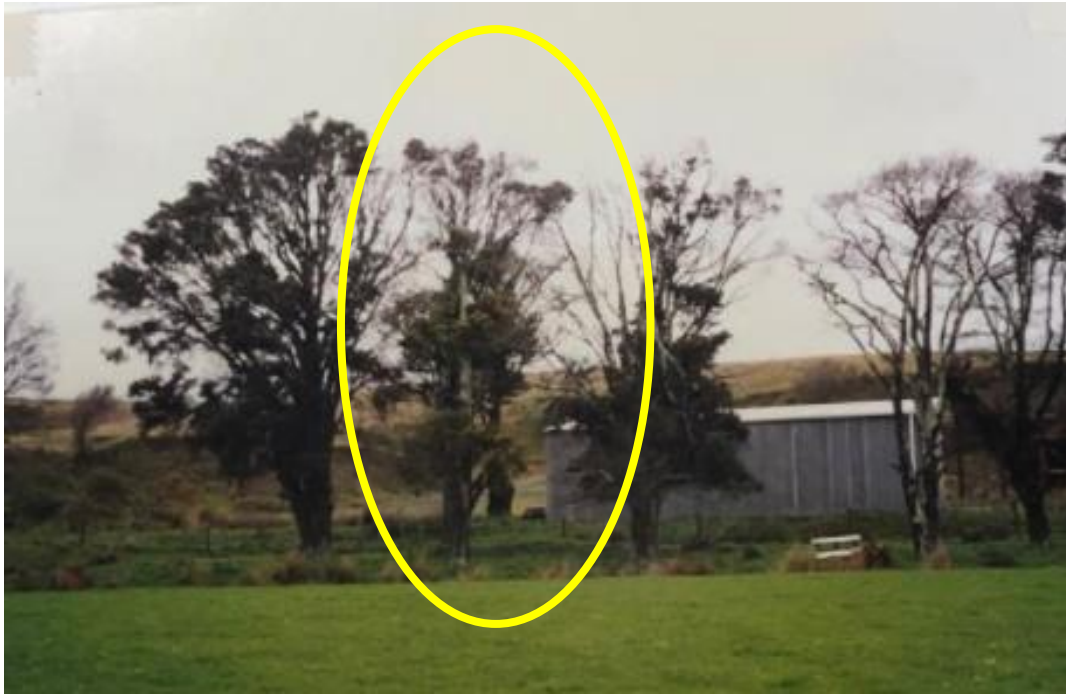
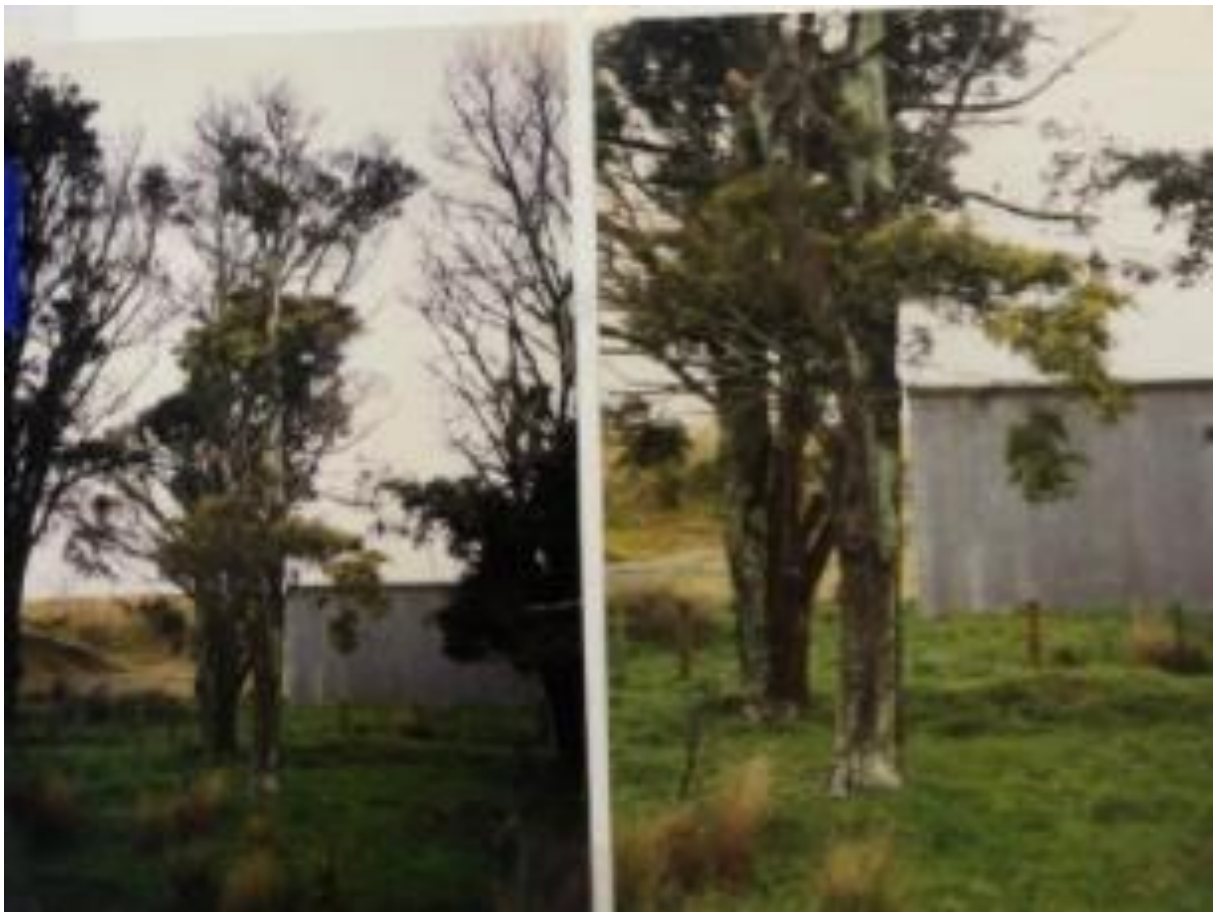
Photos below taken from 1995. Tree is now in poorer conditions than shown in these old photos.
