FORMER RNZAF OPERATIONS ROOM – Wilson Road, Ohakea

Architect: Public Works Department
Construction date: 1943
Visible materials: Reinforced concrete
Architectural style: Military
Use/building type: Military
Date and Compiler: Ian Bowman, 2016; Val Burr 2017
Proposed ranking: B

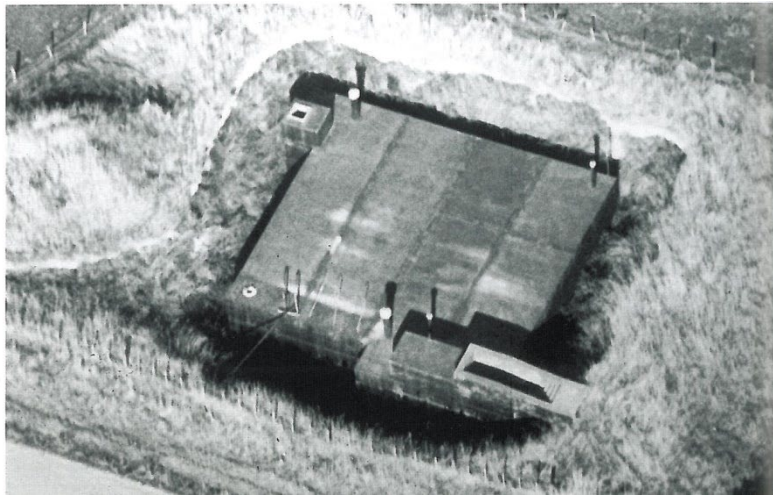
Centre The structure has been built inside the hole, and awaits being covered up. This is the Ohakea facility, north east of the air base. While not completed or used during the war, this was only covered over in the 1950s. Ohakea and Whenuapai both had large station shelters.

Figure 1 The Ohakea operations room structure prior to being covered over in the late 1950s. (Source: Cooke, p. H-8)

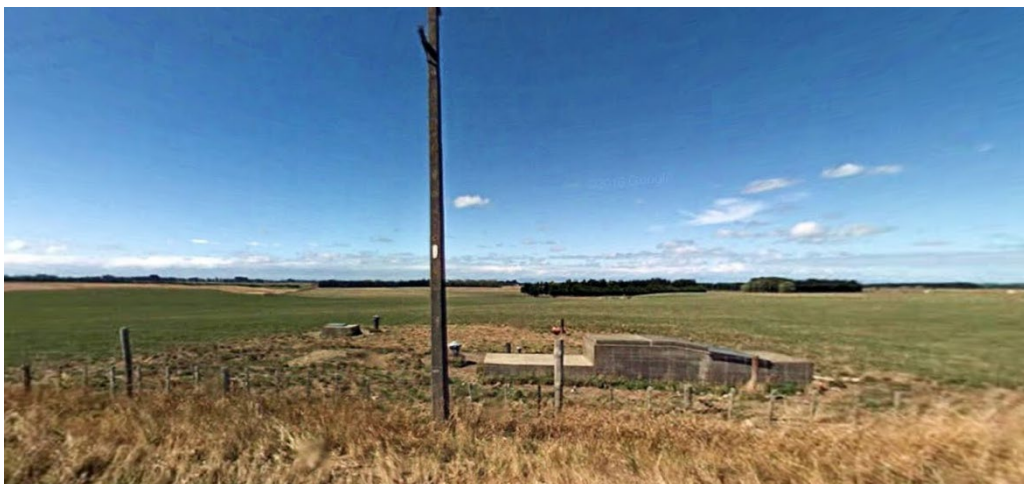
Figure 3 The Ohakea Operations Room still underground, as photographed by Google Street View in March 2008, before the soil was removed from the top of the concrete room. The soil had been cleared by February 2010 (Google Street View image).

The property was transferred into private ownership in the 1970s and farming activities have continued surrounding the operations room. In March 2008 Google Street View images revealed that the operations room was buried under soil, however, by February 2010, the roof of the room had been cleared of soil.

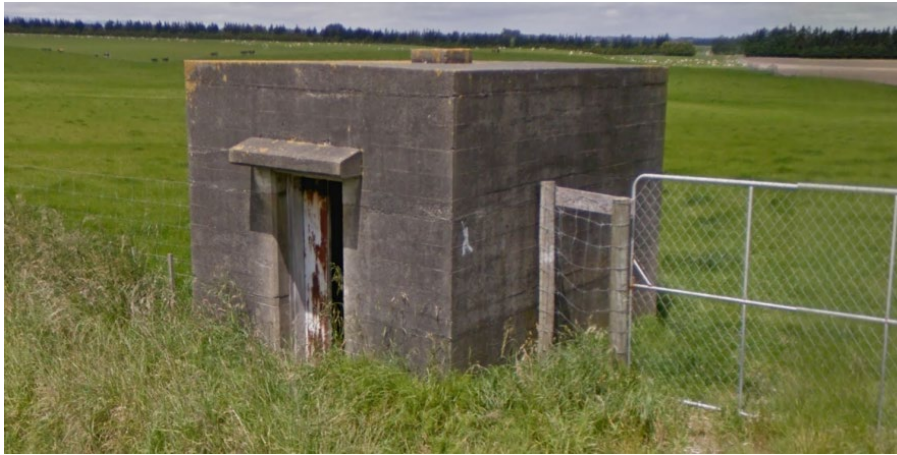
Figure 4 The small structure that contained the engine that powered the operations room
(Source: Google Street View, November 2013)

A small concrete structure was also built to the north east of the control centre, which has a timber door and low-level wall vents. It was possibly a radio or engine shed¹⁰.

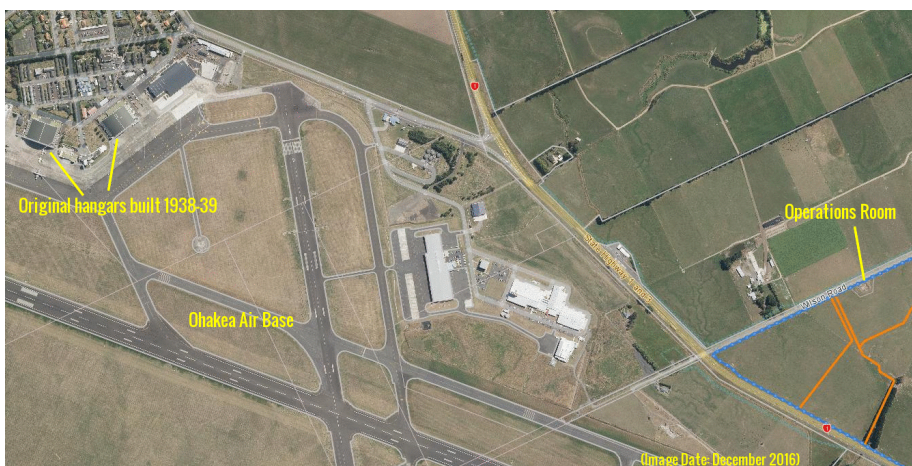
Figure 5 The operations room in relation to Ohakea Air Base. The two original hangars give an indication of how far apart the two centers of activity were during WWII. (Source: Manawatu District Council: <http://maps.mdc.govt.nz/IntraMaps80/default.htm>)
