Ecological Assessment of the Drainage Channels at Pukepuke Lagoon

This report has been prepared following a site visit on 7 April 2025 by Aaron Madden, Biodiversity Project Manager, Green by Nature, and Robert Rose, Senior Environmental Advisor, Manawatu District Council.

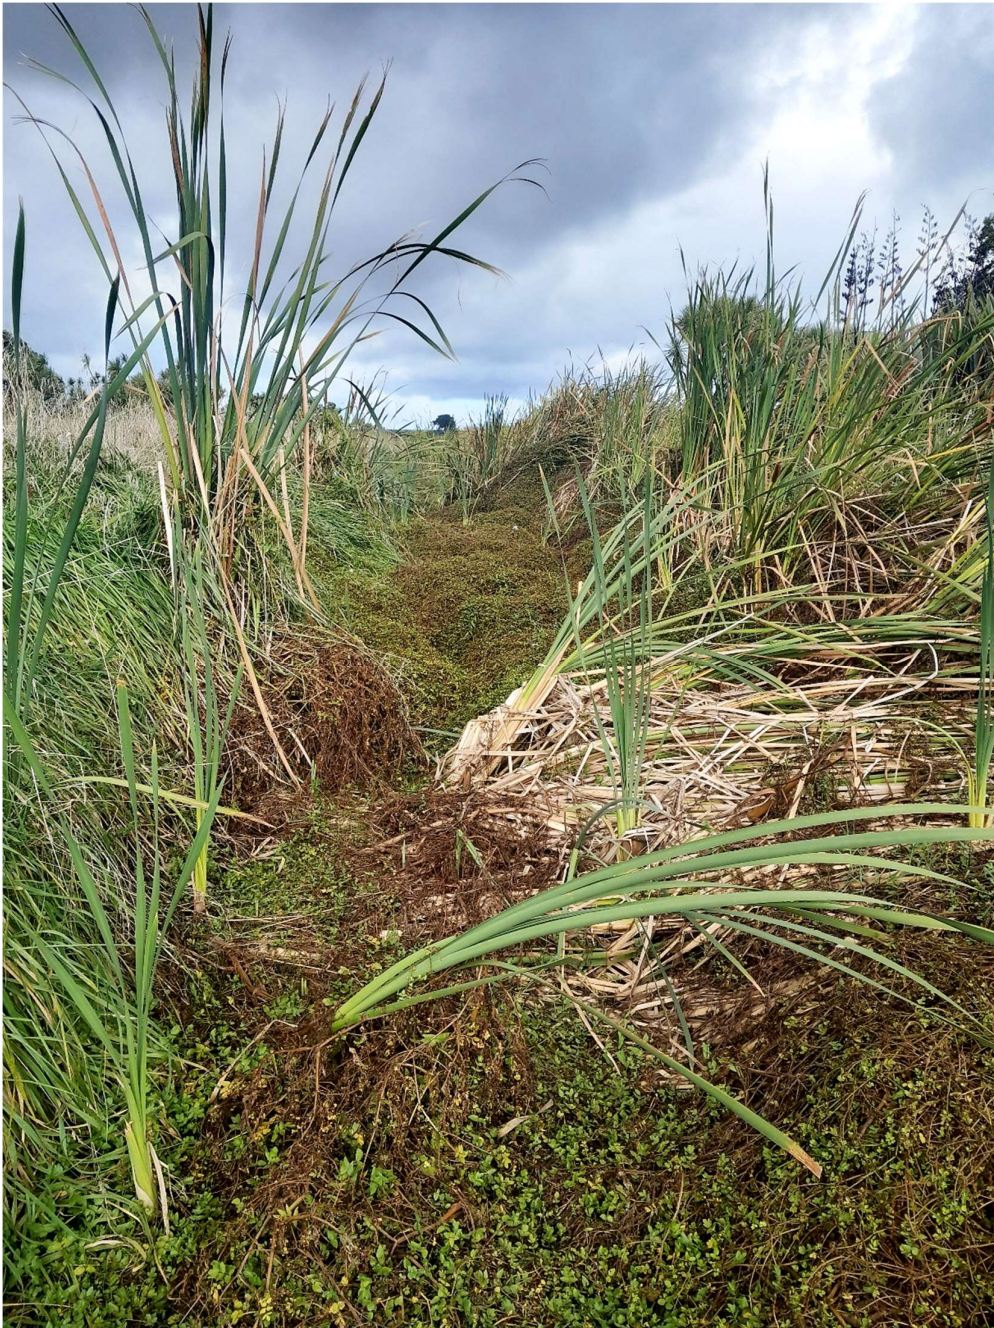
The dominant species in the Inlet Drain are water celery (*Helosciadium nodiflorum*) and raupō (*Typha orientalis*). Both ends of the Inlet Drain were dry but there was a short section of shallow water about midway, with common duckweed (*Lemna disperma*) amongst the raupō.

Water celery and raupō are the dominant species in the bed of the Inlet Drain.

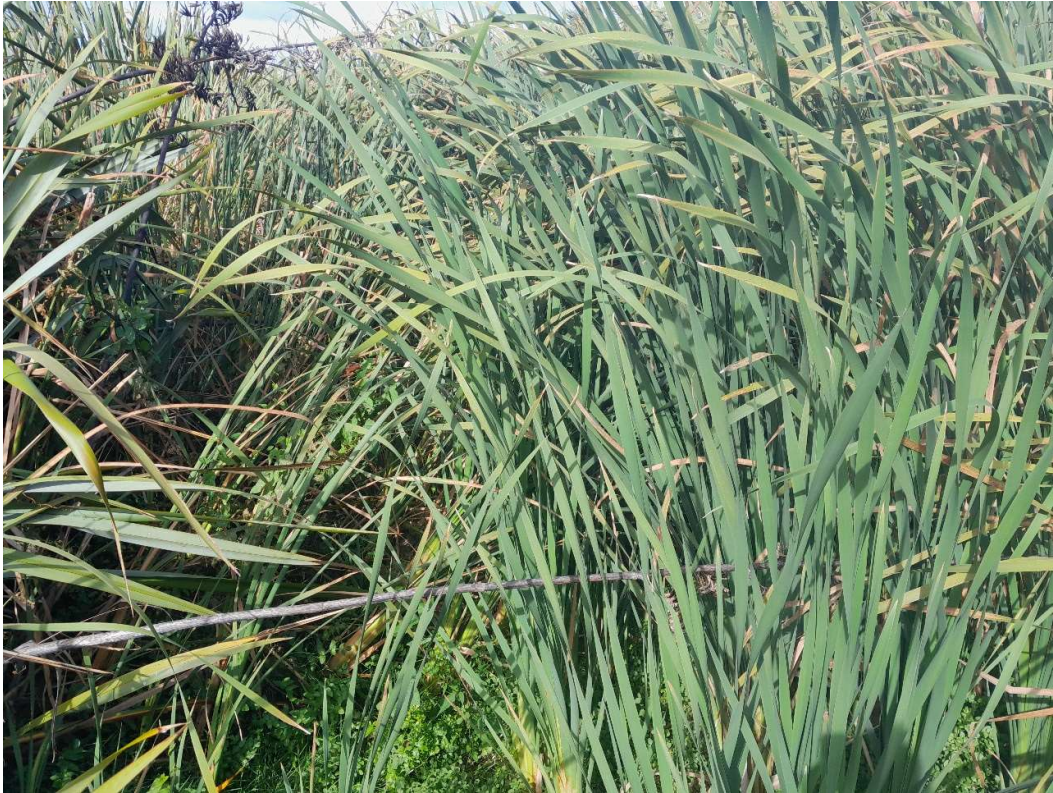
From the Lagoon until the footbridge across the Outlet Drain, the bed is mostly raupō with some water celery. On the other side of the footbridge, it is almost entirely water celery all the way to the Perimeter Drain. The drain is flanked by harakeke with raupō and occasional cabbage trees. There is a rough vehicle track along the eastern side of the Outlet Drain, a few metres away from the edge.

Between the footbridge and the Lagoon, raupō dominates the bed of the Outlet Drain.

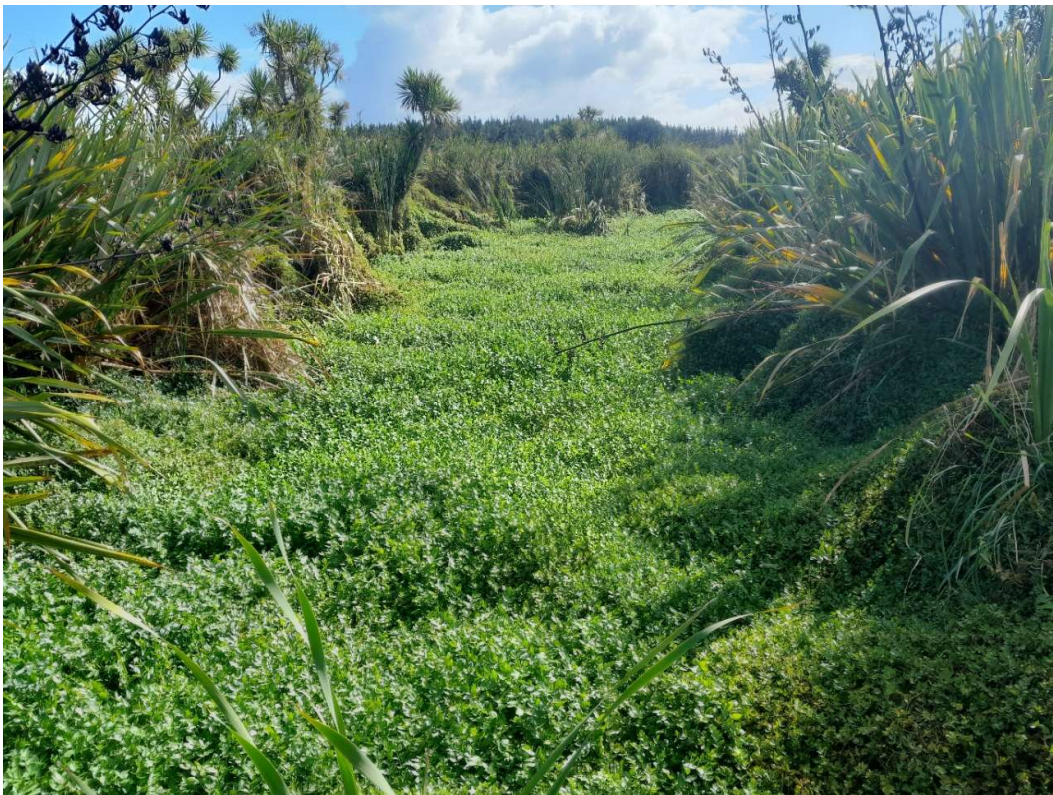
Water celery in the Outlet Drain, looking north from the footbridge.

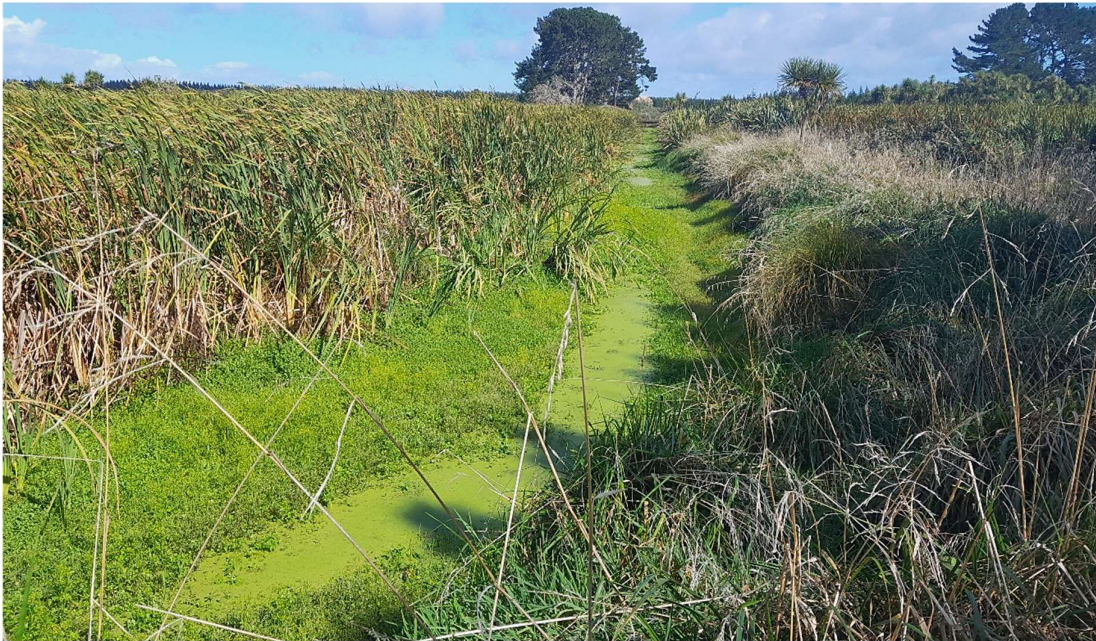
Vegetation in the Perimeter Drain is mostly a mix of water celery and common duckweed. Shallow water was present for most of the drain length although the bed was dry for several metres before the weir. On the southern side of the Perimeter Drain, raupō dominates the vegetation with occasional harakeke and *Carex secta*. The northern side is more open, with occasional harakeke, cabbage trees, mingimingi, *Carex secta* (purei), raupō, *Carex geminata* (cutty grass, rautahi), giant umbrella sedge, and *Bolboschoenus fluviatilis* (marsh clubrush, kukuraho, pūrua grass) amongst various exotic grasses. There is a vehicle track along most of the northern side of the Perimeter Drain that varies in distance from 2 to 10m from the edge.

Western end of the Perimeter Drain, looking west towards the weir.

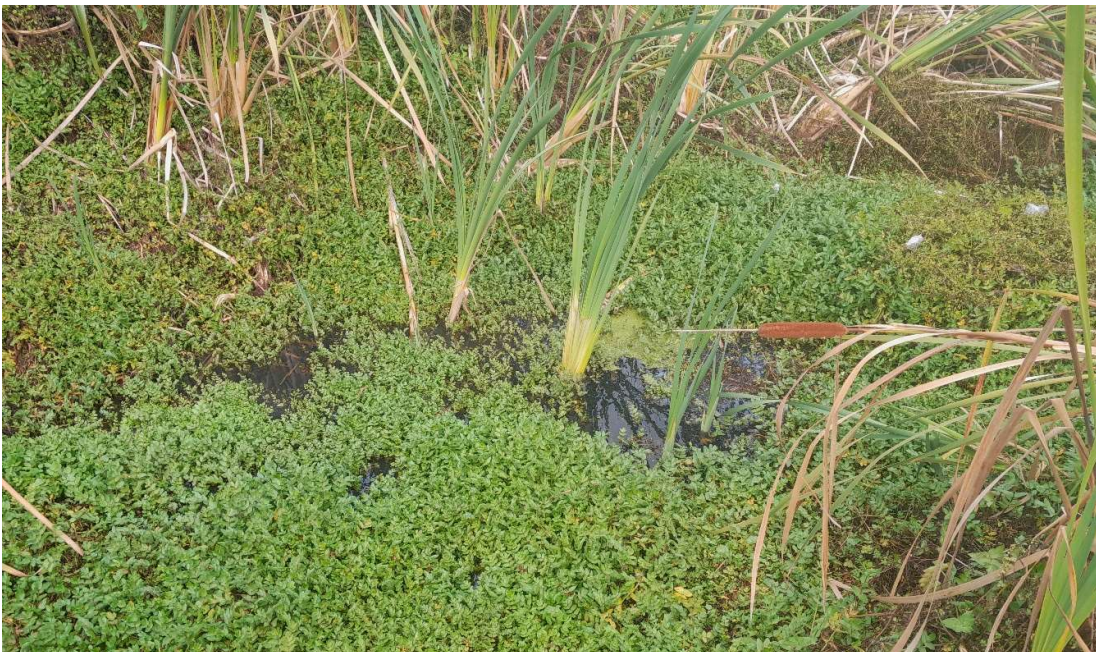
At the eastern end, with less common duckweed and more raupō, both in the bed and on the northern banks.

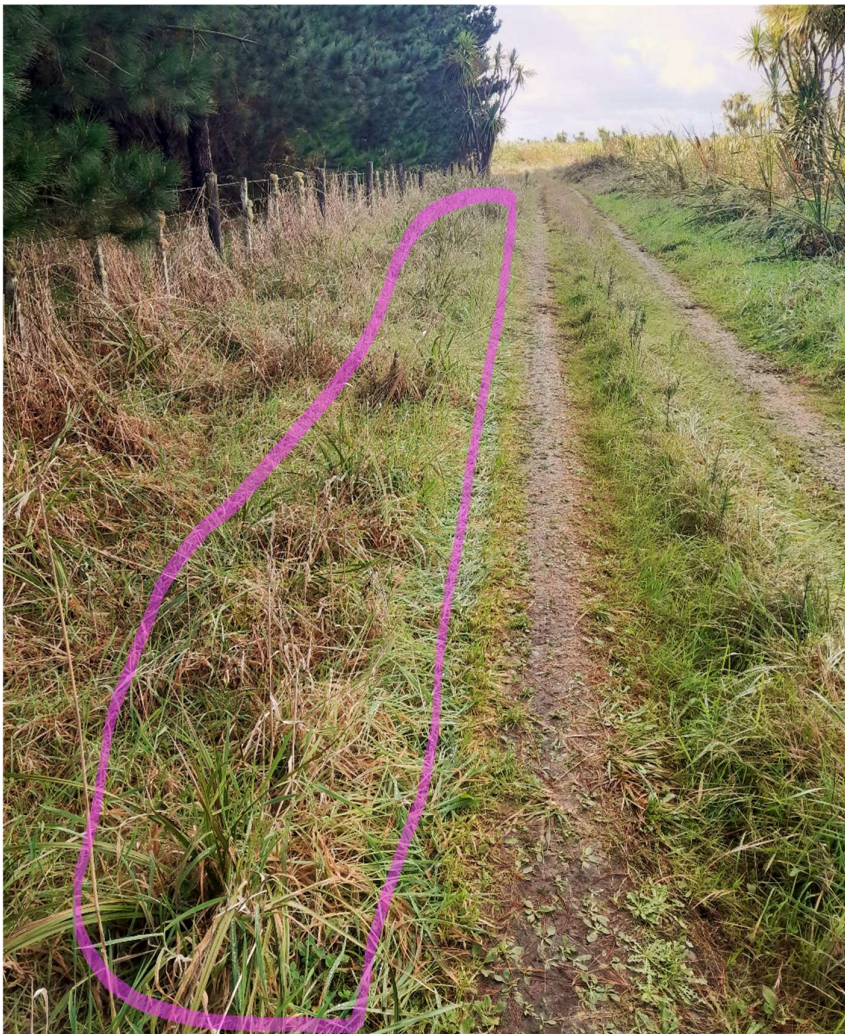
Carex geminata (cutty grass, possibly planted) on the northern side of the track along the Perimeter Drain. Keep drain cleanings on the southern side of the track along this section.

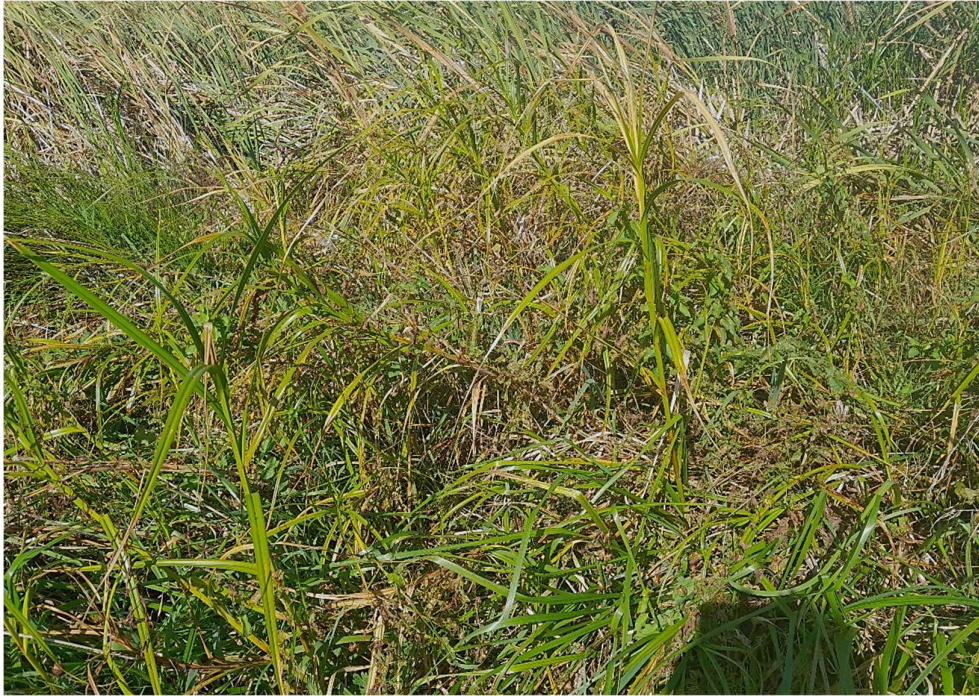
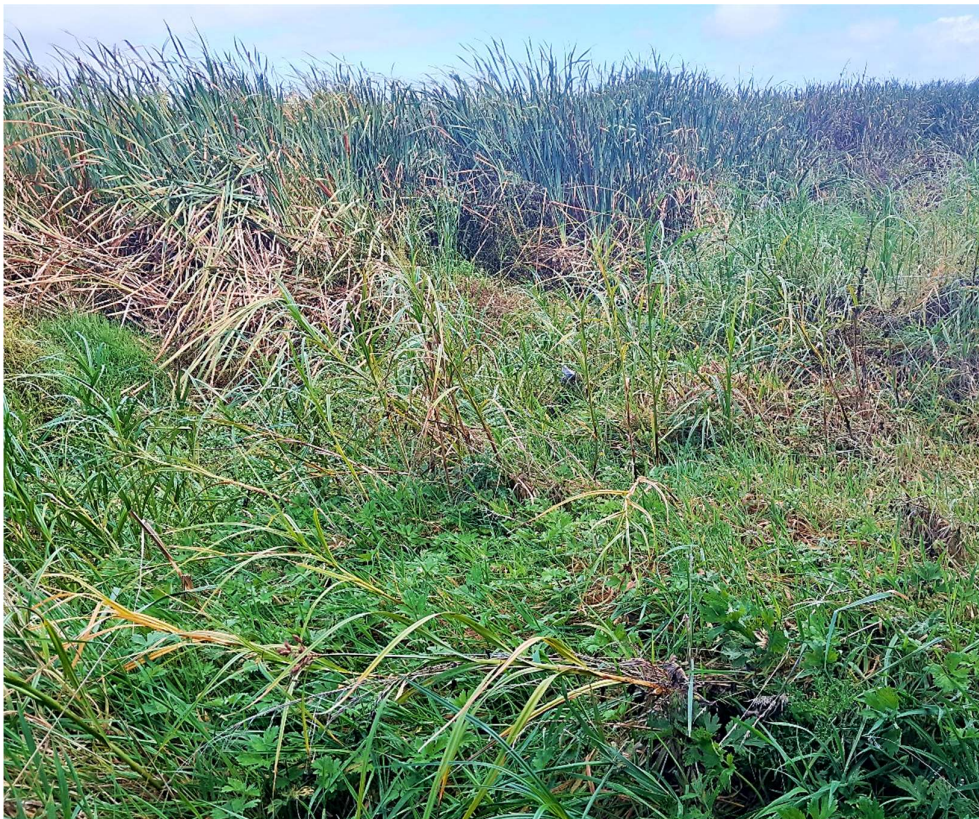
Bolboschoenus fluviatilis (marsh clubrush, kukuraho, pūrua grass) – an upright plant with triangular stems, growing to about 1m.

Plants of this species growing in the bed of the drain can be removed but effort should be made to protect the individuals growing on the banks.

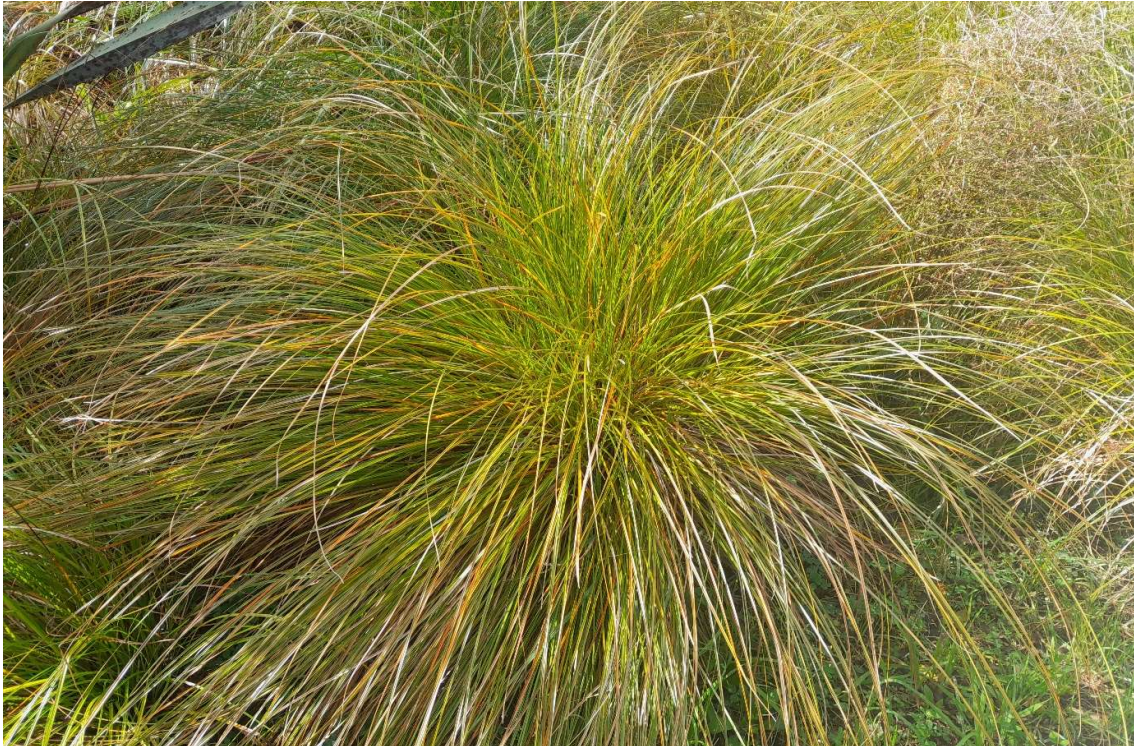
Carex secta (*purei*) – a native grass-like sedge. The leaf tips are often orange, especially on plants in full light.

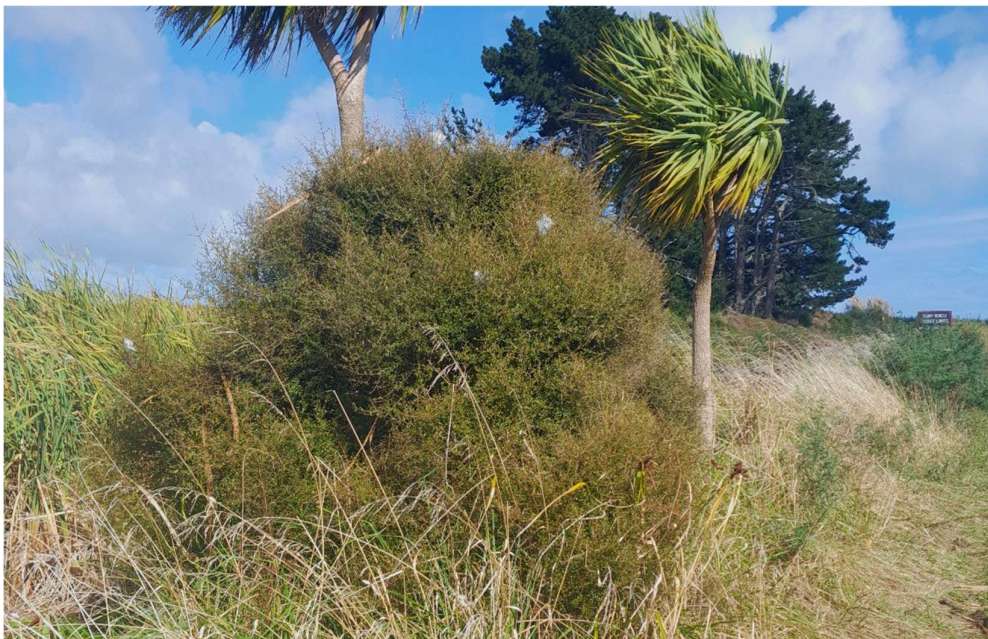
Coprosma propinqua (*mingimingi*) – a small-leaved shrub or small tree growing next to some cabbage trees near the weir.

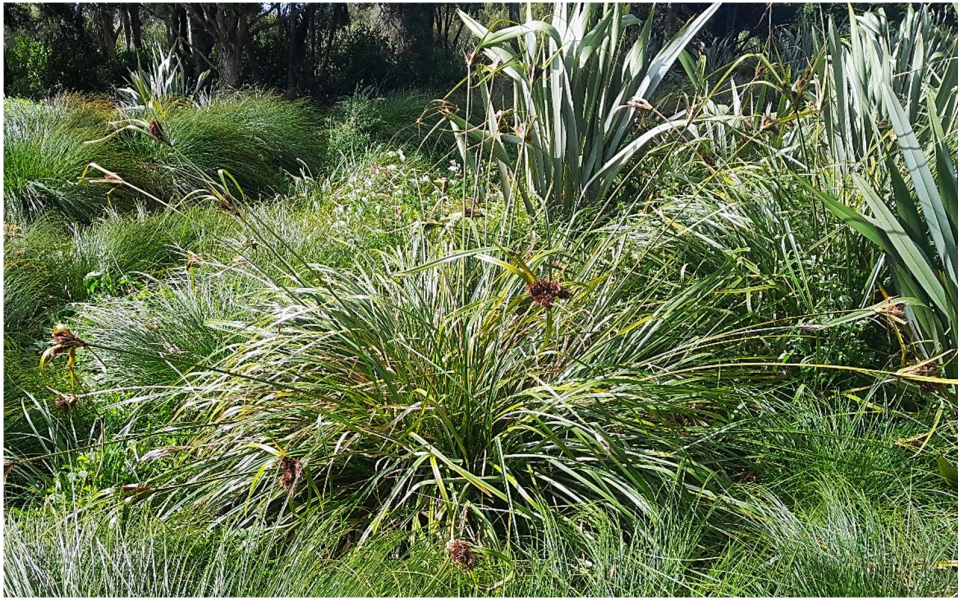
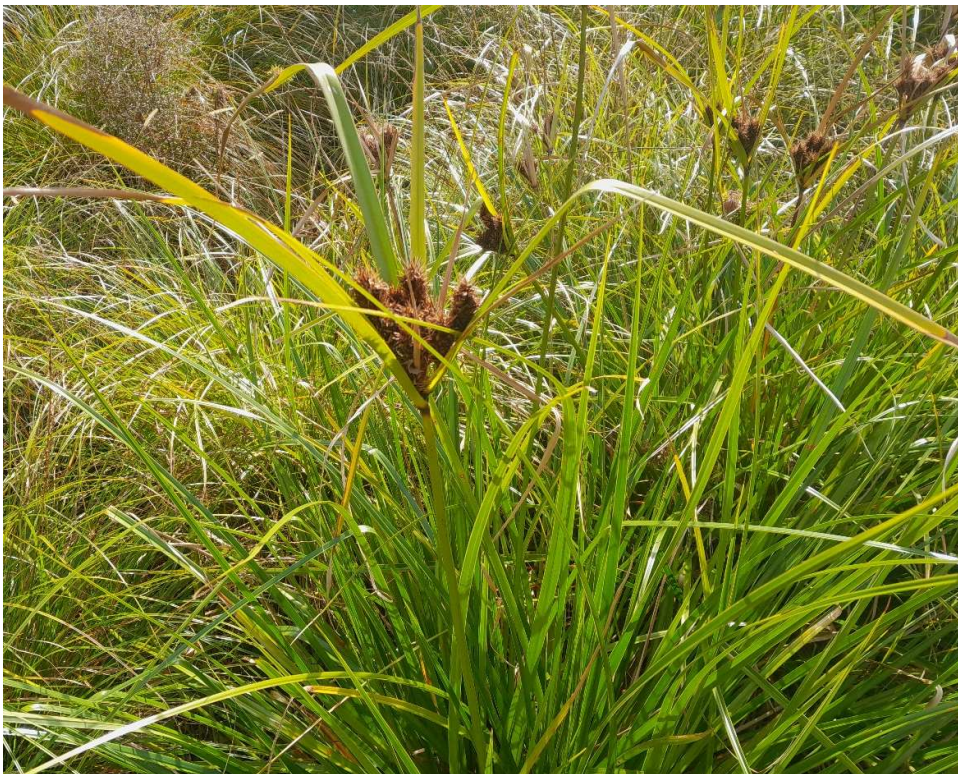
Cyperus ustulatus (giant umbrella sedge) – has long stalks with dark brown seed heads.
