Manawatū District Council
Pukepuke Lagoon Update for
Department of Conservation
28 August 2024

1. Executive Summary

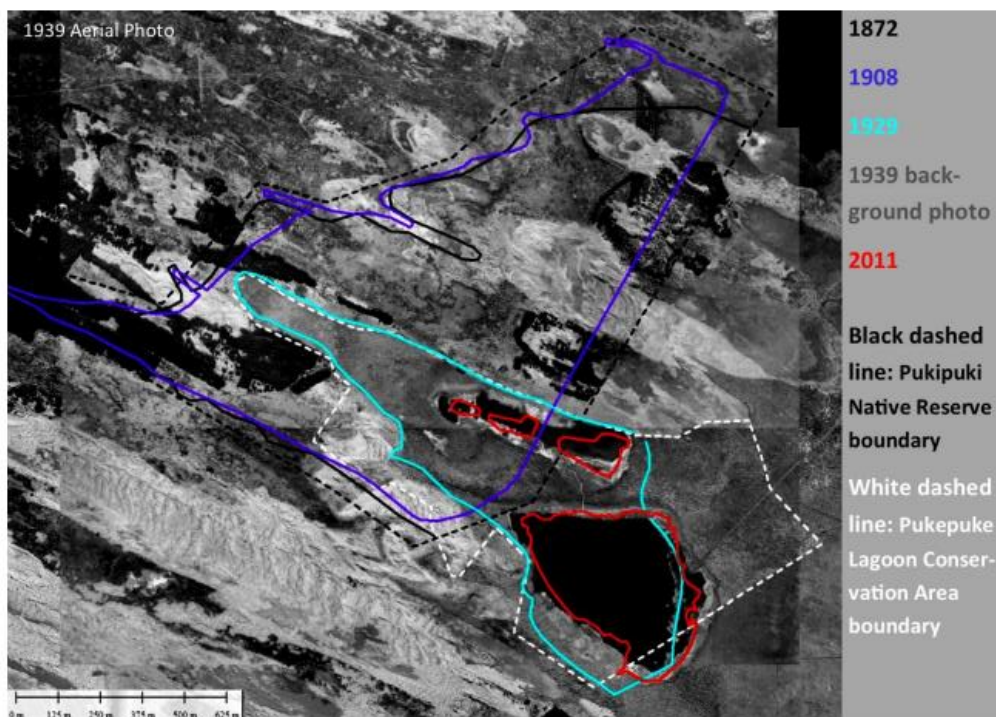
Figure 3: Changes in extent of Pukepuke Lagoon over time

The shape and extent of the lagoon has changed over time with the Lagoon historically stretching further north of its current location. Extensive changes to local drainage, changes in land use and the dynamic nature of coastal strips has resulted in the Pukepuke Lagoon reducing to its current size and location (See Figure 2 and 3 for details).

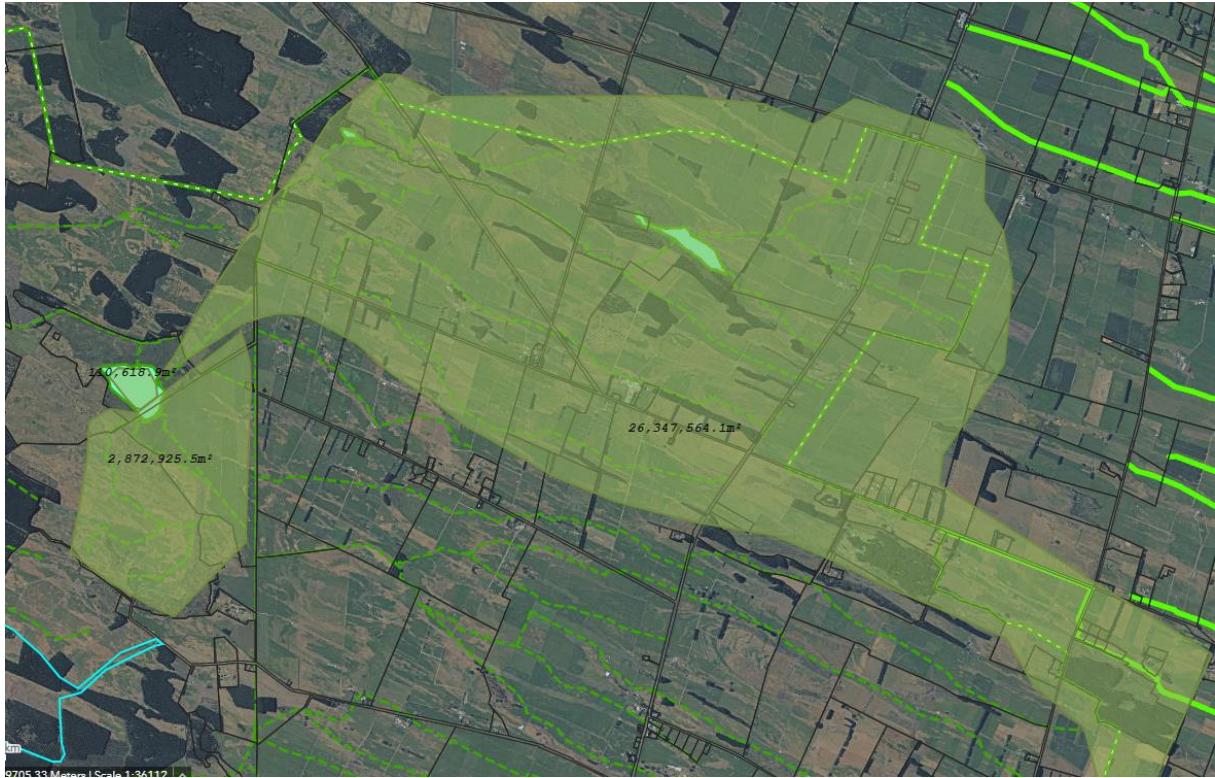
Figure 6: Drainage board catchments for the Pukepuke Lagoon

The Main Drain catchment is almost ten times the size of the adjoining catchment (See Figure 6 for details). Subsequently the pump for the smaller catchment is not designed to pump the combined flows of both catchments. As a result the additional volume of water has caused approximately 13.4 hectares of land to be submerged. Of this approximately 8ha is on Pamu (Landcorp Farming Limited) and 5.4ha is on Percy Pastures land. As these properties are the

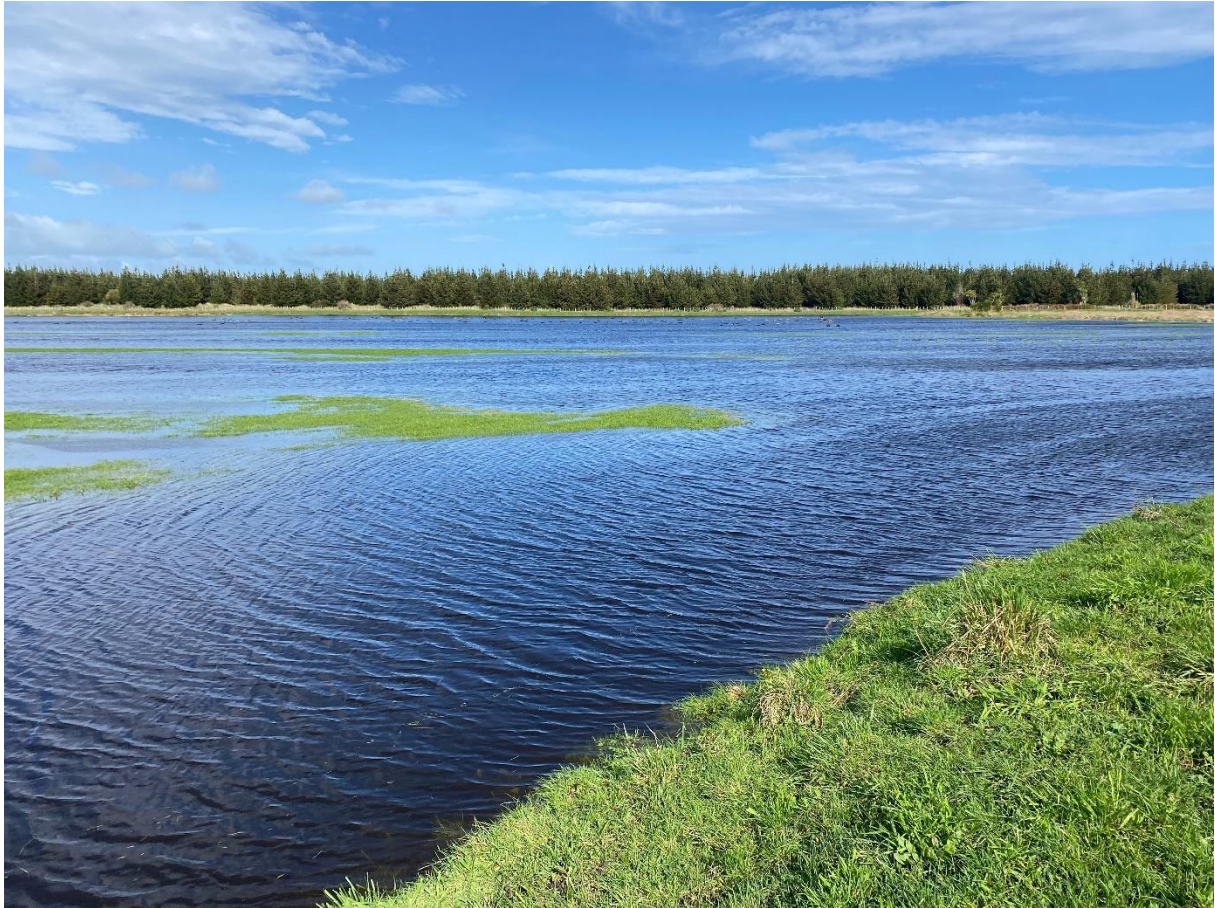
Figure 7: 19 August 2024 flooding event

lowest properties and are situated below Pukepuke Lagoon with no natural outlet, these properties are disproportionately effected when water is prevented from entering or leaving the Pukepuke Lagoon (see Figure 7 and 8 for details).

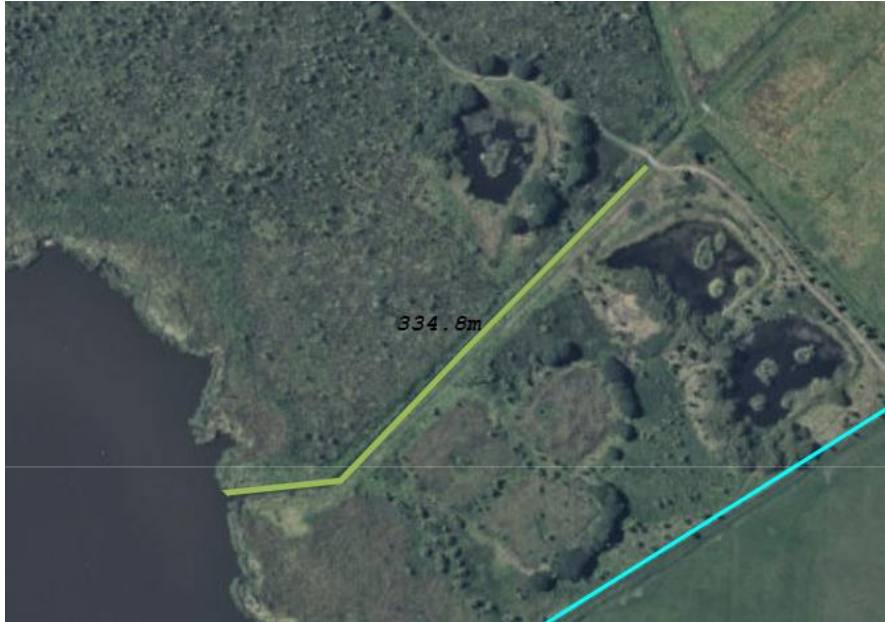
Figure 9: Main Drain Inlet

The Main Drain is approximately 6 m wide within the section that is on private property. Once this drain enters the Conservation Land, the drain is restricted with an average width of 4m but sections are almost completely blocked. This bottleneck within the drain has been caused as there has been no active vegetation removal over the last six years. This has allowed aquatic

plants and raupo to encroach into the drain. In order to remove this constriction the inlet drain needs to be reinstated to its original width of six metres. This section of inlet drain that needs to be reinstated is approximately 335 metres long (See Figure 9 for details). Majority of the work is required in the first 180m of this inlet.

- Reinstall the Main Drain Inlet drain into Pukepuke Lagoon to its original six metre width.
- Reinstall the outlet Drain to its original six metre width

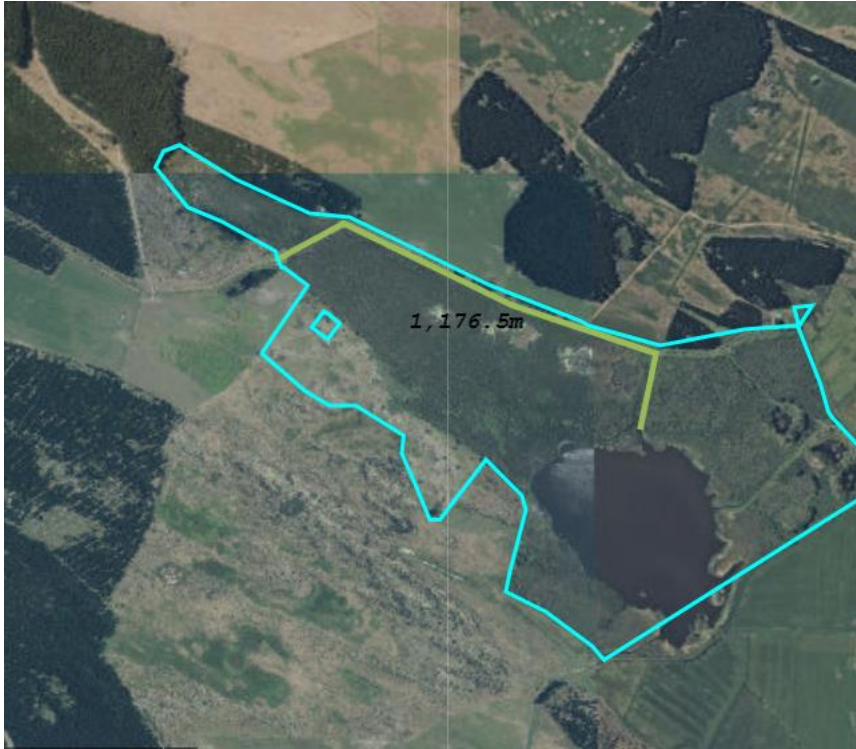
Figure 10: Pukepuke Lagoon perimeter drain

The water level within Pukepuke Lagoon is controlled by the Pukepuke Lagoon outlet weir. However, the vegetation restrict flow further during extreme events. This causes the water level within the lagoon to temporarily rise. As there is limited freeboard this can in turn cause water to spill back out of the lagoon onto the adjoining properties. Subsequently it is equally important that the capacity of the outlet drain is also maintained (See Figure 10 and 11 for details).

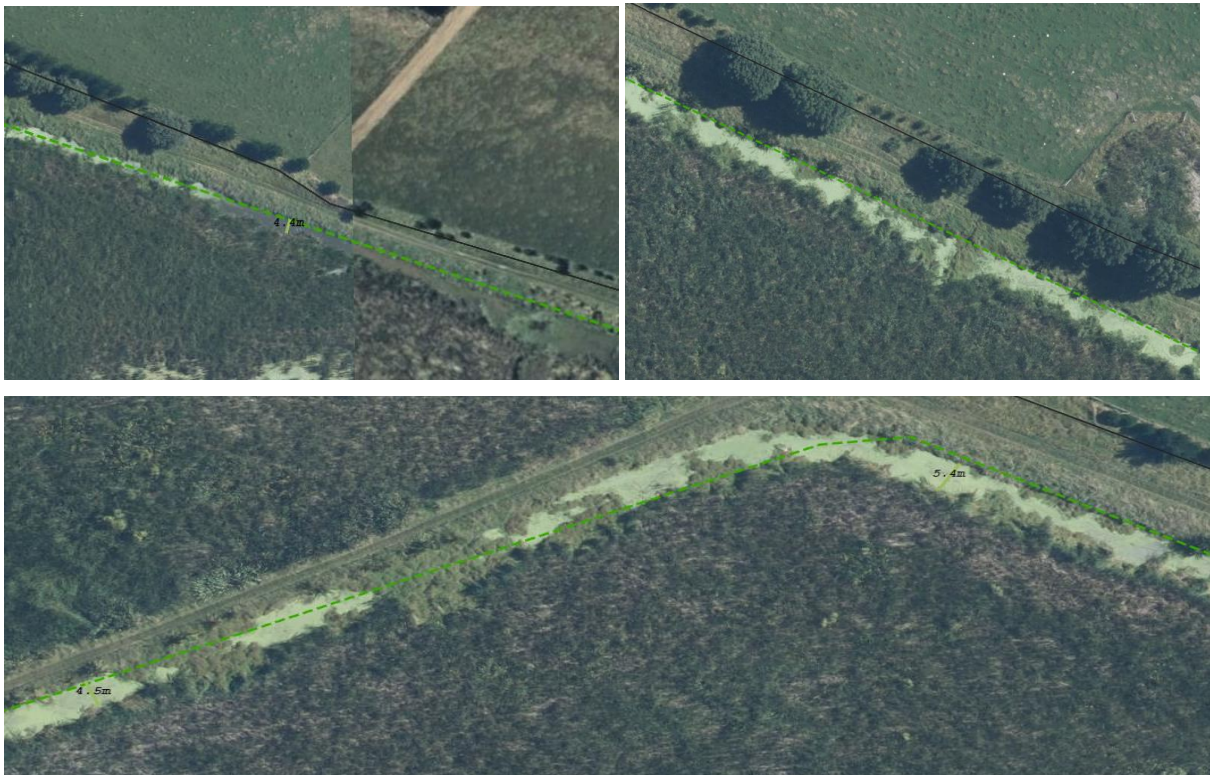
Figure 11: Perimeter Drain

Vegetation has also encroached on the perimeter drain with the average width being approximately four metres. This needs to be increased to six metres in accordance with the concession. While the average width of the perimeter drain is approximately four metres there are sections of this drain where vegetation has blocked the drain in its entirety (See Figure 11 for details).

- Reinstall the secondary flow path so when the Main Drain backs up it flows through the bypass and not floods neighbouring land
- Widen the perimeter drain to its original six metre width

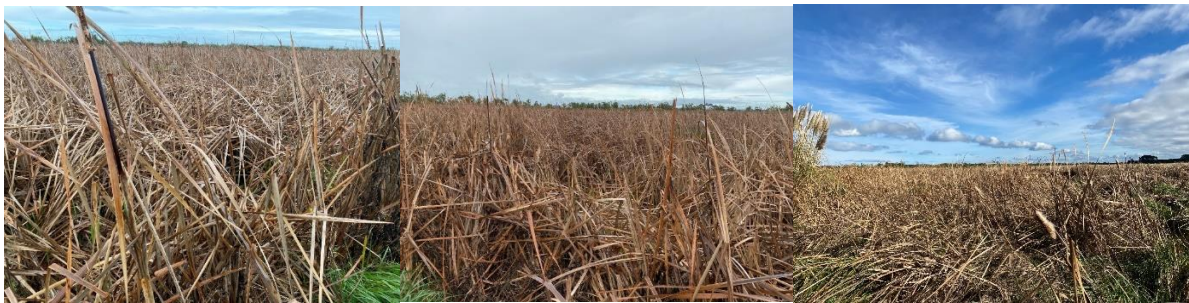
Figure 12: Predominant vegetation - Raupo

Raupo is the dominant vegetation with it covering approximately 80% of the site. Based on anecdotal evidence it has been steadily increases over the last six years. Reports from Massey University indicate that the extent of Raupo is increasing at approximately 0.2ha per year. This increase is the main reason why the Main Drain inlet and outer perimeter has reduced capacity.

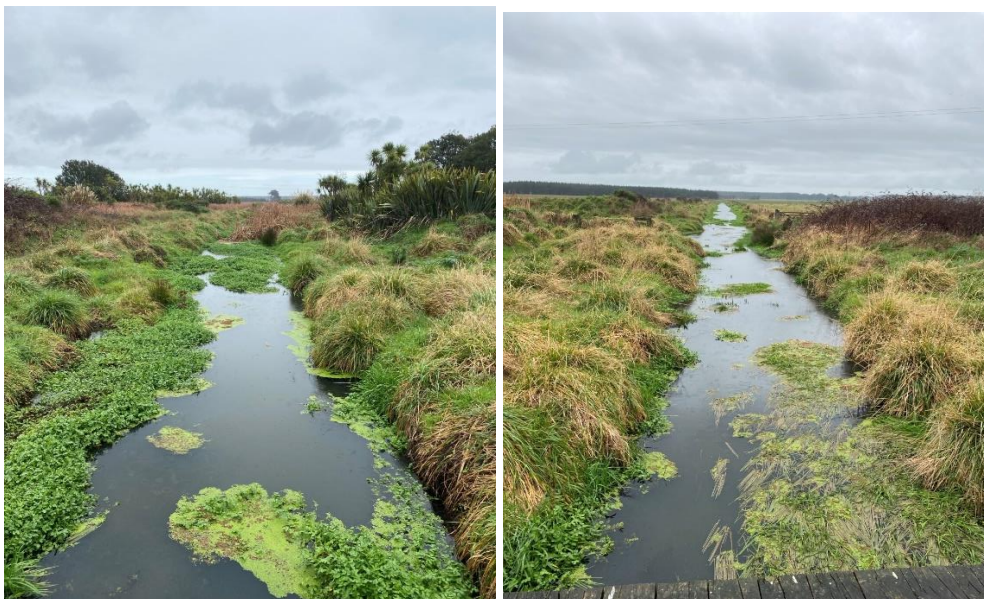
Figure 13: Main Drain inlet – Pukepuke Lagoon versus private section of Main Drain

In the background of the left image in Figure 13 raupo can be seen partly blocking the Main Drain Inlet. Based on satellite imagery these restraints are common within the first 180 metres of the inlet drain. During high flows these restraints create a barrier that forces water to back up within the drain. In comparison the Main Drain within private property has retained its design capacity (see Figure 13 for details on the right). As the vegetation within the drain is periodically submerged it is unlikely to provide a suitable nesting habitat. Notwithstanding this a survey of the entire length of the Main Drain inlet is required before any vegetation removal occurs.

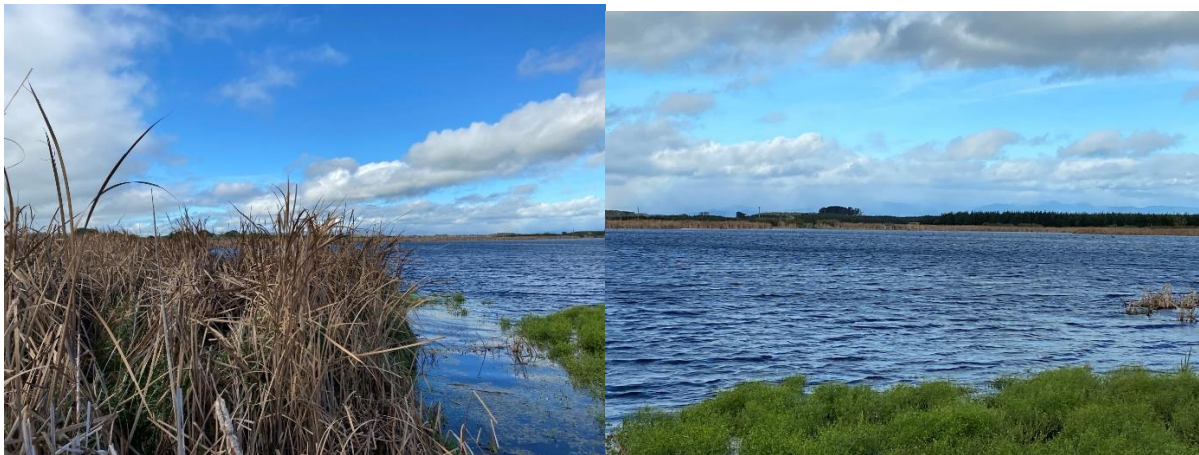
Figure 15: Raupo is reducing the extent of the main open water section of the Lagoon

Raupo can be seen around the entire perimeter of Pukepuke Lagoon dune lake (See Figure 15 for details).

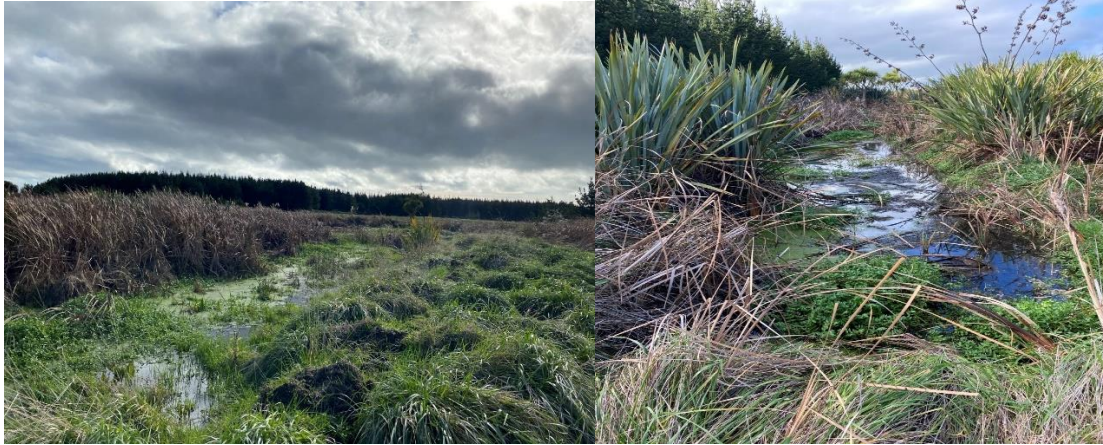
Figure 16: Vegetative restrictions within Outlet of the Lagoon and Perimeter Drain

While the outlet weir ultimately controls the water level with Pukepuke Lagoon the vegetation within the outlet holds up water during high flow events. This results in the lagoon level fluctuating by approximately 1000mm over the year. As can be seen from Figure 16, sections of the Pukepuke Lagoon outlet drain are restricted due to vegetation.

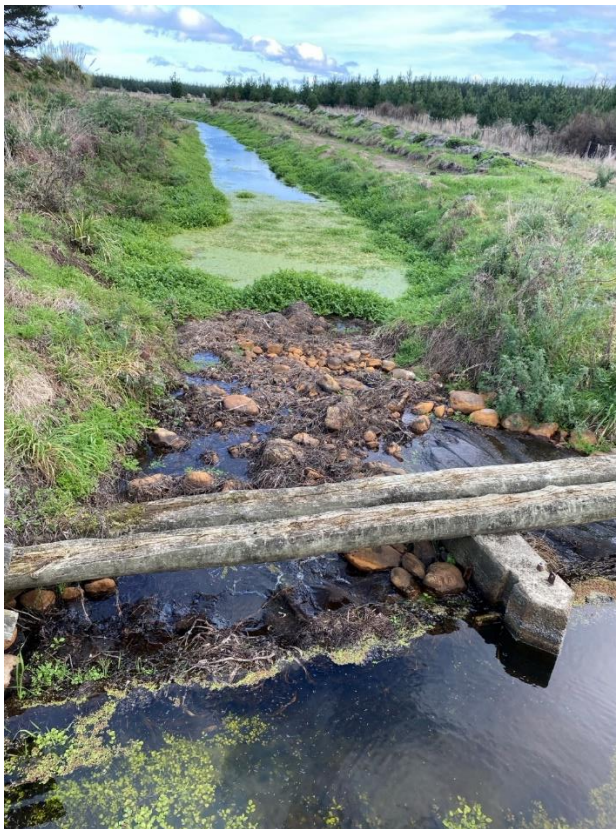
Figure 17: Fish Pass and section of perimeter outlet on private property

At the time of the site visits with the current flows the fish passage was considered that aquatic vertebrates could migrate from the coast to Pukepuke Lagoon with no physical barriers within the perimeter drain observed (See Figure 17 for details). While outside the control of the concession holder the fish passage could be compromised during low flow conditions.

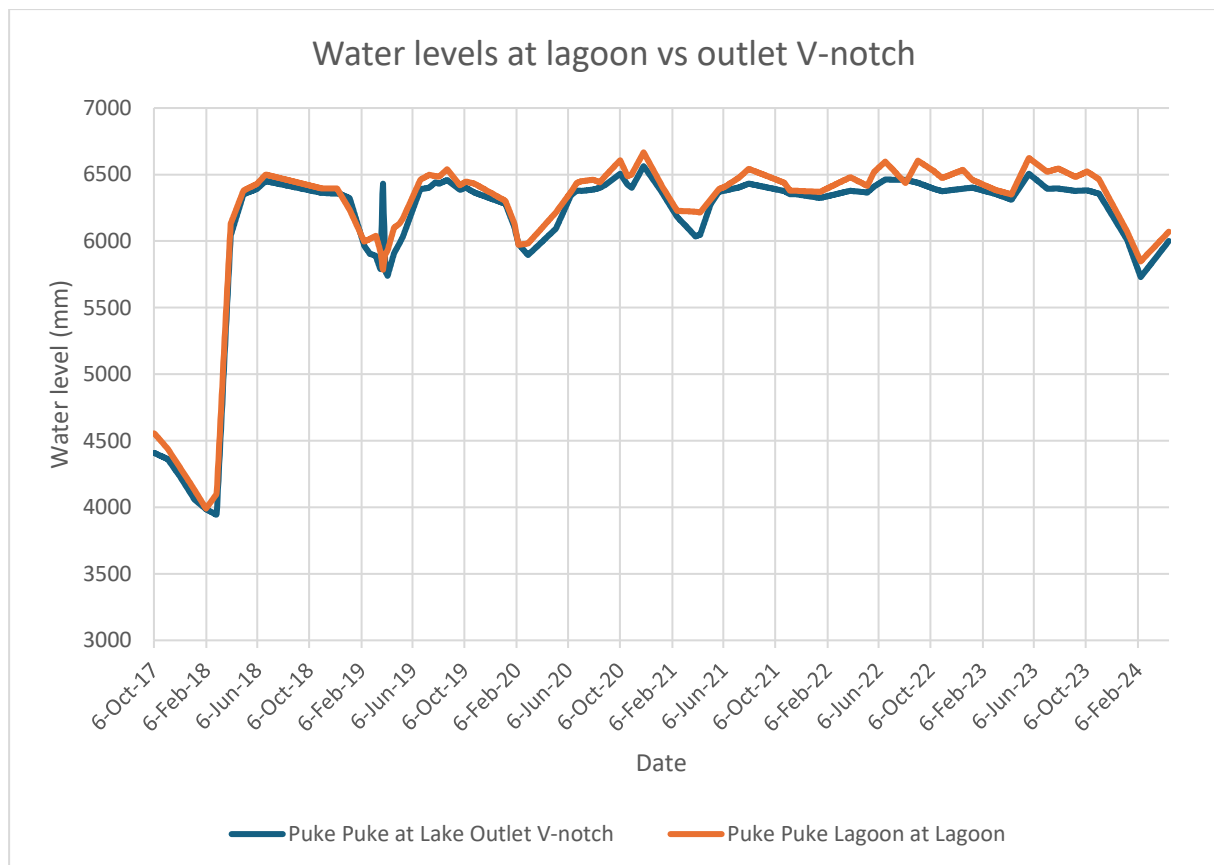
Figure 18: Daily water level records from Pukepuke Lagoon.

Horizons continuously measure the water level with Pukepuke Lagoon. Based on the current daily data set there is a clear seasonal fluctuation of the lake between the weir high and the maximum freeboard. This seasonal pattern was more distinct in historical data recorded prior to 2018. Something occurred in 2018 that suddenly increased the water level within Pukepuke

Lagoon (see Figure 18 for details). This increased the minimum water level from approximately 4336mm to approximately 5784mm. Given that there was a step change it appears that the outlet weir was altered in 2018 to change the minimum water level by 1,448mm. A change of this nature effects how the Pukepuke Lagoon operates hydraulically and increases the importance of maintaining inlet outlet capacity as there is limited freeboard. Notwithstanding this, the water level within the Lagoon since this change has fluctuated between 5784mm and 6667mm (883mm). As the water level post the change in 2018 increased steadily over a period of couple of months this change indicates that the Lagoon was steadily filling up rather than a step change where the levels were recalibrated where the change would have been instantaneous. More information is required to understand what caused this increase and why it was implemented.

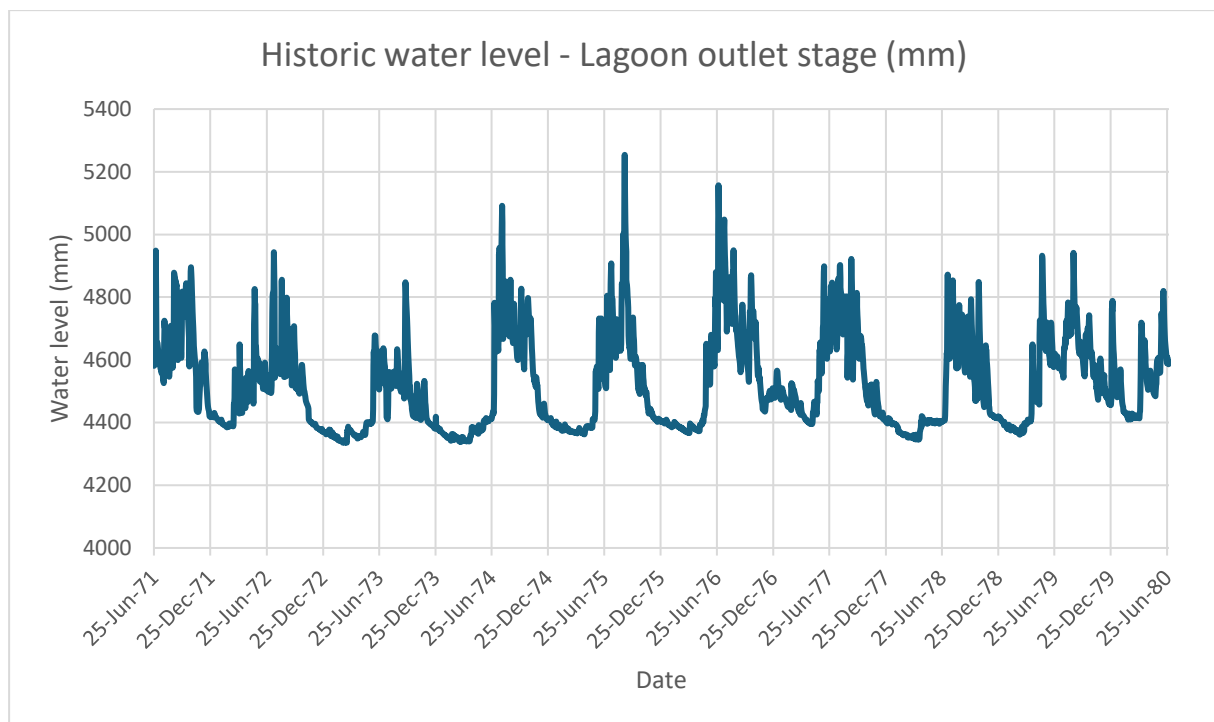
Figure 19: Historical water level records

The historical information demonstrates that the Lagoon used to reseed down to 4336mm mark on a seasonal basis (See Figure 19 for details). Therefore the changes in 2018 permanently lifted the level of the lagoon and significantly increased the risk of flooding for surrounding land.

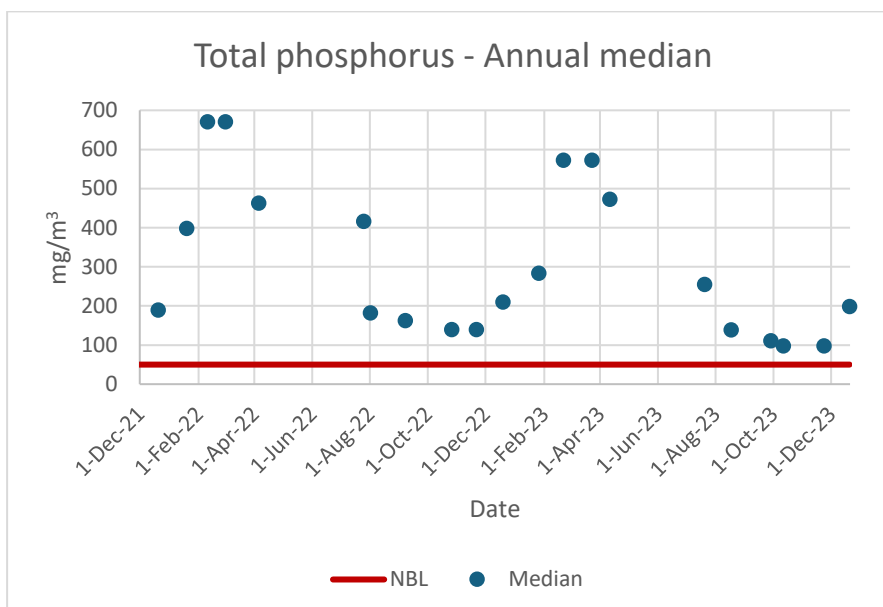
Figure 24: Median phosphorous concentrations

The poor water quality assessment is primarily due to elevated Nitrogen and phosphorous concentrations (See Figures 21 and 25 for details).
