Pukepuke Lagoon Concession WA-219

Annual report

**Prepared for the Department of
Conservation**

3 November 2025

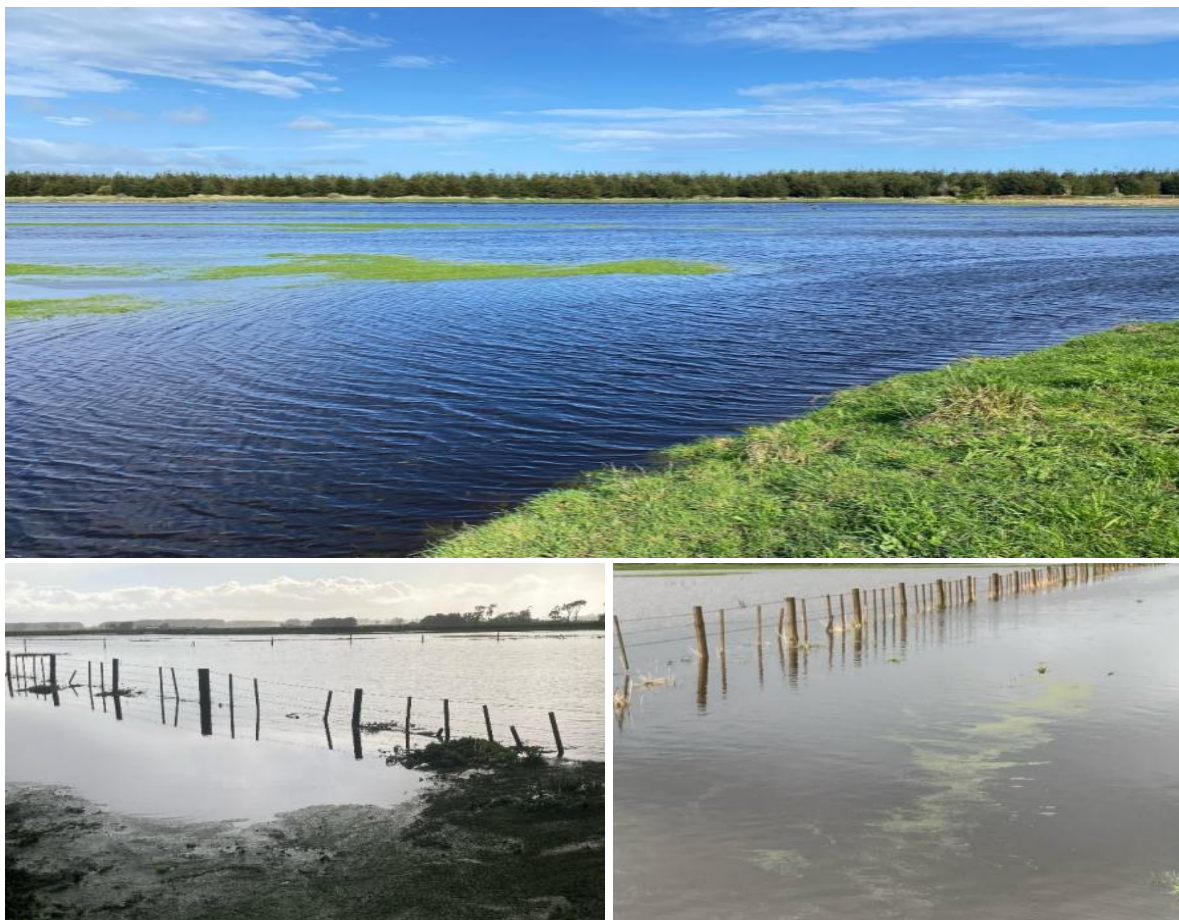
Prior to this mechanical clearance, Council prepared a vegetation removal plan which recommended that DOC lift the concession suspension to enable mechanical clearance to be undertaken of the drains. As no mechanical clearing had occurred since 2018, vegetation had proliferated and reduced the hydraulic capacity of the inlet, outlet and perimeter drains. As a result, neighbouring properties frequently experienced flooded pastures during wet periods of the year, while lagoon levels fell due to restricted inflows from vegetation which caused the inflow to bypass the lagoon via an emergency bypass channel located to the north east of the lagoon. The repeated flooding of adjacent pastures over several consecutive years resulted in an adjacent landowner losing productive land (see images below).

Figure 1: Flooding of adjacent paddocks (2024 above & 2023 below)

It is evident from the difference in the site visit pictures taken between July 2024 and October 2024 that the mechanical clearance of the perimeter drain of Pukepuke Lagoon has had a positive impact on the lagoon's level as well as the surrounding farmland with no flooding issues being highlighted by the landowners during the winter of 2025.

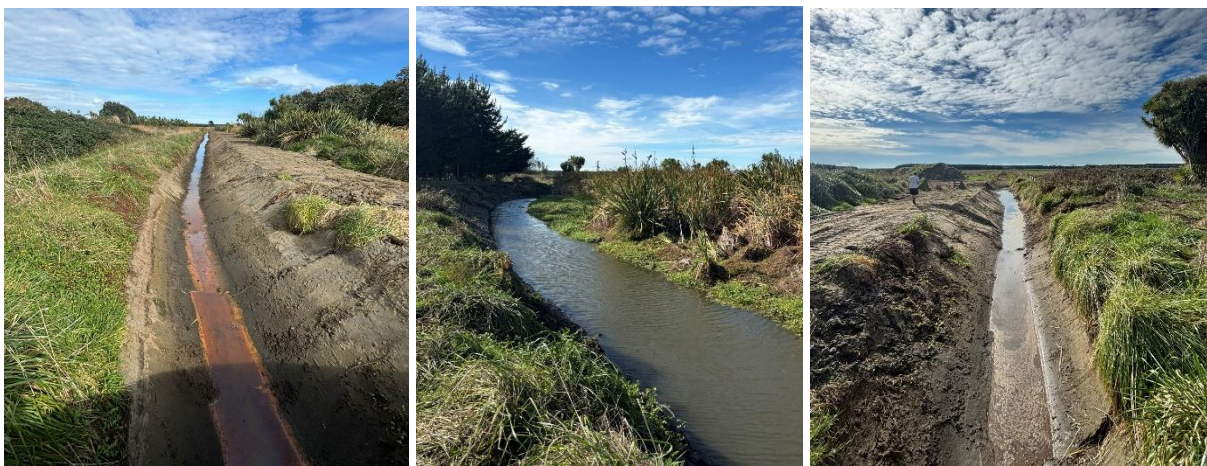
Figure 2: Drains following mechanical clearance

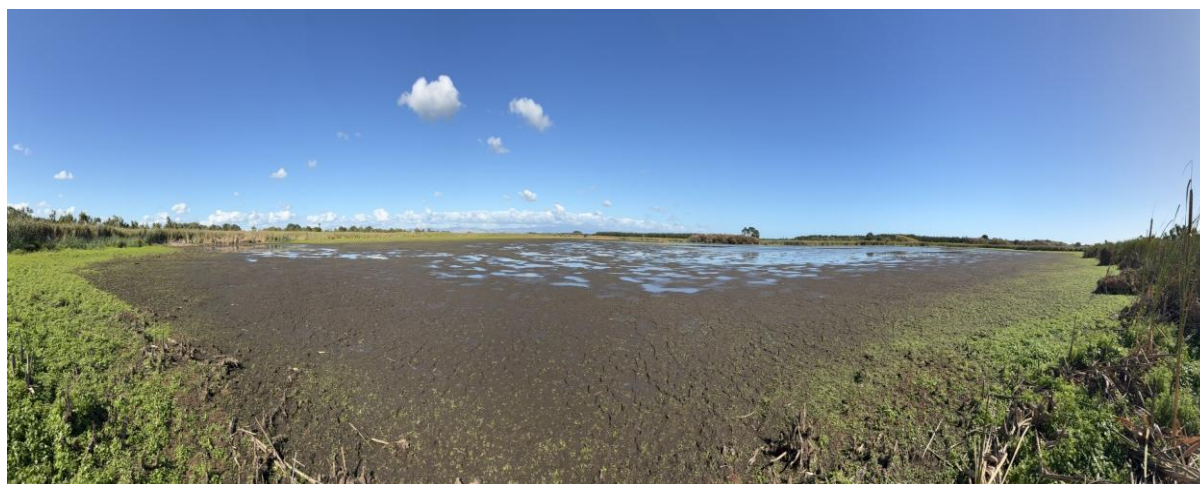
Updated information was requested in October 2025 with the results including 65 black swan observed during an aerial count in January 2025. The Fish & Game officer highlighted the fact that there were some issues at the lagoon early in 2025 with the lake being largely dry leading up to May 2025 which may have had an impact on the swan populations at the time of counting, Council also became aware of this lack of water in April 2025 (see figures 1 & 2 below).

Figure 3: Pukepuke lagoon in dry state Jan 2025 – from Fish & Game

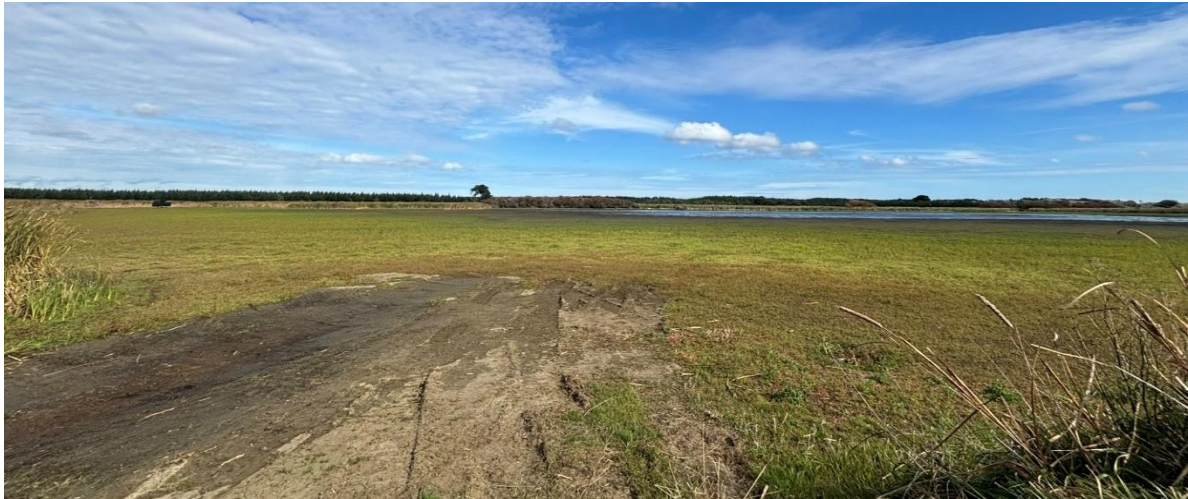
Figure 4: Pukepuke lagoon in dry state April 2025 – from Manawātū District Council

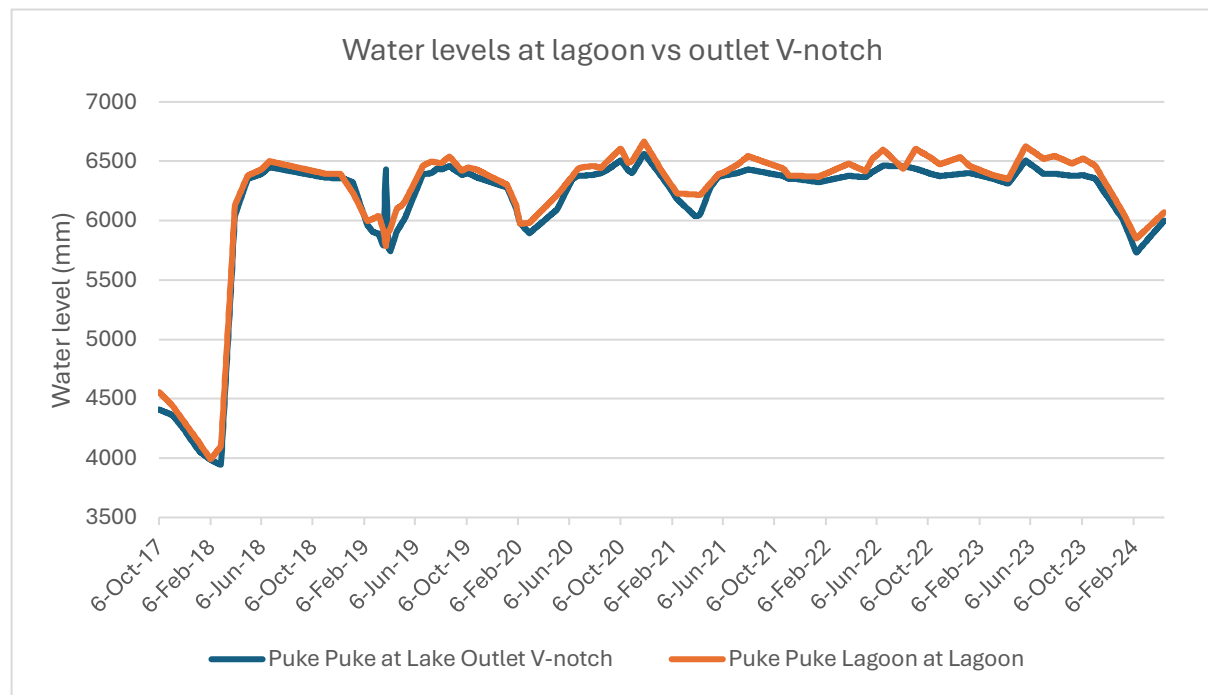
The graph below shows the change in the lagoon water quantity over the time period of 2017 to 2024. Council will request updated water quantity data from Horizons in order to see any changes which may have occurred since Feb 2024.

As mentioned in Council's Concession Management Plan the lake levels raised significantly between February and July in 2018, the cause of this is not certain.

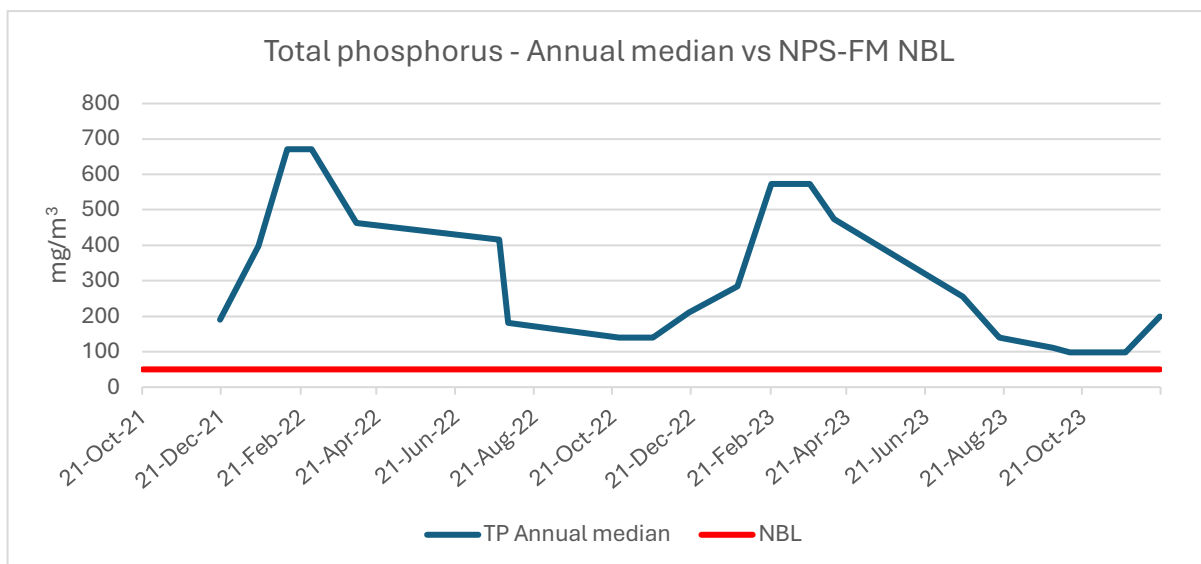
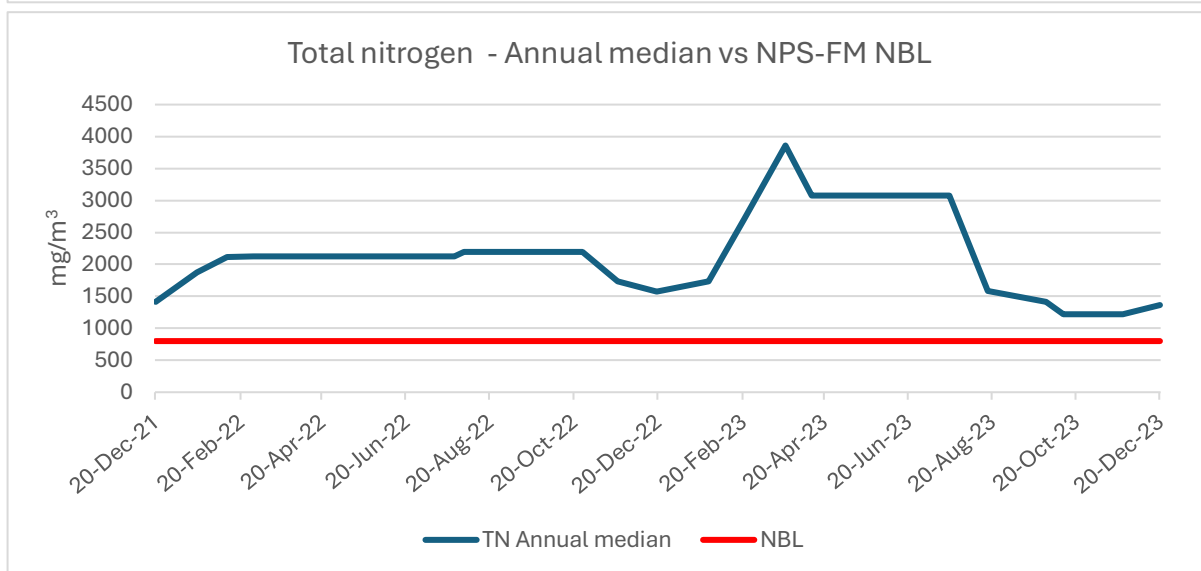
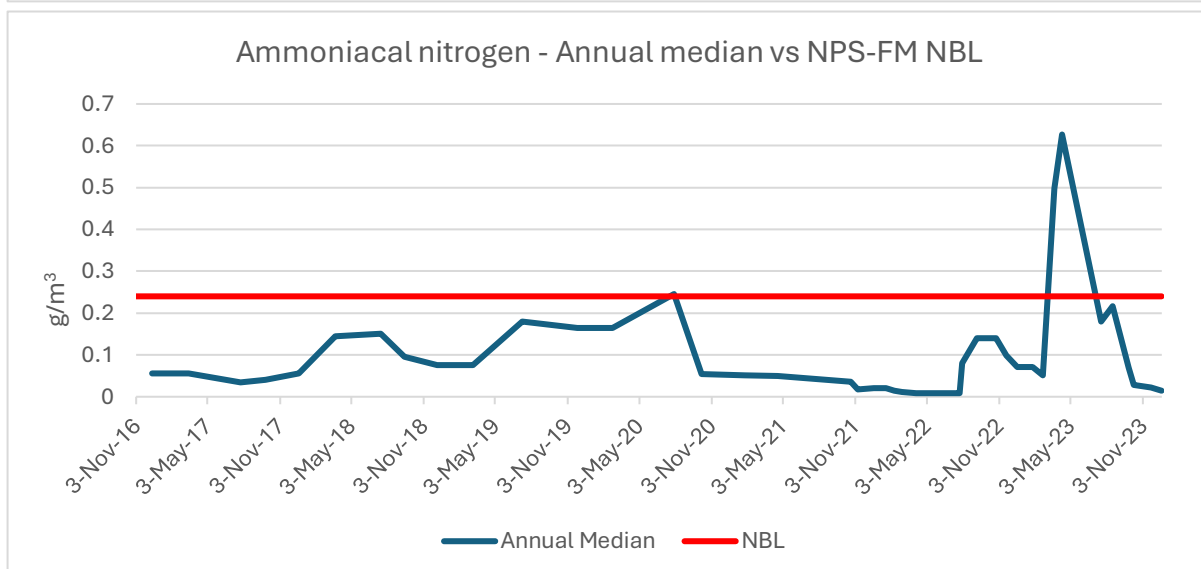
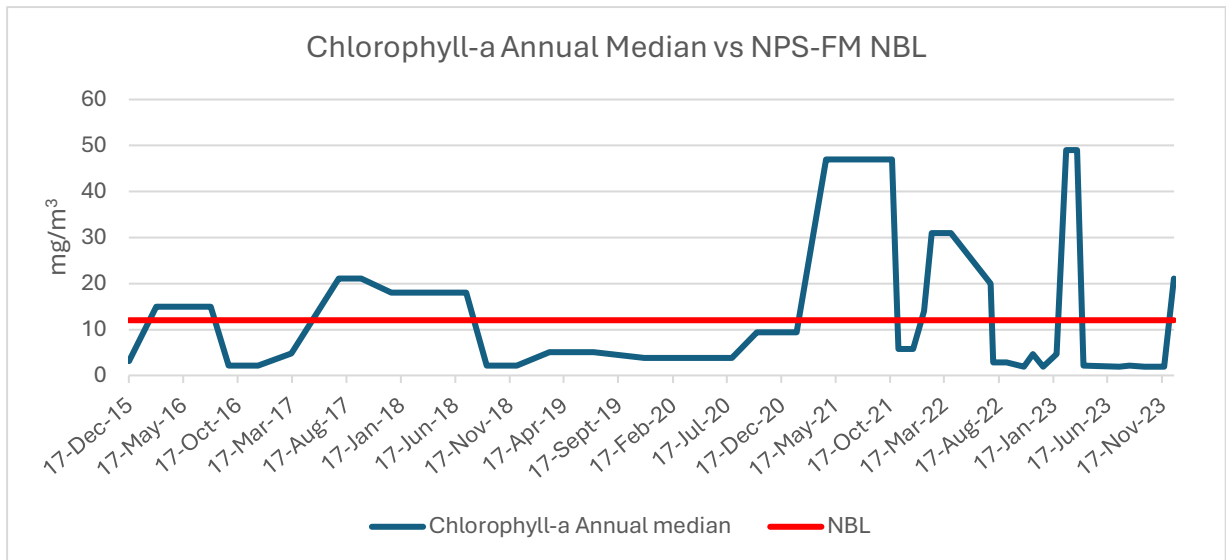
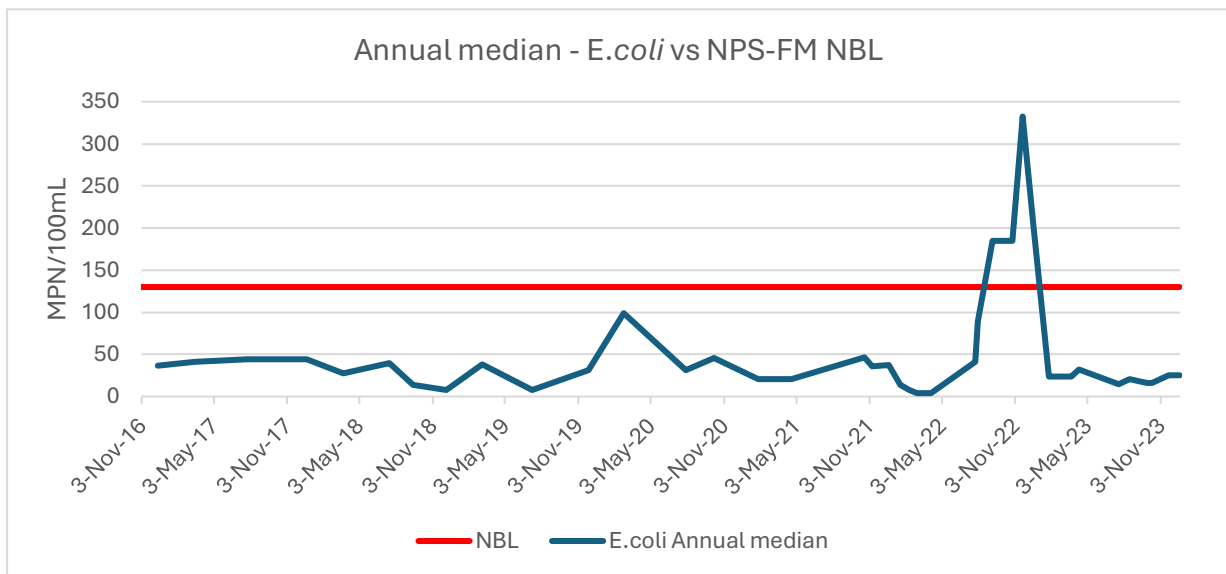
The graphs below show the water quality within Pukepuke Lagoon for parameters including total phosphorus, E.coli, total nitrogen, chlorophyll-a & ammoniacal nitrogen. The annual median has been calculated and compared against the national bottom lines outlined in the National Policy Statement for Freshwater Management (NPS-FM). Although concession WA-219 does not authorise activities that directly affect water quality, reporting these results provides environmental context, establishes a baseline and helps detect catchment driven trends that may inform future management of the area.

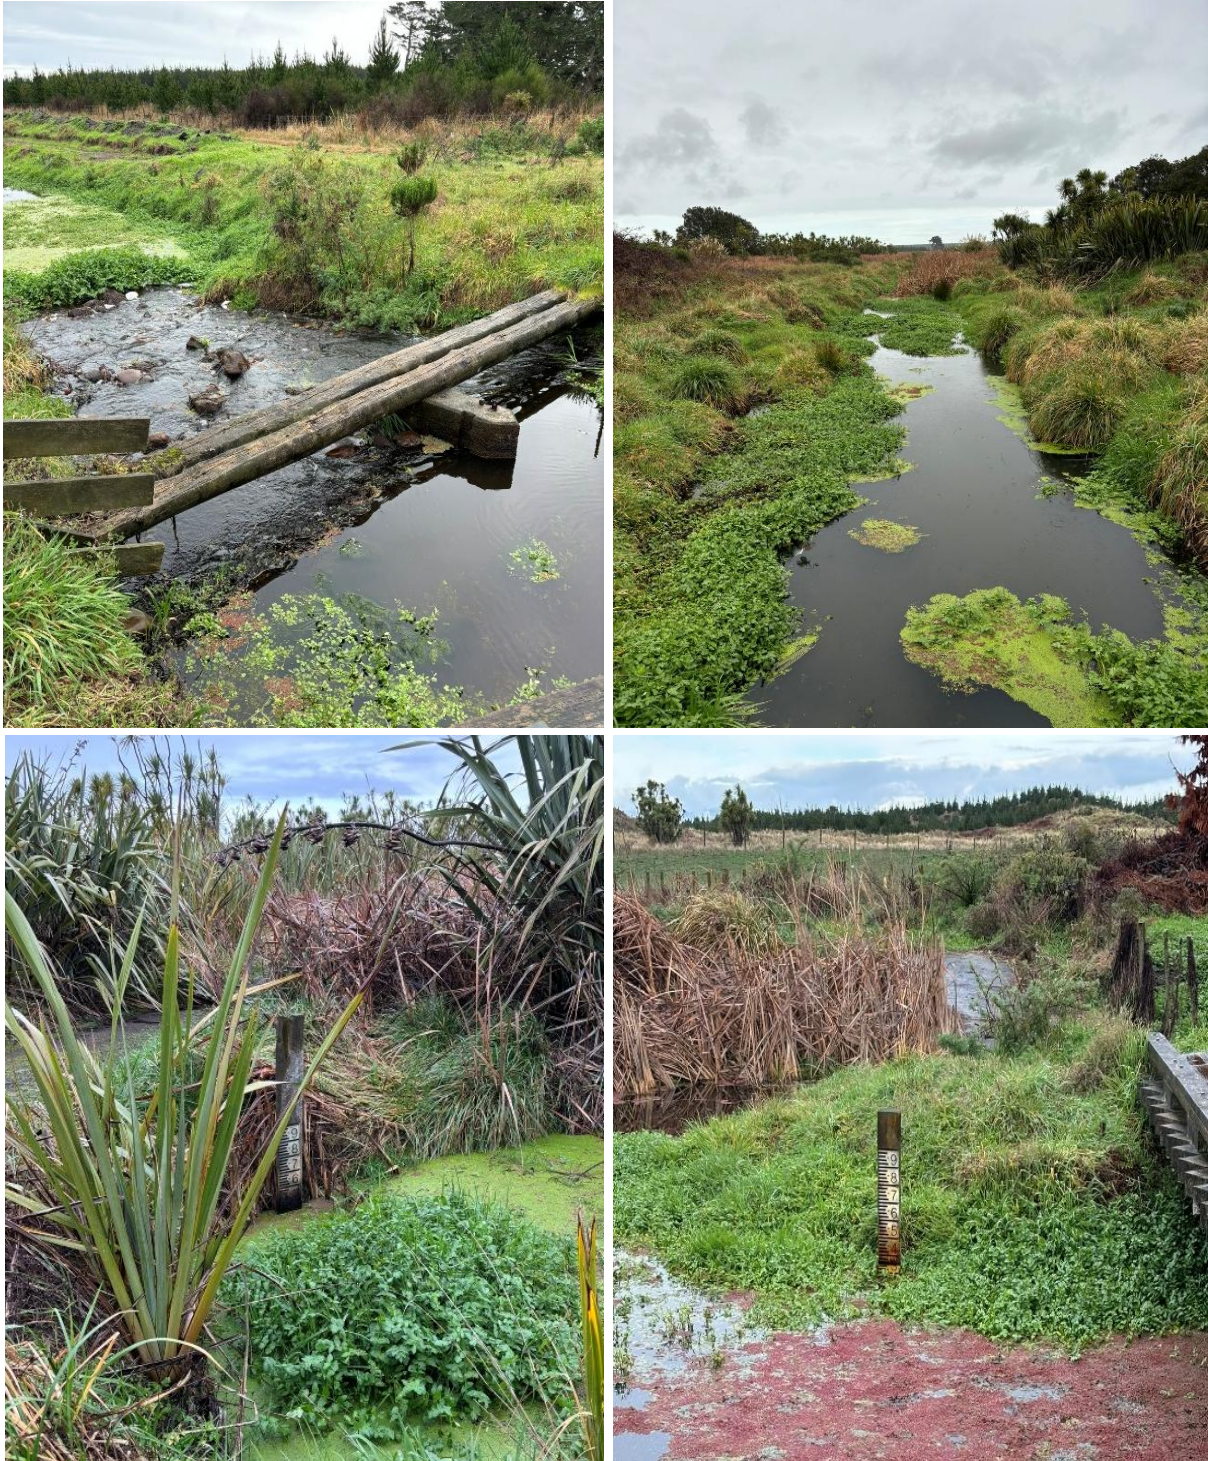
July 2024

Figure 5: fish passage (top left), drainage channel (top right), upstream gauge (bottom left), weir gauge (bottom right)

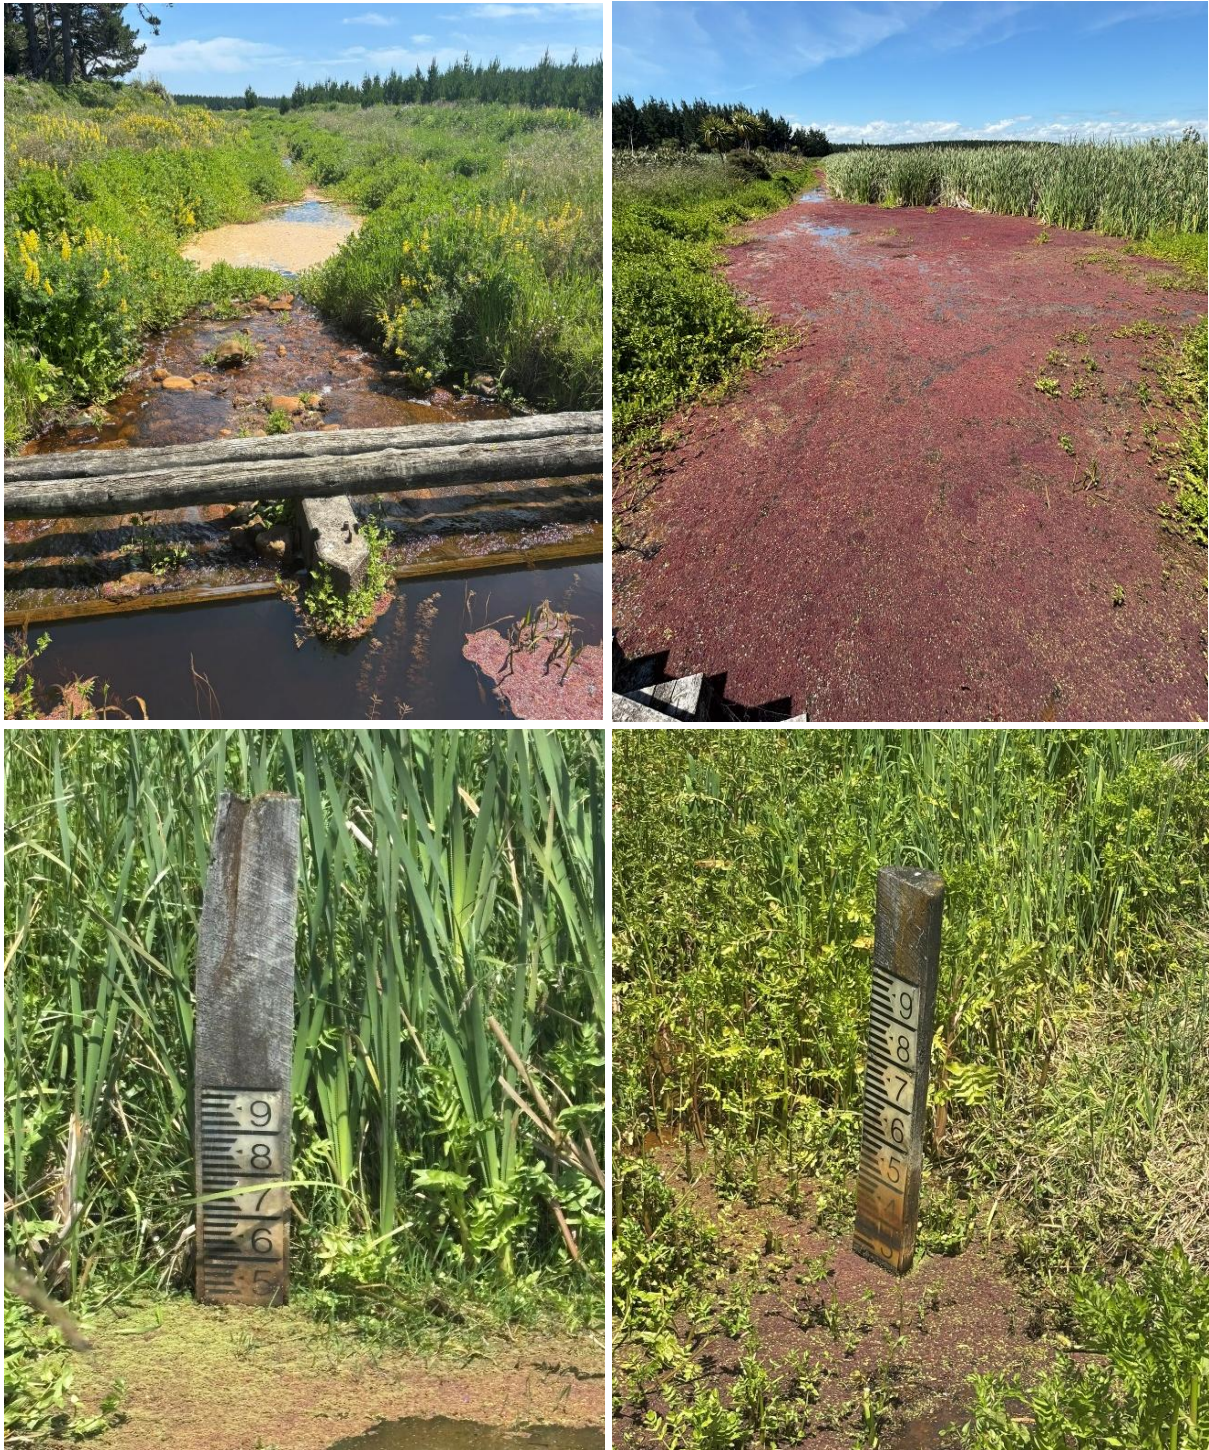
| Visit month | Date | Staff | Gauge 1 (m.a.s.l.) | Gauge 2 (m.a.s.l.) | Fish passage Ok? | Actions raised | Notes |
|---|---|--|---|---|--|--|---|
| November 2024 | 19/11/24 | Andrew van Bussel Robert Rose Anastasia Boniface | 1.4 | 1.25 | Yes | Research and plan required on Council's requirements under the concession | |

Figure 6: fish passage (top left), weir looking east (top right), upstream gauge (bottom left), weir gauge (bottom right)

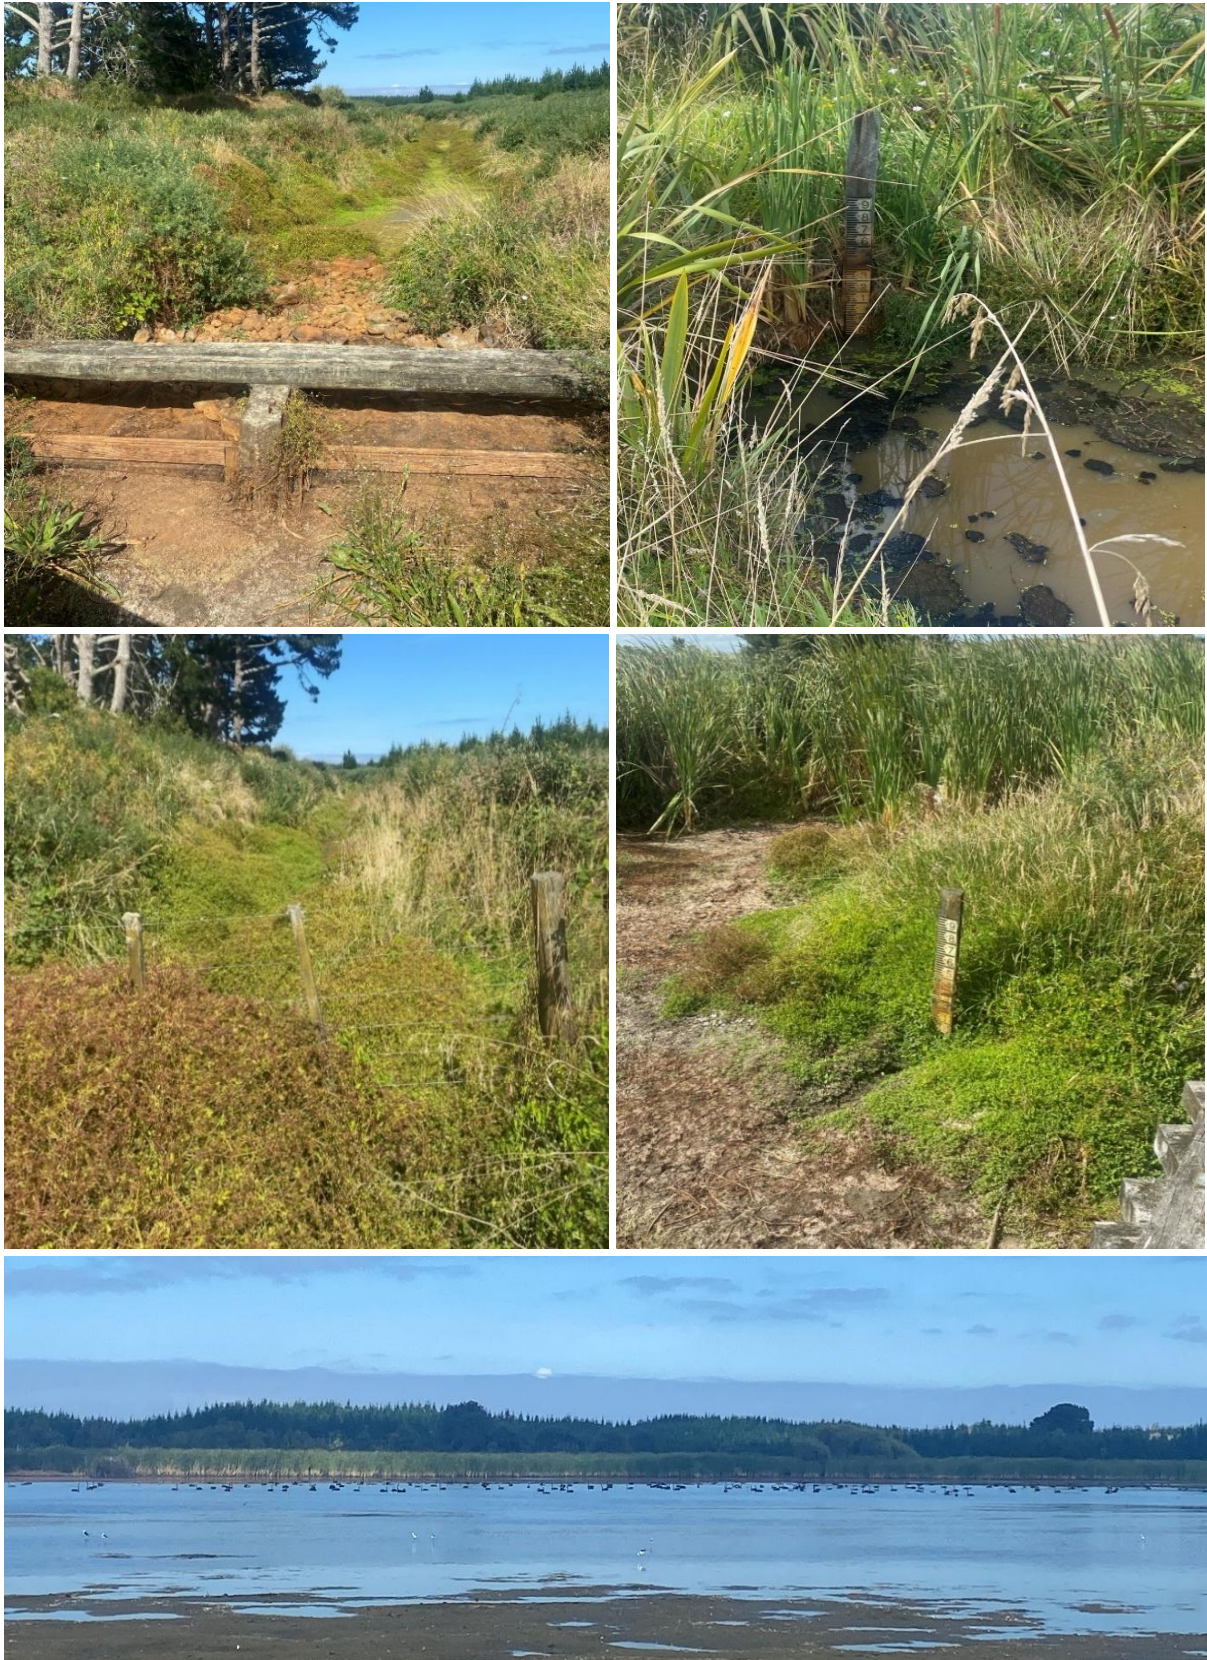
10 February 2025

| Visit month | Date | Staff | Gauge 1 (m.a.s.l.) | Gauge 2 (m.a.s.l.) | Fish passage Ok? | Actions raised | Notes |
|---|---|--|---|---|--|--|---|
| February 2025 | 10/02/25 | Wiremu Greening Robert Rose Adam Jamieson | 1.5 | 1.5 | Completely dry at fish passage | Begin discussion with DOC on vegetation clearance | Drain levels low |

Figure 7: fish passage (top left), upstream gauge (top right), spillway looking west (bottom left), weir gauge (bottom right), lake level (bottom)

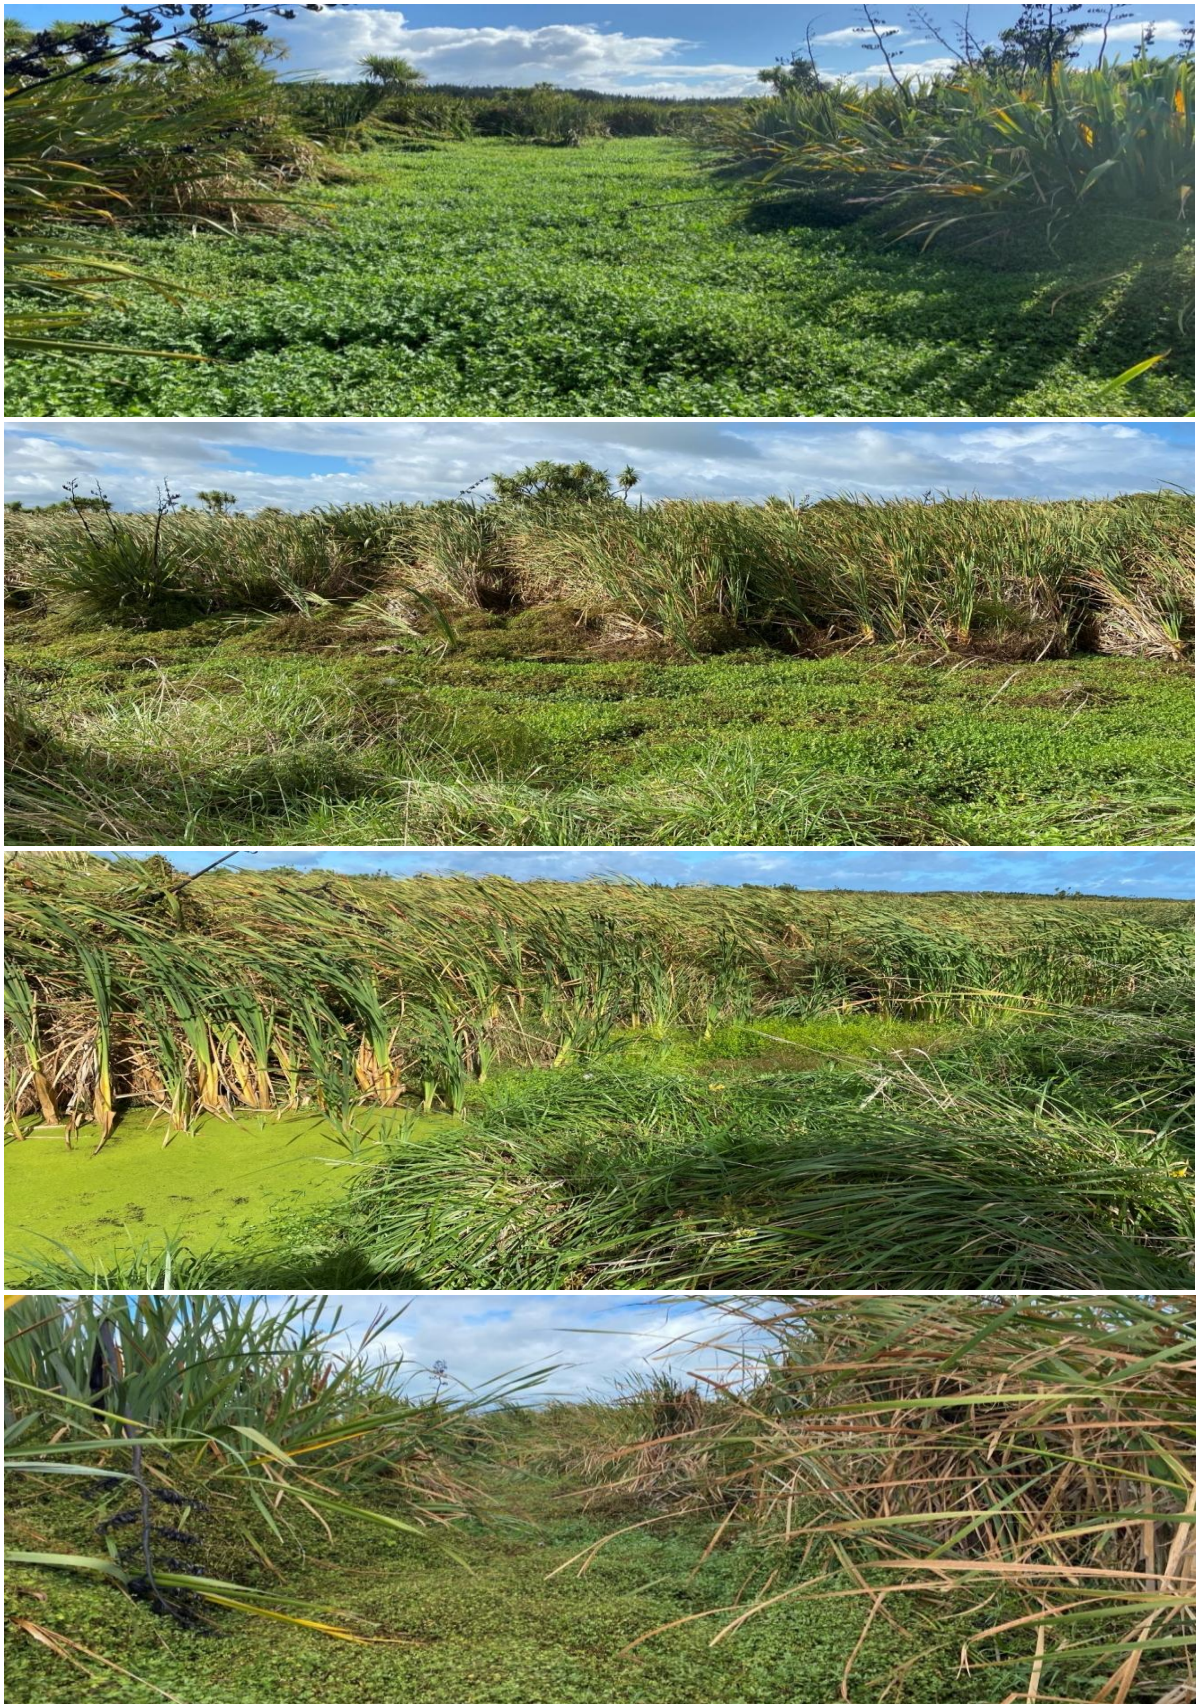
7 April 2025 – pre mechanical clearance

Figure 8: images of over vegetated drains

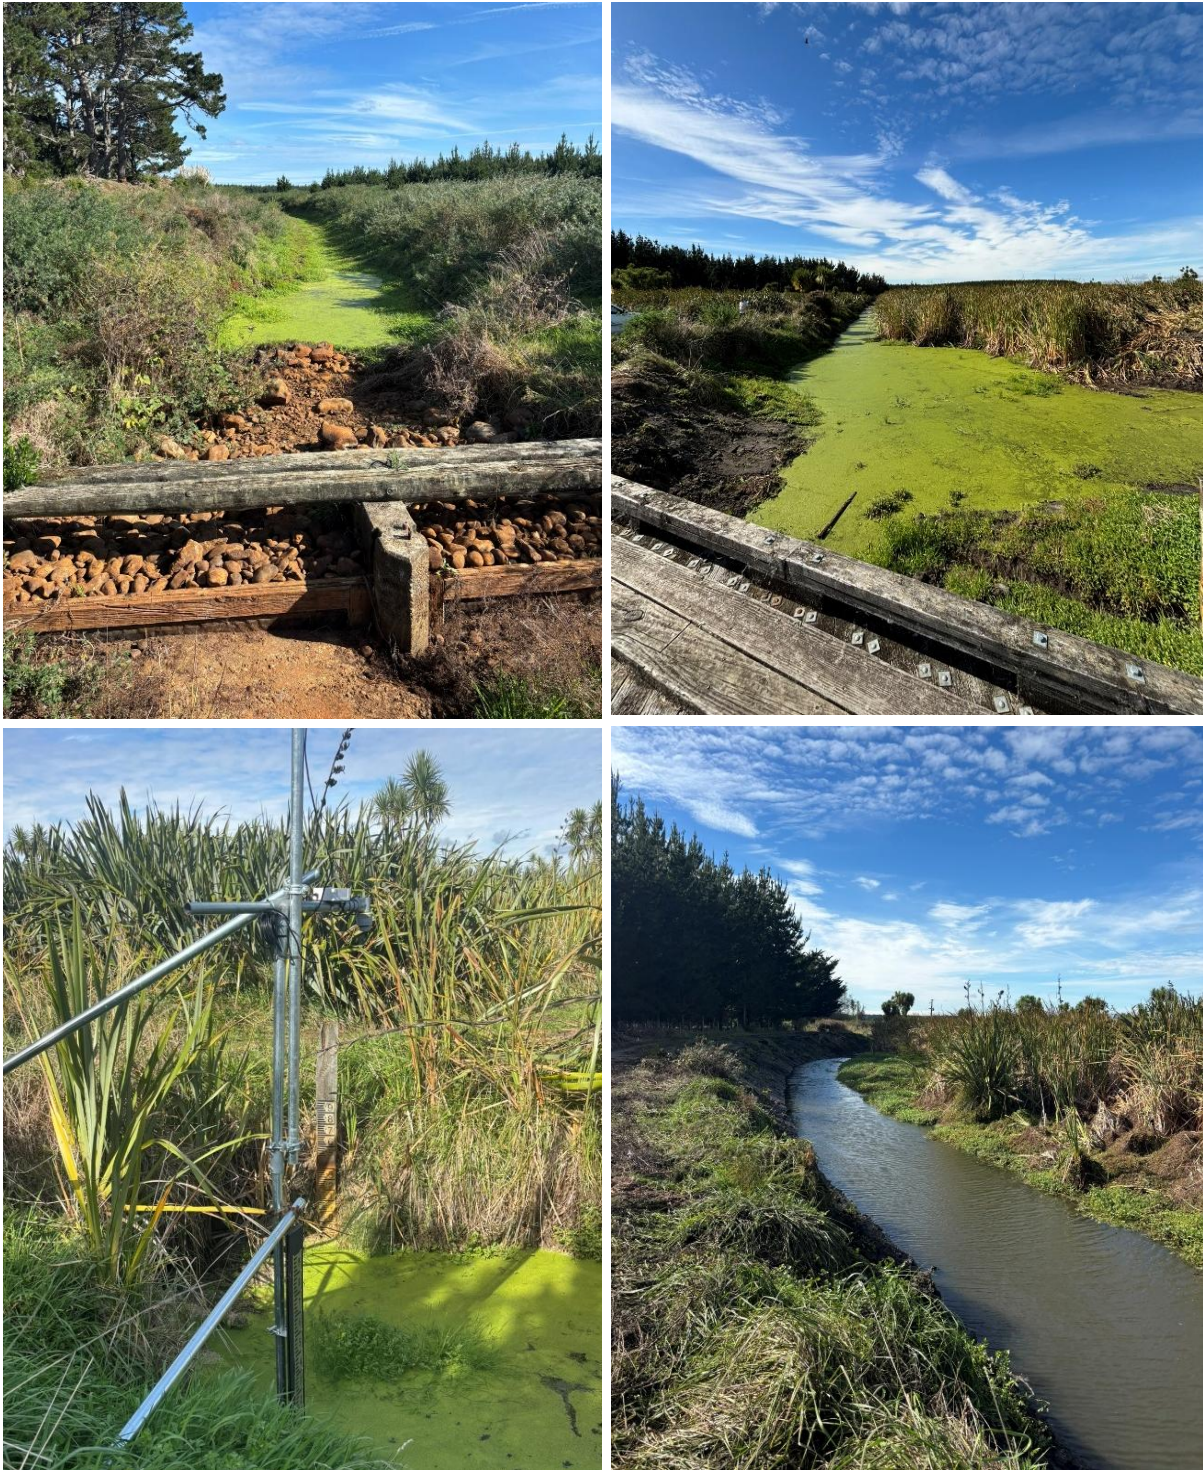
29 April 2025 – post mechanical clearance

| Visit month | Date | Staff | Gauge 1 (m.a.s.l.) | Gauge 2 (m.a.s.l.) | Fish passage Ok? | Actions raised | Notes |
|---|---|--|---|---|--|--|---|
| April 2025 | 29/04/25 | Robert Rose Tracey Evans Anastasia Boniface | 0.75 | 0.6 | Still no water around fish passage – however the rocks had been repositioned following mechanical vegetation clearance. | None | Inspection undertaken following the mechanical clearance of the drains on 22 nd April. No water flowing in or out of the lagoon and perimeter drain level still well below the top of the fish passage. |

Figure 9: fish passage (top left), weir looking east (top right), upstream gauge (bottom left), cleared drain (bottom right)

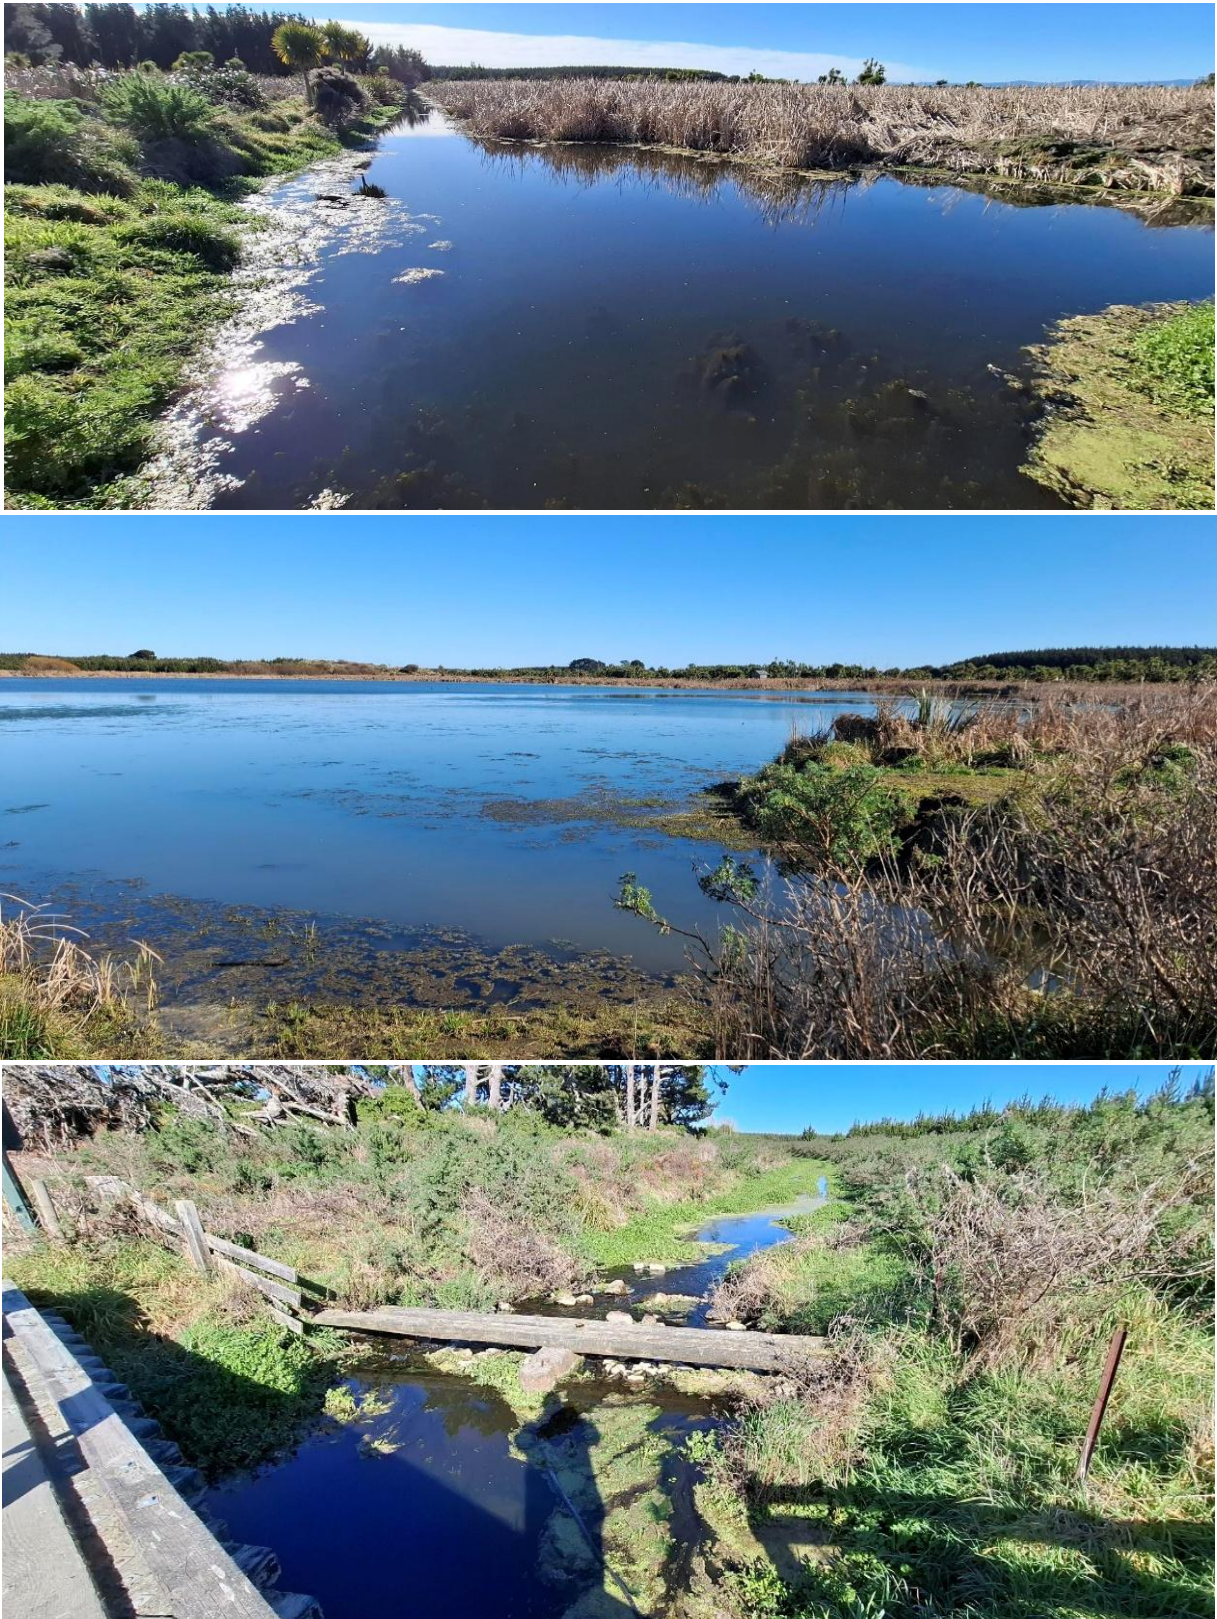
| Visit month | Date | Staff | Gauge 1 (m.a.s.l.) | Gauge 2 (m.a.s.l.) | Fish passage Ok? | Actions raised | Notes |
|---|---|--|---|---|--|--|---|
| August 2025 | 27/08/25 | Adam Jamieson Gavin Cobcroft | Not recorded | Not recorded | Yes | None | Lagoon had more water since previous site visit, drains working as intended following clearance. |

Figure 10: weir looking east (top), lagoon level (middle), fish passage (bottom)

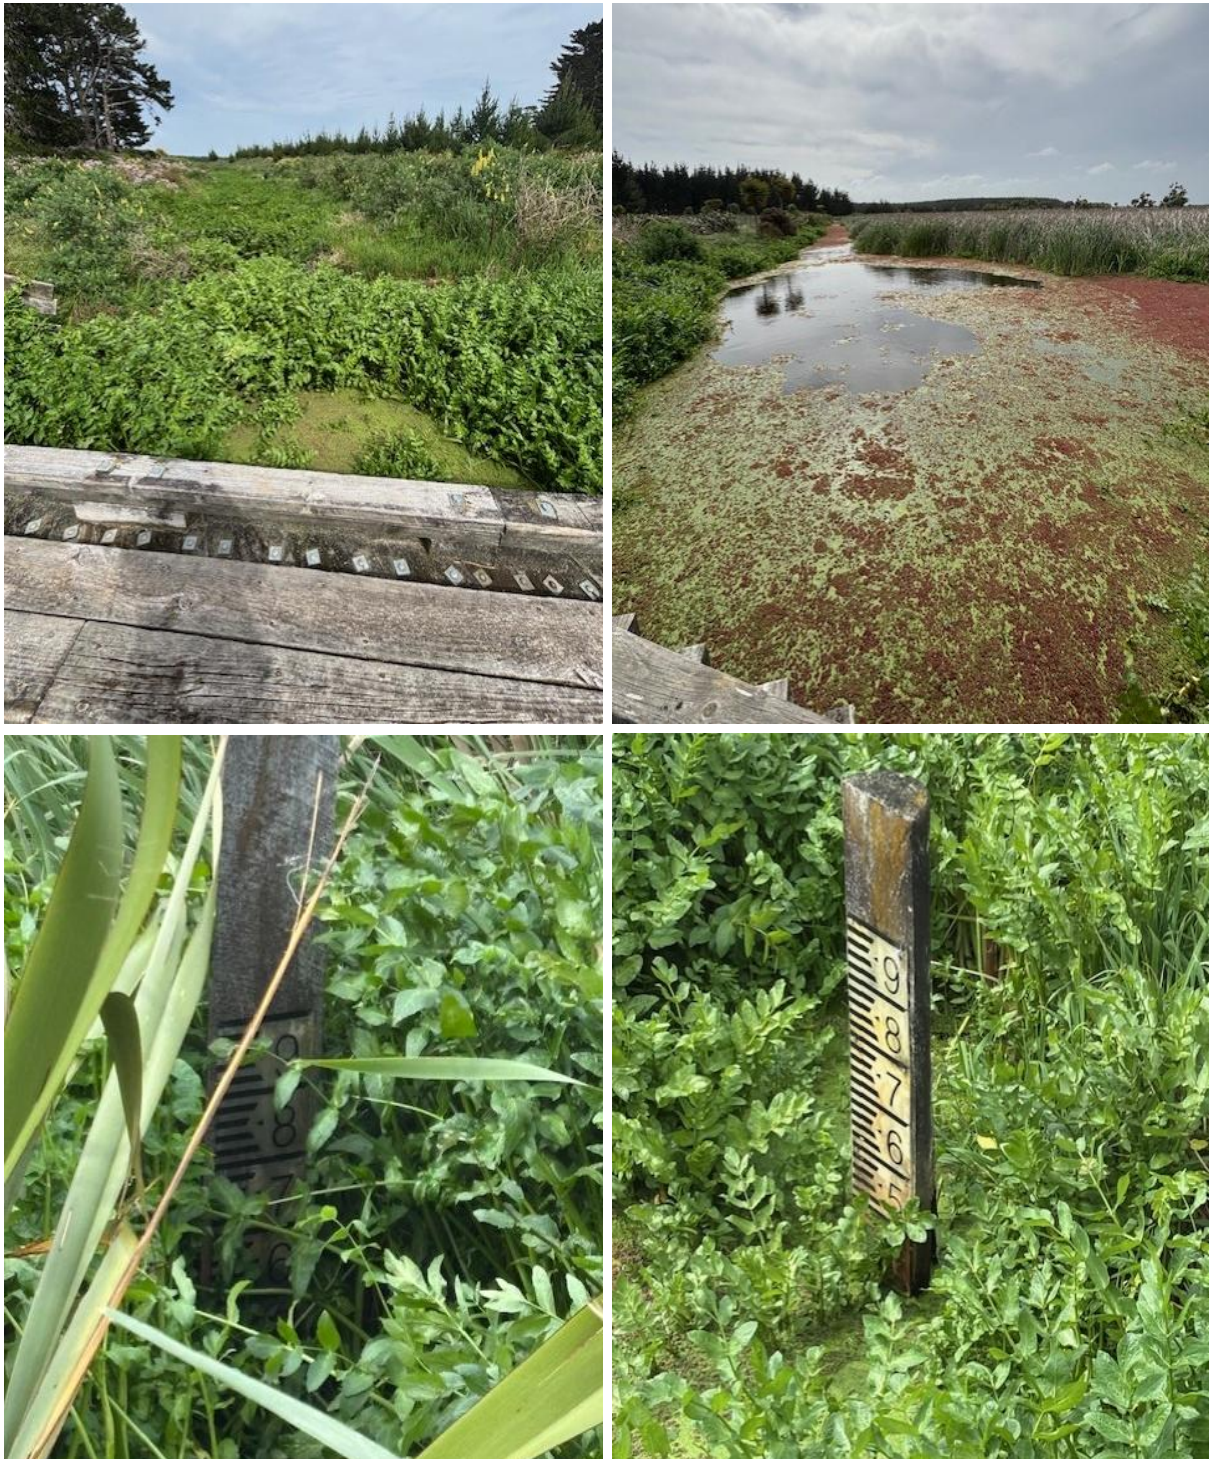
| Visit month | Date | Staff | Gauge 1 (m.a.s.l.) | Gauge 2 (m.a.s.l.) | Fish passage Ok? | Actions raised | Notes |
|---|---|--|---|---|--|--|---|
| October 2025 | 22/10/25 | Robert Rose Anastasia Boniface | 1.4 | 1.38 | Yes, water flowing however covered by vegetation (see site visit images) | Complete annual report | |

Figure 11: fish passage (top left), weir looking east (top right), upstream gauge (bottom left), weir gauge (bottom right)

The last site visit undertaken on 22 October 2025 confirms that no further vegetation is required to be removed at this stage. Monitoring of the drains, weir, fish passage, spillway and bird numbers will continue in 2026 via bi-monthly site visits with the water levels and any issues being recorded within the log sheet to avoid these being missed.
